FIELD INSPECTION

| Project Name: | Mountain Valley Pipeline | Inspector: | Marshall Willis |
| Spread I: Franklin County | STA 13626+10 – 13644+52 | Weather (Wet/Dry/Rain): | Wet |

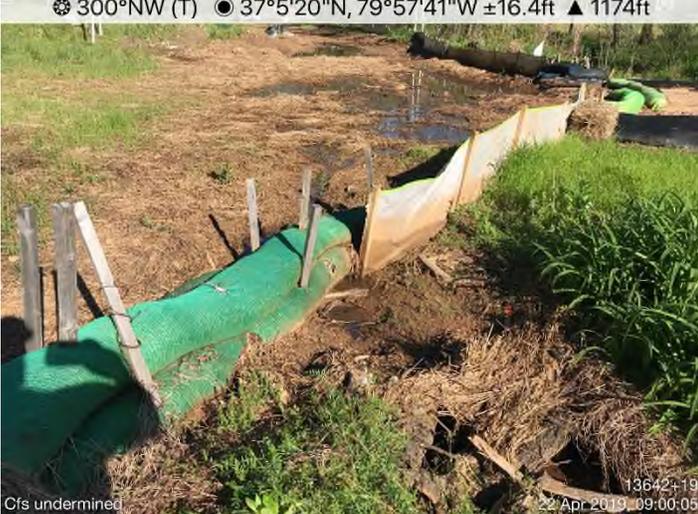
STA 13642+19: CFS undermined on CIS of S-E28.

| <p>Fig. 1: STA 13642+19 – CFS undermined CIS S-E28.</p> <div style="border: 1px solid gray; padding: 2px; margin-bottom: 5px;"> 300°NW (T) ● 37°5'20"N, 79°57'41"W ±16.4ft ▲ 1174ft </div> <div style="display: flex; justify-content: space-between; font-size: x-small; margin-top: 5px;"> Cfs undermined 13642+19 22 Apr 2019, 09:00:05 </div> | <p>Fig. 2: STA 13630+00 – 13631+50 – Erosion below permanent waterbars.</p> <div style="border: 1px solid gray; padding: 2px; margin-bottom: 5px;"> 239°SW (T) ● 37°5'25"N, 79°57'52"W ±16.4ft ▲ 1202ft </div> <div style="display: flex; justify-content: space-between; font-size: x-small; margin-top: 5px;"> 22 Apr 2019, 09:12:31 </div> |

Recommended Corrective Action: Maintain and install all controls per the approved plan and specs.

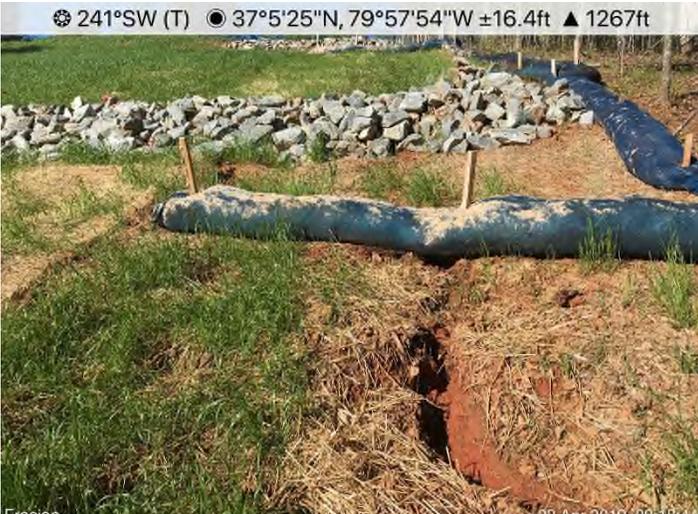
STA 13630+00 – STA 13631+50: Erosion on downslope side of permanent waterbar end treatments.

| <p>Fig. 3: STA 13630+00 – 13631+50 – Erosion below permanent waterbars.</p> <div style="border: 1px solid gray; padding: 2px; margin-bottom: 5px;"> 241°SW (T) ● 37°5'25"N, 79°57'54"W ±16.4ft ▲ 1267ft </div> <div style="display: flex; justify-content: space-between; font-size: x-small; margin-top: 5px;"> Erosion 22 Apr 2019, 09:18:44 </div> | <p>Fig. 4: St. Clair Access Road – Stabilize shoulder of access road.</p> <div style="border: 1px solid gray; padding: 2px; margin-bottom: 5px;"> 126°SE (T) ● 37°5'21"N, 79°57'55"W ±16.4ft ▲ 1338ft </div> <div style="display: flex; justify-content: space-between; font-size: x-small; margin-top: 5px;"> Stabilize St. Clair Access 22 Apr 2019, 09:49:42 </div> |

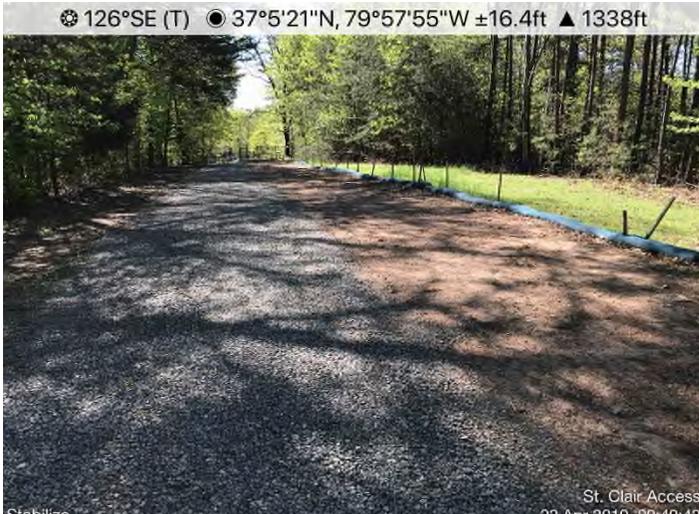
St. Clair Access Road: Stabilize shoulders of access road.
