FIELD INSPECTION

Project Name:	Mountain Valley Pipeline	Inspector:	Matthew Grant
Inspection Date:	Tuesday, May 14, 2019	Project Contact:	Brian Clauto
Spread: Pittsylvania County MP296-298 St15650-15739	Spread I	Weather (Wet/Dry/Rain):	Dry

FIELD INSPECTION PHOTO LOG

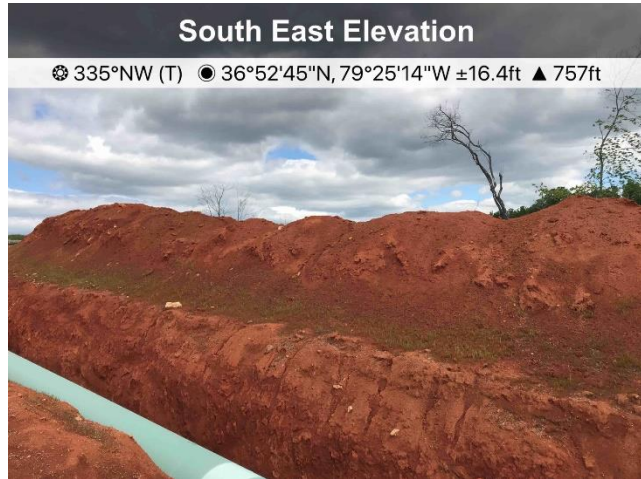
- Streams / wetlands inspected included: S-Q4, W-Q2, S-Q3, S-Q2, SB-6, SB-8, SB-9. ECD's were in place at all inspected streams and no impacts were observed.
- St#15699- Soil stockpile lacks adequate stabilization
- Designated stream SB-8 remove accumulated sediment from bridge approach and repair undermined CFS

▪ Fig. 1 St15699 soil stock pile lacks adequate stabilization

Recommended Corrective Action: Maintain all controls per the approved plan and specs.

Deadline: Within 24hr notification

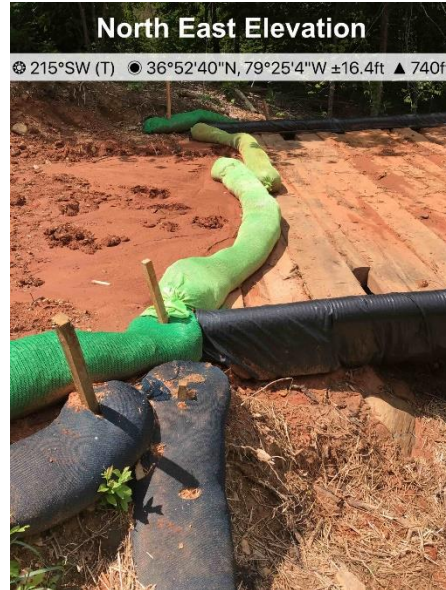
▪ Fig. 2 SB-8 remove accumulated sediment from bridge approach and repair undermined CFS
