FIELD INSPECTION

Project Name:	Mountain Valley Pipeline	Inspector:	Matthew Grant
Inspection Date:	Tuesday, September 25, 2018	Project Contact:	Brian Clauto
Spread: Montgomery County	Spread H	Weather (Wet/Dry/Rain):	Wet

FIELD INSPECTION PHOTO LOG

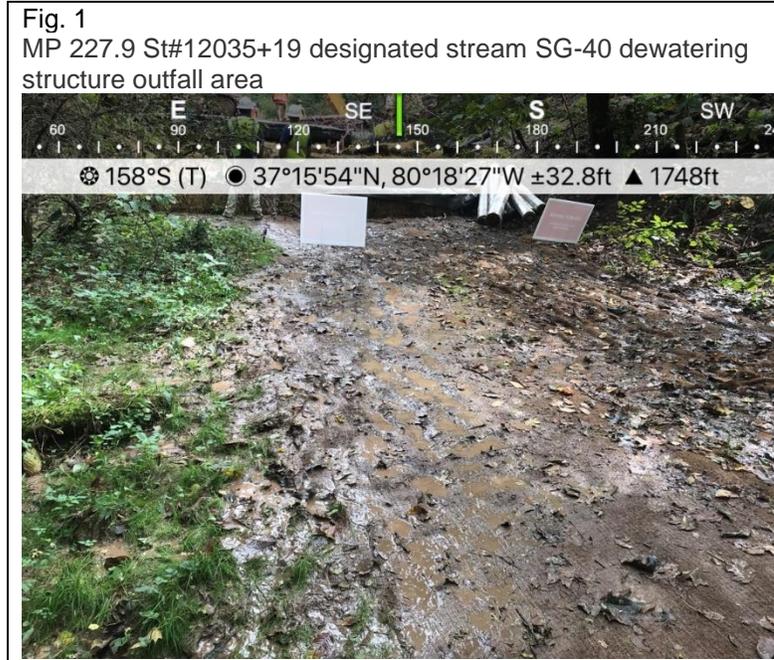
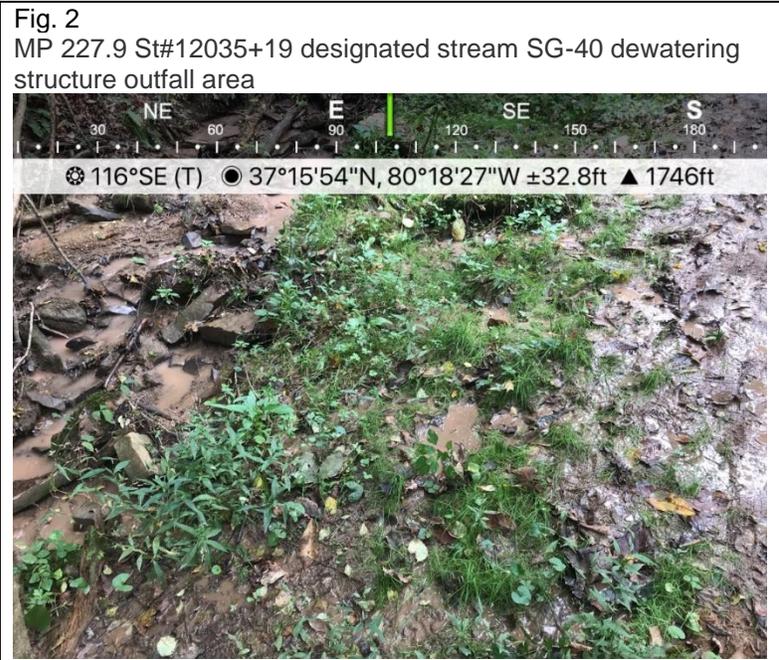
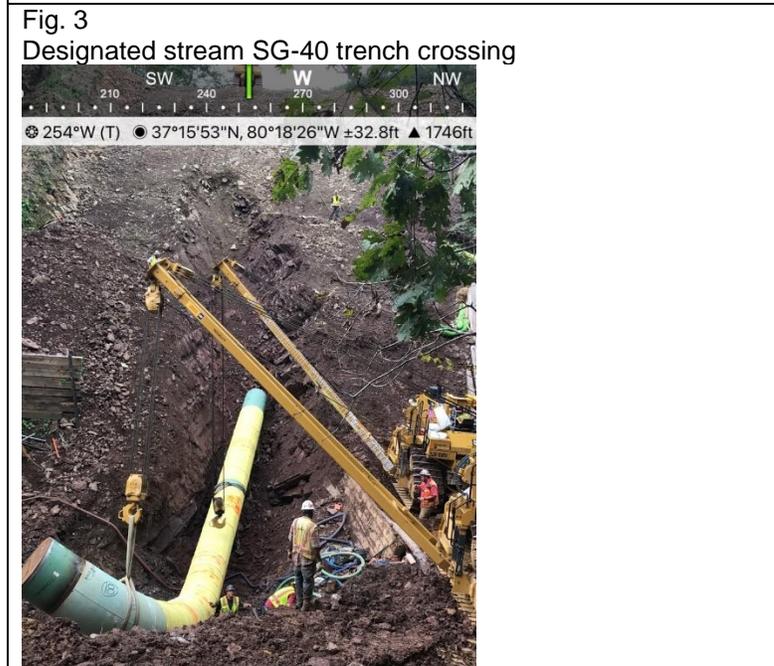
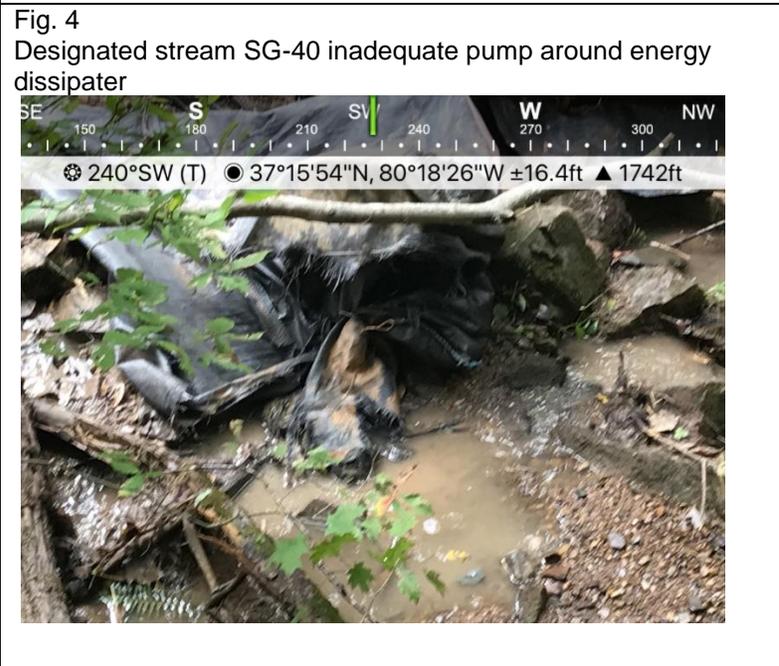
- **Area 1** - MP 227.9 station#12035+19 designated stream SG-40 dewatering structure outlet area was inadequately stabilized and pump around energy dissipater was inadequate. Remove sediment per DEQ approval.

Deadline: Immediately
