FIELD INSPECTION

Project Name:	Mountain Valley Pipeline	Inspector:	Matthew Grant
Inspection Date:	Wednesday, September 26, 2018	Project Contact:	Brian Clauto
Spread: Franklin County	Spread I	Weather (Wet/Dry/Rain):	Wet

FIELD INSPECTION PHOTO LOG

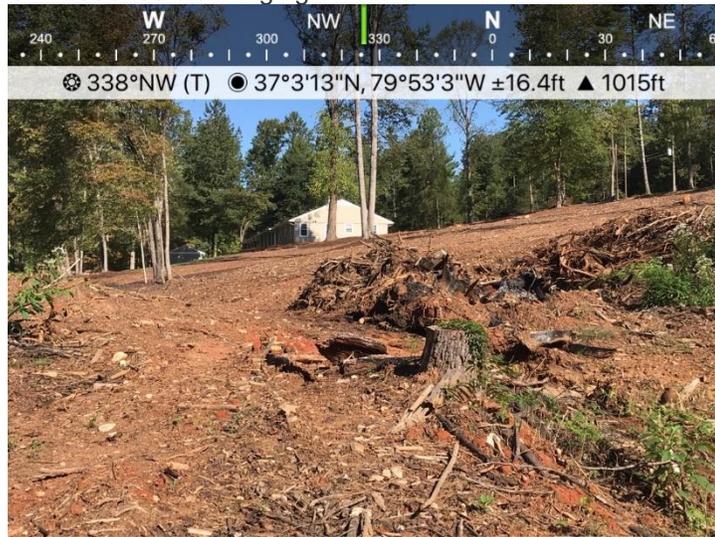
Adjacent property not associated with pipeline near St#14000+09 has discharged onto ROW and may have affected the ECD at ST#14000+09.

Fig. 1
Adjacent property not associated with pipeline near St#14000+09 discharging onto ROW.

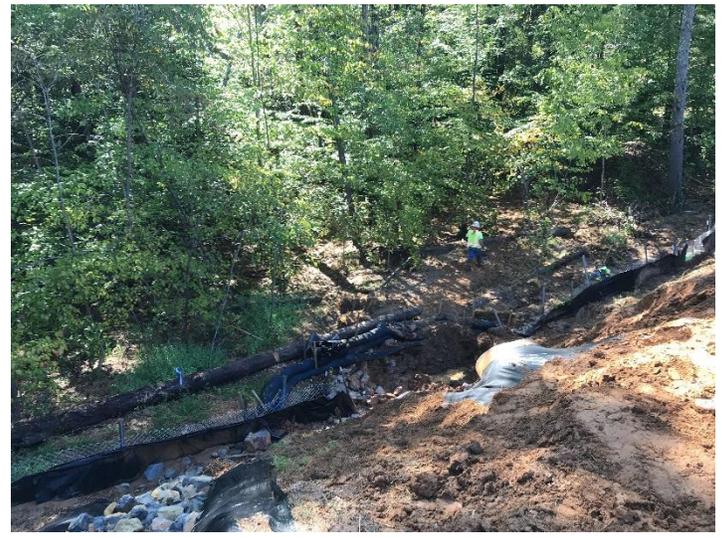
- **Area 1** – MP 265 St#14000+09 crews on site removing sediment off ROW
- **Area 2** - MP 265 St#14000+09 ECD requires maintenance

Fig. 2
Area off of ROW near St#14000+09 impacted by sediment.

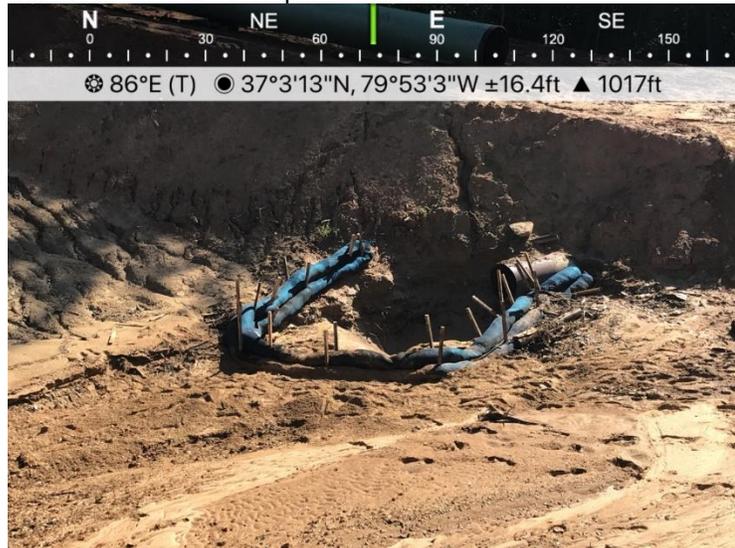
Fig. 3
St#140009+00 ECD requires maintenance

Deadline: Within 24hr notification

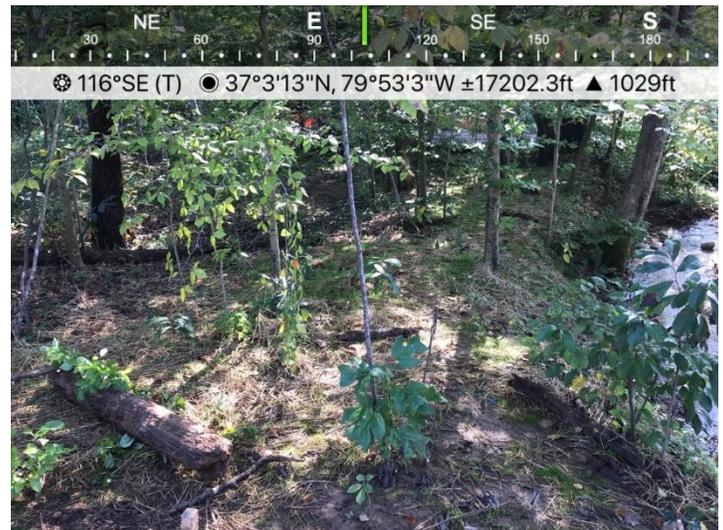
Fig. 4
St# 13998+00 sediment has been removed.
