## FIELD INSPECTION

Project Name:	Mountain Valley Pipeline	Inspector:	Matthew Grant
Inspection Date:	Wednesday, September 26, 2018	Project Contact:	Brian Clauto
Spread: Franklin County	Spread I	Weather (Wet/Dry/Rain):	Wet

## FIELD INSPECTION PHOTO LOG

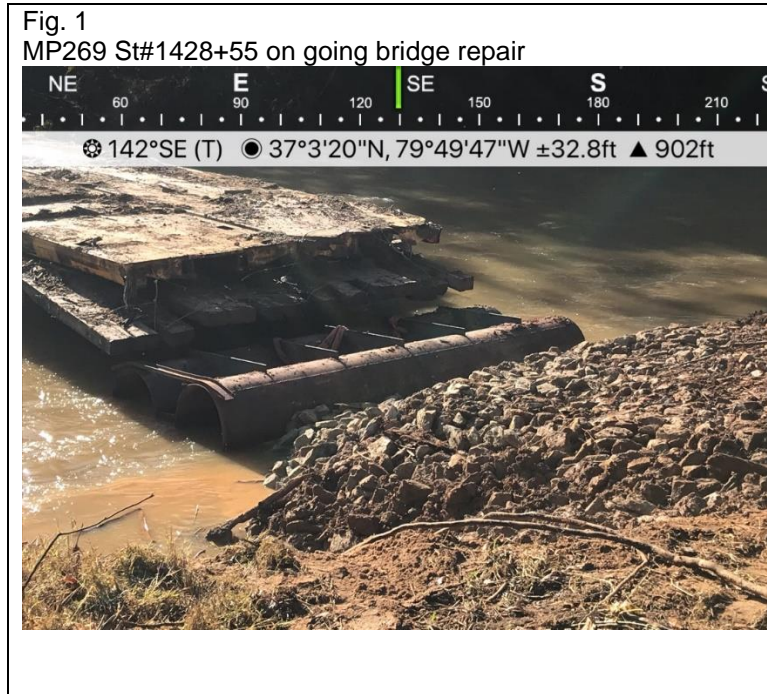
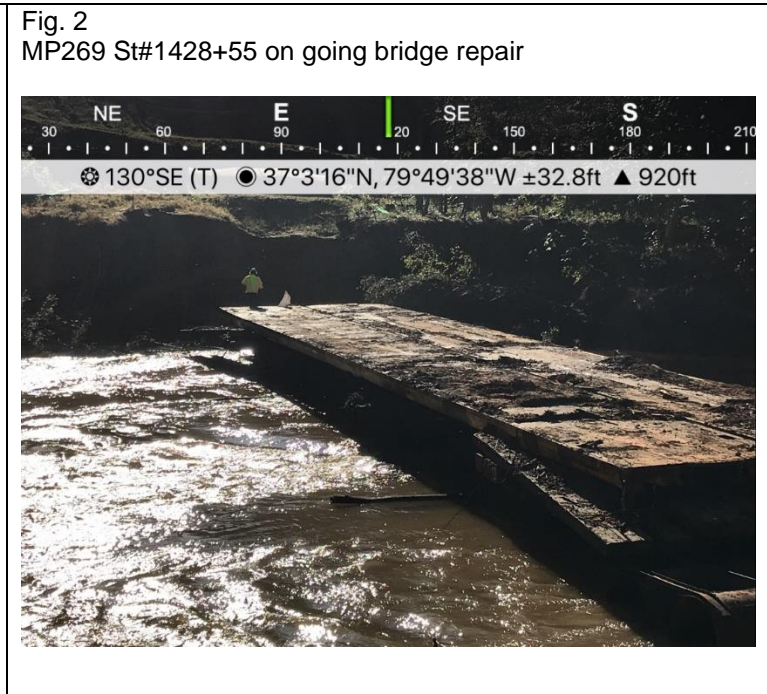
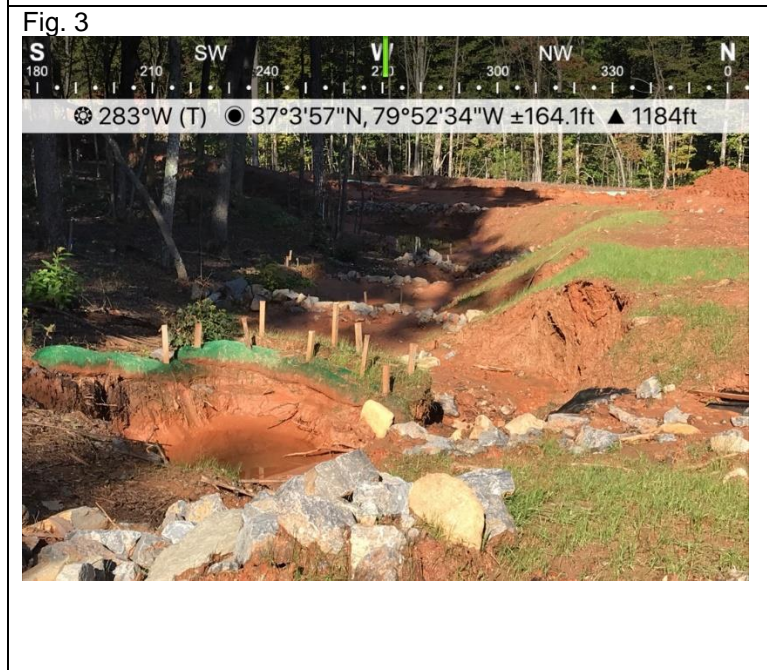
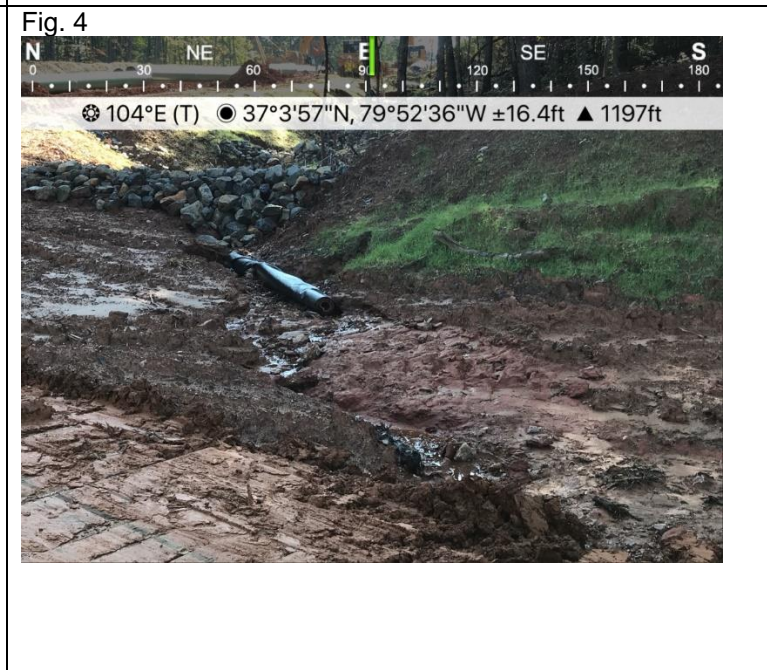
- **Area 1** – MP 269 St#14248+55 on going bridge repair.
- **Area 2** - MP 266 St#14059+00 rock check dams require repair & maintenance.
- **Area 3** - MP 266 St#14059+28 sump outlet conveyance channel requires stabilization.

All issues noted for maintenance & stabilization above were added to the daily corrective action punchlist.

**Deadline:**     Within 24hr notification
