## FIELD INSPECTION

Project Name:	Mountain Valley Pipeline	Inspector:	Matthew Grant
Inspection Date:	Thursday, July 12, 2018	Project Contact:	Brian Clauto
Spread:	Spread H	Weather (Wet/Dry/Rain):	Dry

## FIELD INSPECTION PHOTO LOG

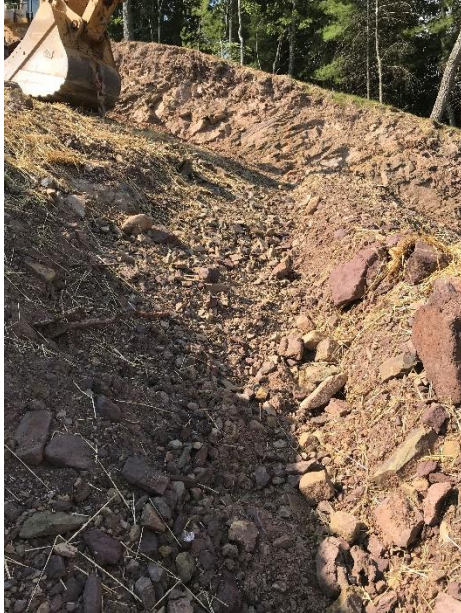
- Area 1- Spread H, near Catawba Rd. in Montgomery Co, station 12026+00 (MP 227.6) to 12023+00 (MP 227.7). This area included a small section of the ROW (two water bars and end treatments) which were observed to be deficient.

Fig. 1 Inadequate water bar near station #12024+00

**Deadline:**     Prior to release to work

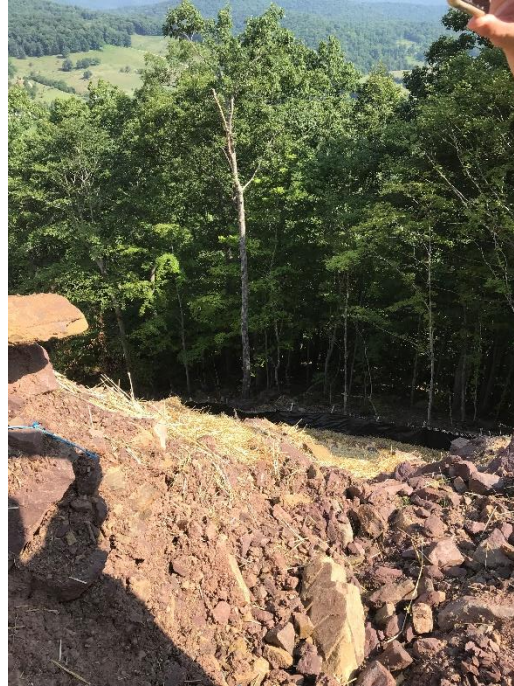
Fig. 2 Water bar with missing end treatment near station # 12024+00
