VWP FIELD INSPECTION CHECKLIST

Site Name: Mountain Valley Pipeline_Spread H; Wetland IJ-10

Date: 9/20/2018

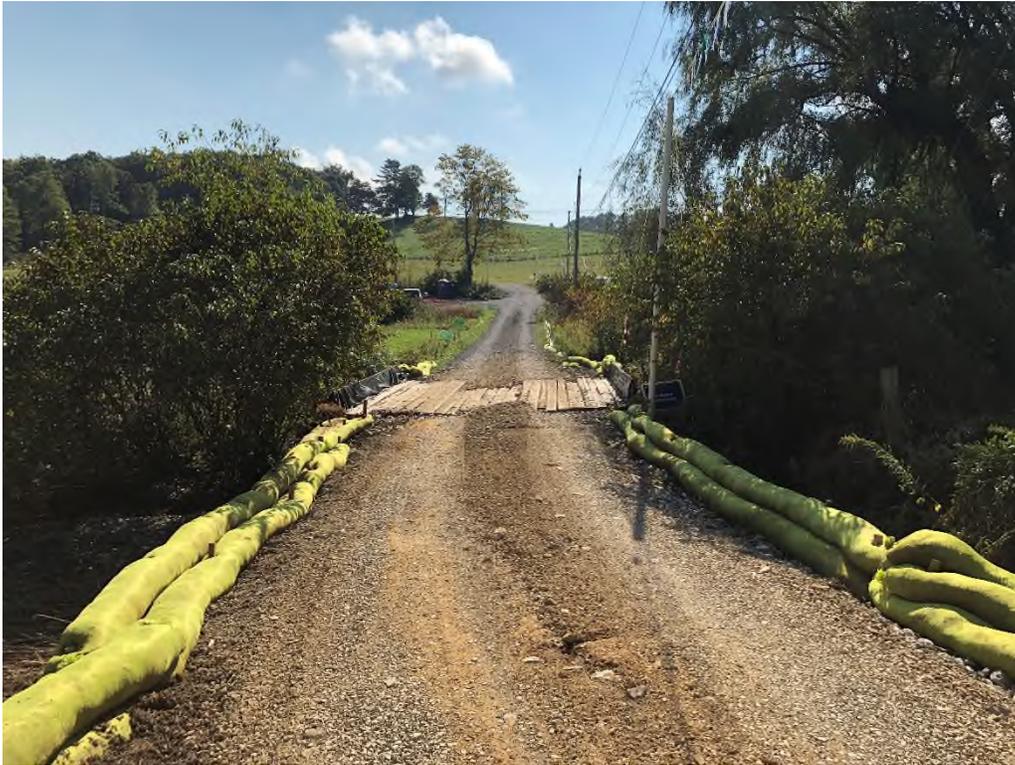
Photo 1: Access Road 288

Access Road 288 being maintained; ESCs replaced and functioning properly

Orientation: Facing Bent Mountain Road

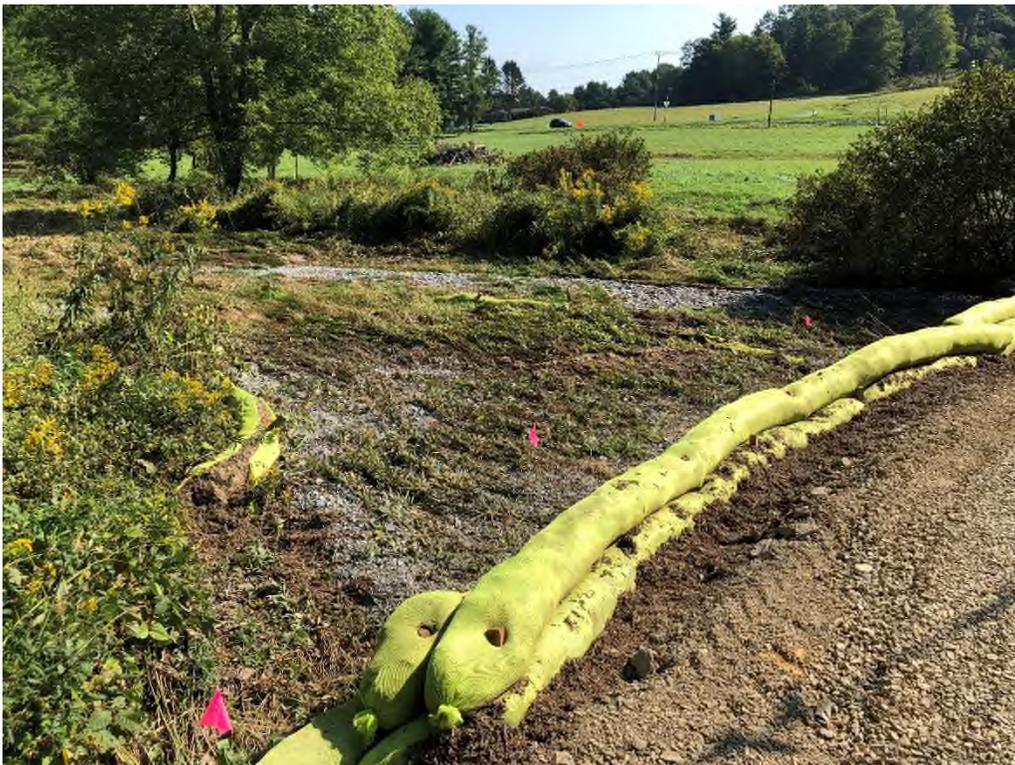
Approximately 350 square feet of wetlands contained gravel ranging from <0.5-inch to a maximum depth of 6-inches was observed.

Photo 2: Gravel from Access Road 288 in Wetland IJ-10 due to ESC failure
Orientation: N/A

1. Repair erosion and sediment controls in areas where needed;
2. Stabilize all slopes above and below perimeter controls;
3. Remove gravel from impacted wetland using hand removal methods (i.e. buckets and shovels) and stabilize with appropriate seed mix where applicable.
