FIELD INSPECTION

Project Name:	**Mountain Valley Pipeline**	**Inspector:**	**Matthew Grant**
Inspection Date:	**Thursday, January 10, 2019**	**Project Contact:**	**Brian Clauto**
Spread: Montgomery County MP228-231	**Spread H**	**Weather (Wet/Dry/Rain):**	**Dry**

FIELD INSPECTION PHOTO LOG

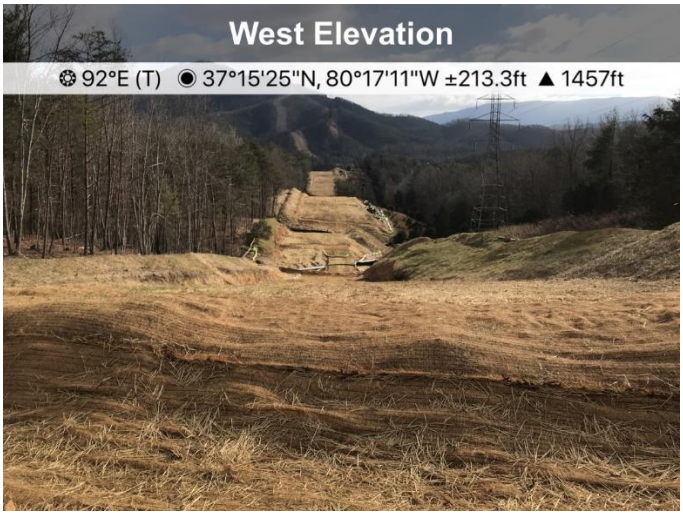
- Fig. 7 ECD are in place and functioning at designated stream SF-16
