FIELD INSPECTION

Project Name:	**Mountain Valley Pipeline**	**Inspector:**	**Matthew Grant**
Inspection Date:	**Wednesday, August 7, 2019**	**Project Contact:**	**Cory Chalmers**
Spread: Montgomery County MP236-237 St12475-12543+56 AR278.01	**Spread H**	**Weather (Wet/Dry/Rain):**	**Dry**

FIELD INSPECTION PHOTO LOG

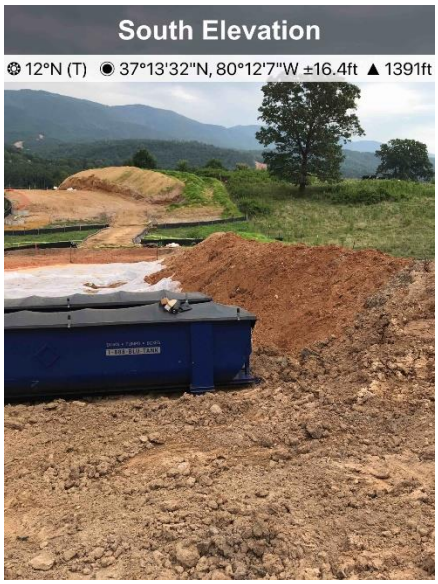
- Fig. 6 St 2481 stabilization of diversion near bins is required
