FIELD INSPECTION

Project Name:	**Mountain Valley Pipeline**	**Inspector:**	**Matthew Grant**
Inspection Date:	**Tuesday, February 5, 2019**	**Project Contact:**	**Brian Clauto**
Spread: Franklin County MP 262-264	**Spread I**	**Weather (Wet/Dry/Rain):**	**Dry**

FIELD INSPECTION PHOTO LOG

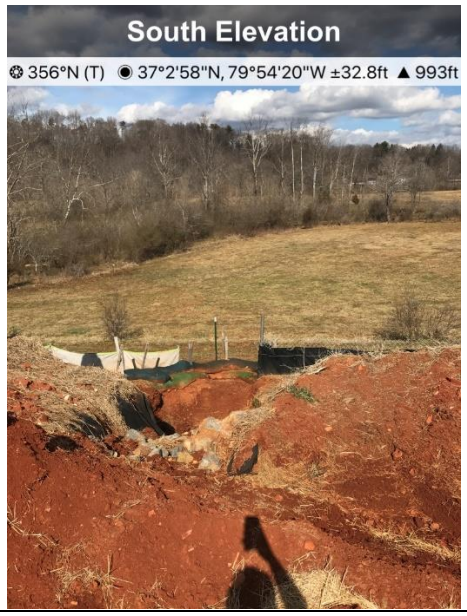
- Fig. 1 St#13955+05 P1 fence requires maintenance

- Fig. 2 St#13919+00 sump inlet requires maintenance

Recommended Corrective Action: Maintain all controls per the approved plan and specs.

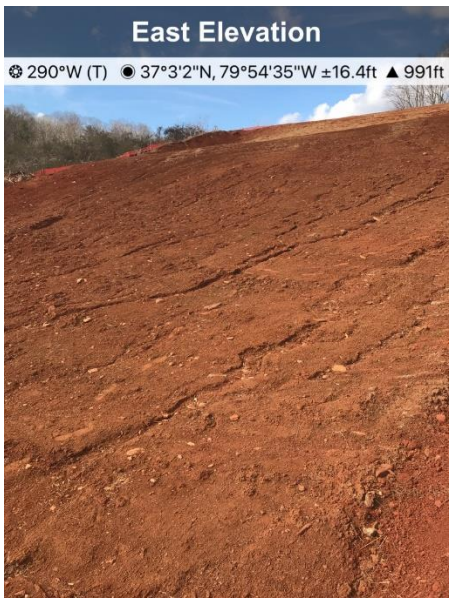
- Fig. 3 ATWS 698C P1 fence and CFS requires maintenance

- Fig. 4 St#13909+08 slope requires repair and stabilization
