FIELD INSPECTION

Project Name:	**Mountain Valley Pipeline**	**Inspector:**	**Matthew Grant**
Inspection Date:	**Thursday, August 22, 2019**	**Project Contact:**	**Brian Clauto**
Spread: Franklin Co. MP261 St13805-13803 MP265.9	**Spread I**	**Weather (Wet/Dry/Rain):**	**Dry**

FIELD INSPECTION PHOTO LOG

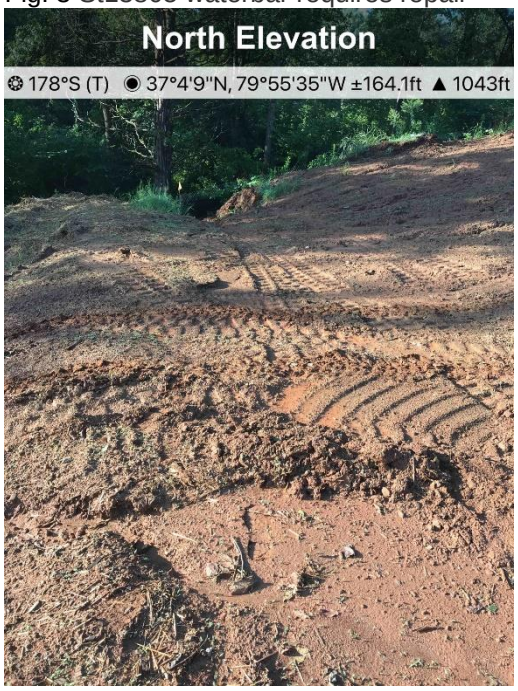
- Fig. 3 St13805 waterbar requires repair

Recommend Corrective Action: Maintain and install all controls per the approved plan and specs, remove sediment per DEQ approval.

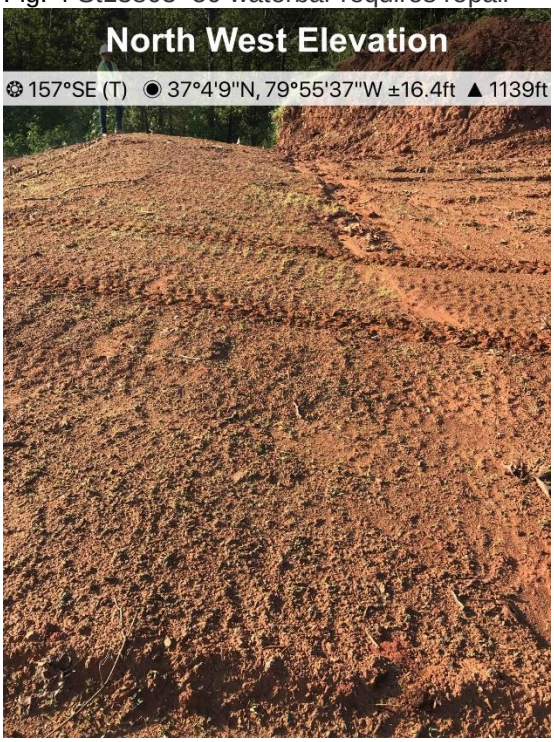
- Fig. 4 St13803+50 waterbar requires repair
