FIELD INSPECTION

Project Name:	**Mountain Valley Pipeline**	**Inspector:**	**Matthew Grant**
Inspection Date:	**Wednesday, October 10, 2018**	**Project Contact:**	**Brian Clauto**
Spread: Montgomery County MP 226 St#11933-11965	**Spread G**	**Weather (Wet/Dry/Rain):**	**Wet**

FIELD INSPECTION PHOTO LOG

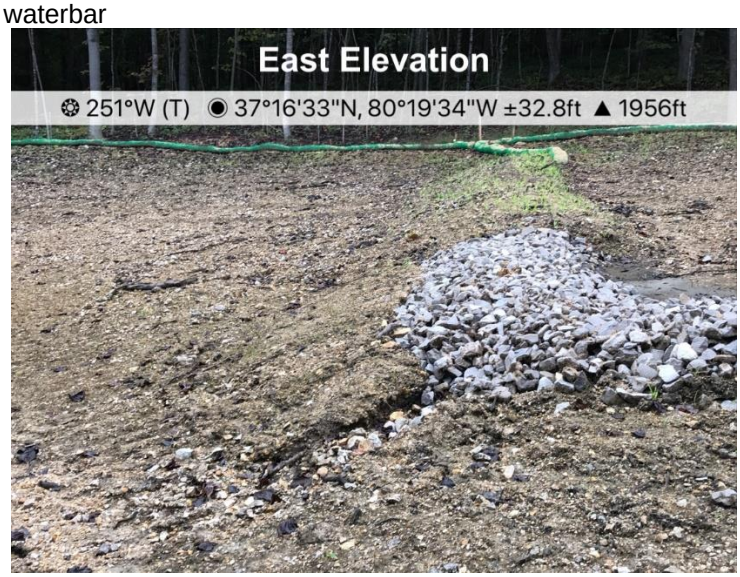
Fig. 2
At St#11952+58 rill erosion has occurred below rock of waterbar

Fig. 3
At St#11953+58 rill erosion has occurred below rock of waterbar

- **Area 1** –MP 226 St#11952+58 through St#11953+88 erosion has occurred below rock of waterbars repair and re install per the spec MVP17.7

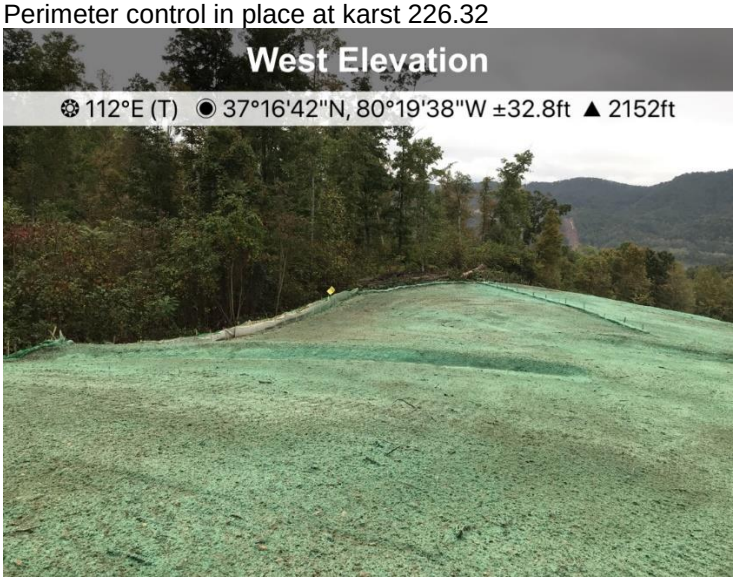
Fig. 4
Perimeter control in place at karst 226.32

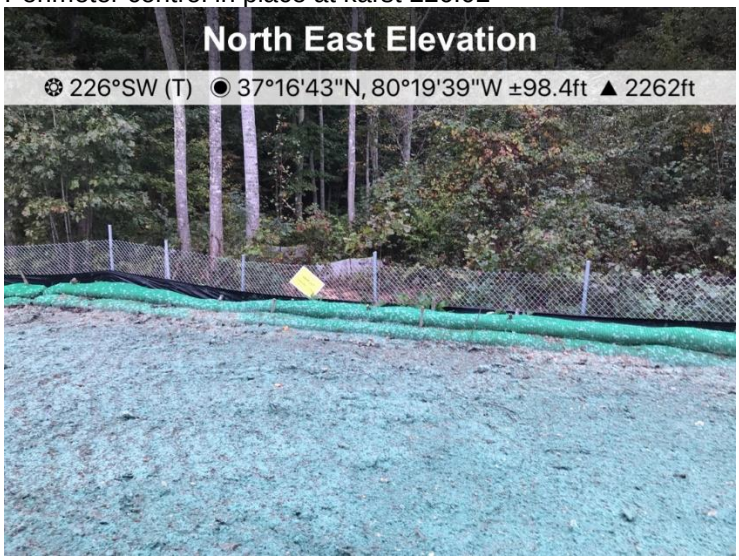
Fig. 5
Perimeter control in place at karst 226.02
