FIELD INSPECTION

Project Name:	**Mountain Valley Pipeline**	**Inspector:**	**Matthew Grant**
Inspection Date:	**Wednesday, May 29, 2019**	**Project Contact:**	**Brian Clauto**
Spread: Franklin County **MP272-273** **MP275** **MP255** **MP266**	**Spread I**	**Weather (Wet/Dry/Rain):**	**Dry**

FIELD INSPECTION PHOTO LOG

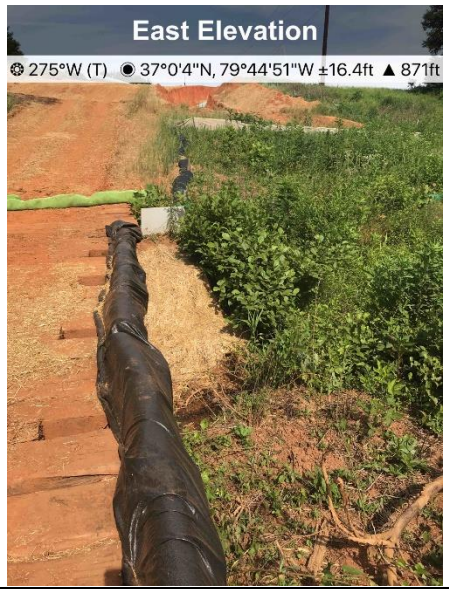
- Fig. 3 Designated stream S-E18 area near bridge has been matted
