# Most Probable Stressor

## Lower MF Cunningham Creek

# X-TRIB TO NORTH FORK (NF) CUNNINGHAM CREEK

# LOWER NORTH FORK (NF) CUNNINGHAM CREEK

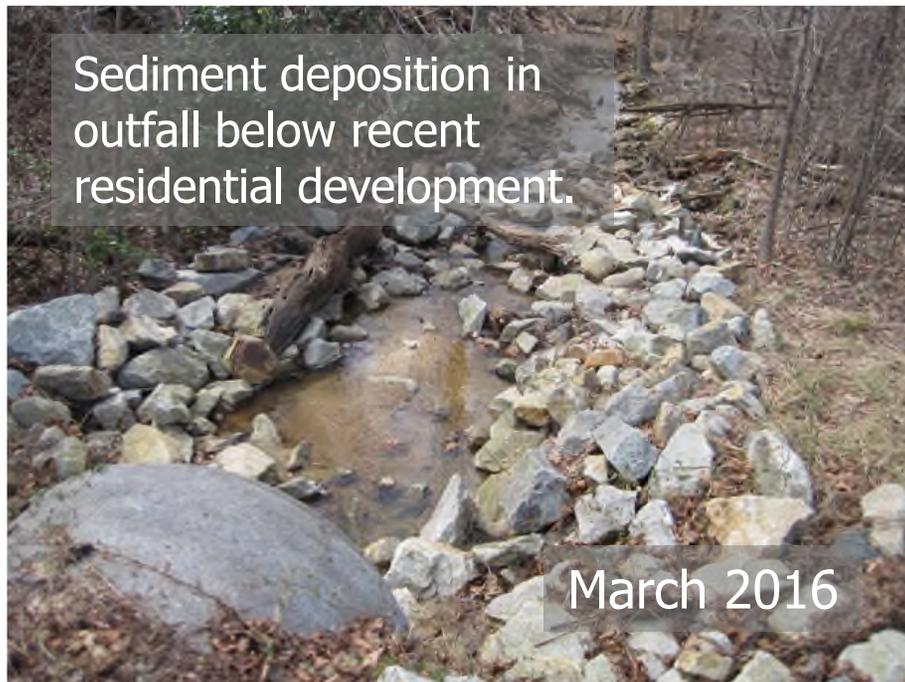
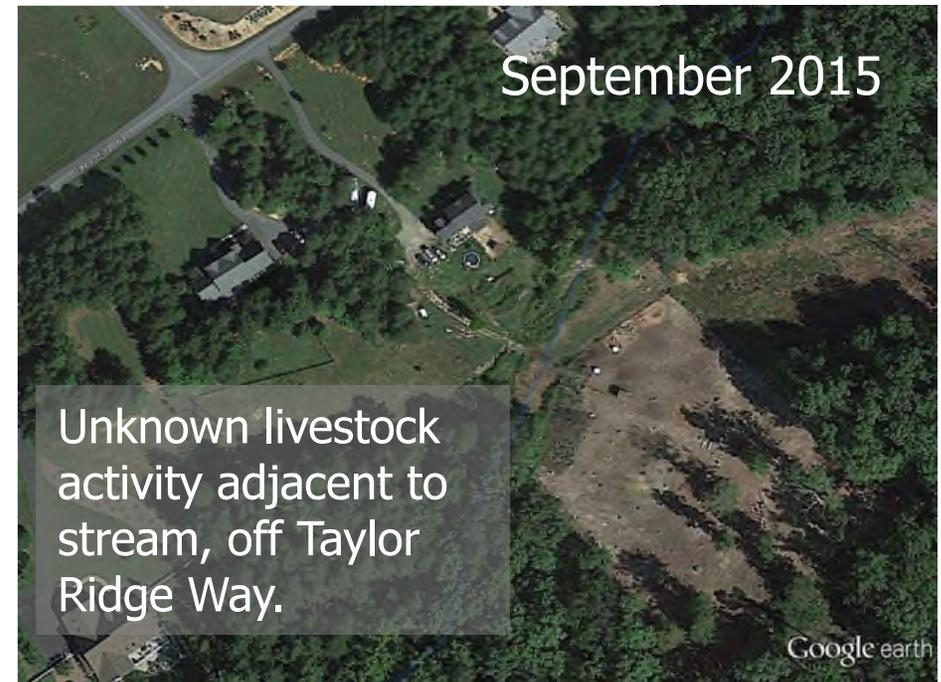
- **Most probable stressor in 2010:** sediment from new home construction.
- **Most probable stressor today:** sediment from new construction near outlet. Other potential sources: Lawn fertilization, unbuffered riparian livestock activity.

- Pro-Active Implementation is recommended
  - Upper MF: monitor benthics; check septics
  - Lower MF: install riparian vegetation; check for isolated bank stability issues
  - Lower NF: fix dam outlet erosion
  - X-trib to NF: stabilize areas near outlet; add a buffer to unknown livestock activity

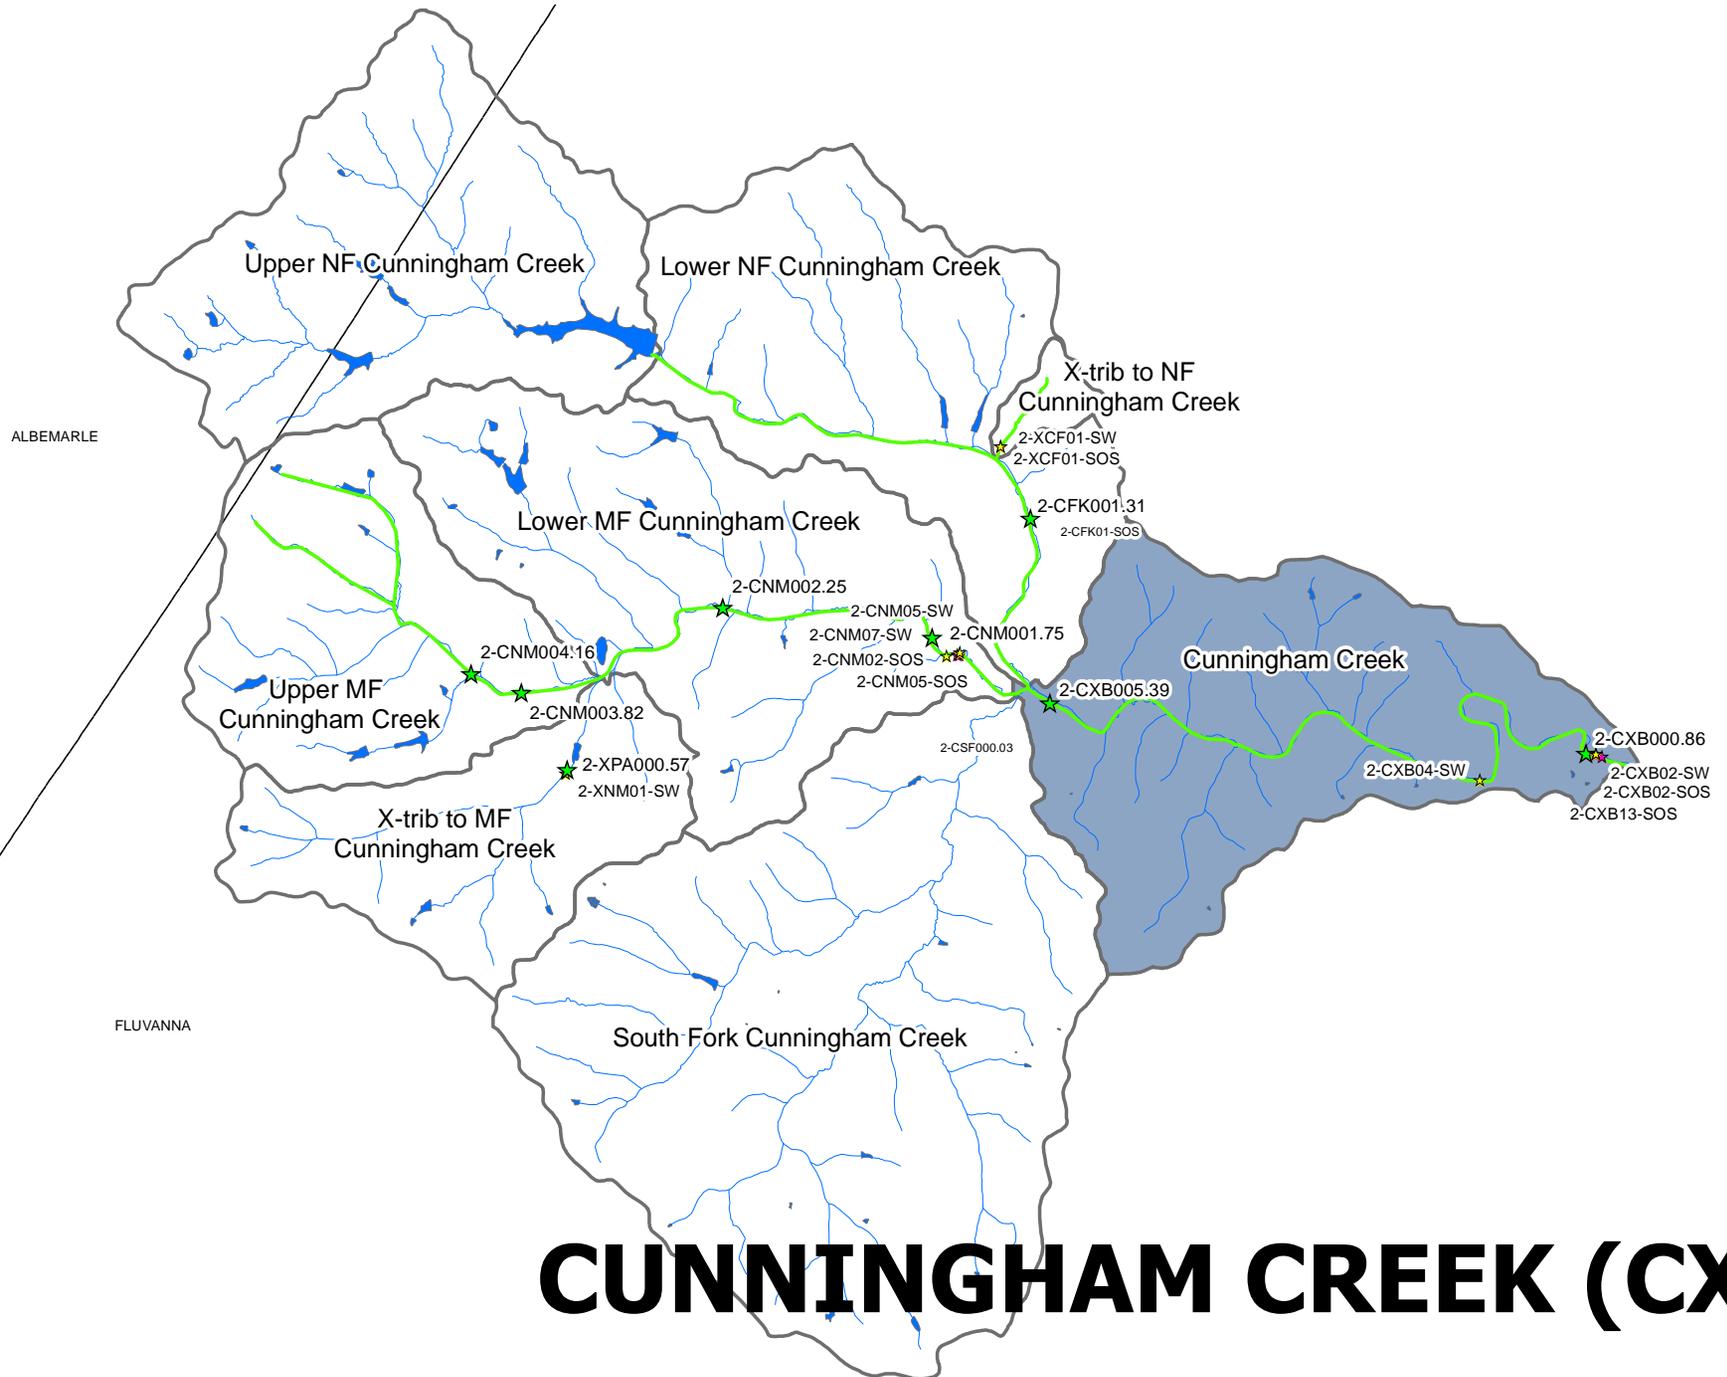
**Most probable stressor in 2012 and currently:**  
sediment from gully erosion near lake outlet, residential development, possibly some timber harvesting.

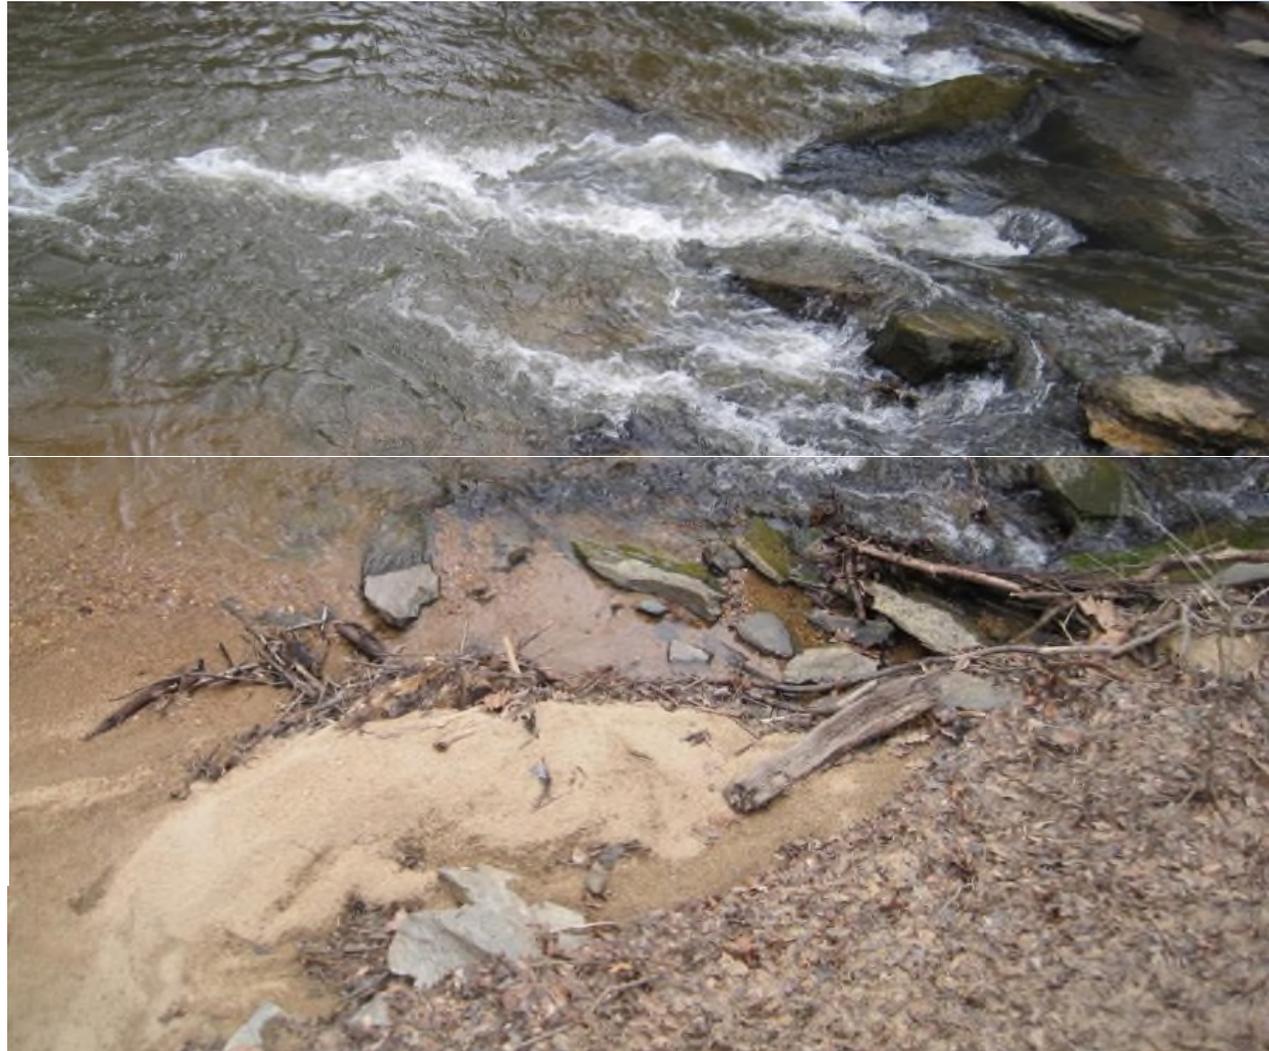
**Most probable stressor currently:** Probable sediment sources include upstream sources, as evidenced by cloudy stream conditions at 2-CXB005.39, and pasture runoff, periodic timber harvesting, and bank instability contributing to sediment deposits at 2-CXB000.86.
