FIELD INSPECTION

Project Name:	Mountain Valley Pipeline	Inspector:	Marshall Willis
Inspection Date:	Monday, July 15, 2019	Project Contact:	Brian Clauto
Spread H: Franklin County	STA 13258+74 – 13262+66 STA 13060+00 – 13070+00 MVP-FR-293.01/290 ATWS 344/1055	Weather (Wet/Dry/Rain):	Dry

Project Name: Mountain Valley Pipeline

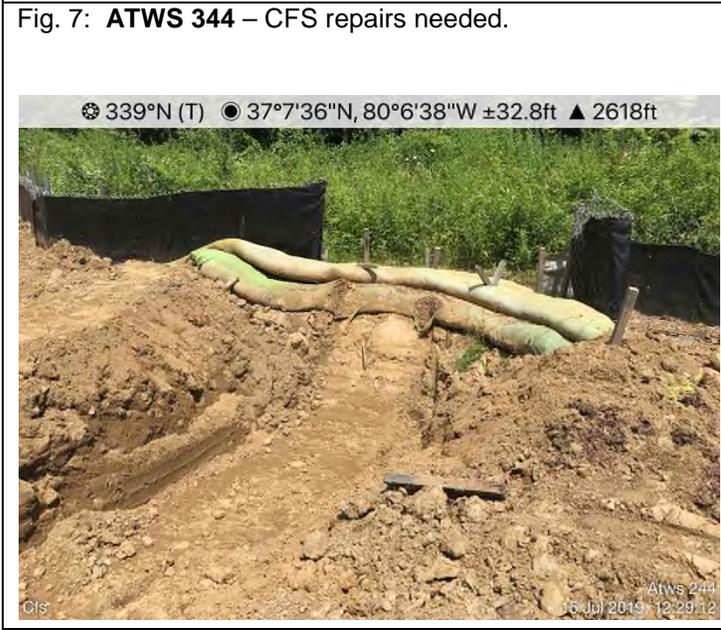
Fig. 9: **STA 13064+82** – P1 in repair needed.

- STA 13063+10: (S-G27) Re-establish and stabilize 50' buffer zone.
- ATWS 344: Repair CFS end-treatment.
- ATWS 344: Repair CFS end-treatment and sump.
- STA 13064+82: Repair P1.
- STA 13063+64: Repair P1.
