Sheet Flow to Vegetated Filter Strips & Conserved Open Space

Grass Channel Exercise

Permeable Pavement Exercise

Bioretention Exercise

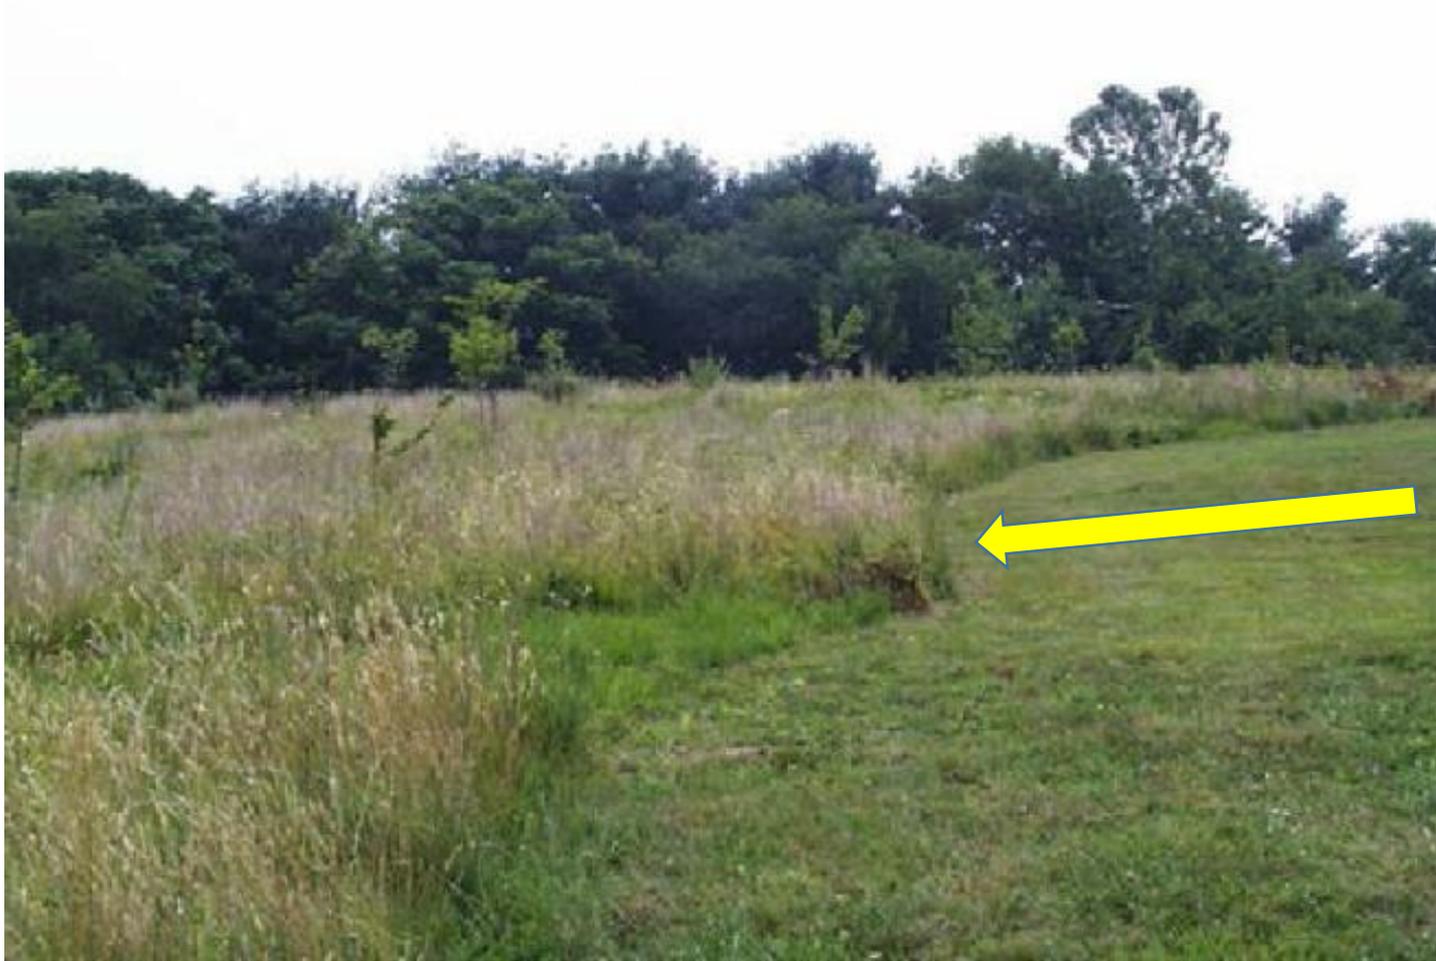
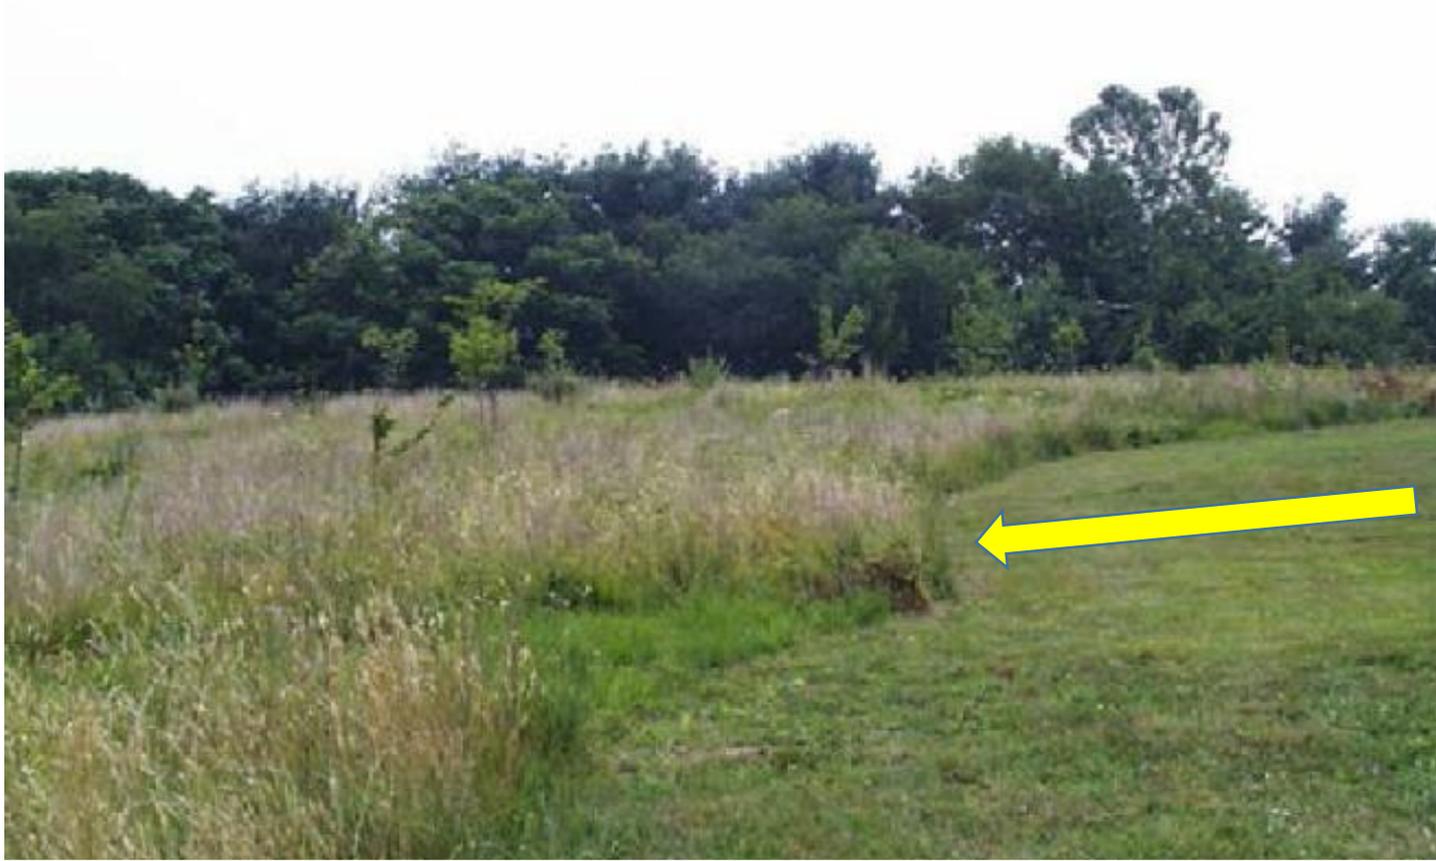
Q1: Would this be a good time to conduct a post-construction inspection for this Conserved Open Space area?

A: Seems good – recommended to do an inspection in the non-growing season to see flow path. SECTION 9.2.

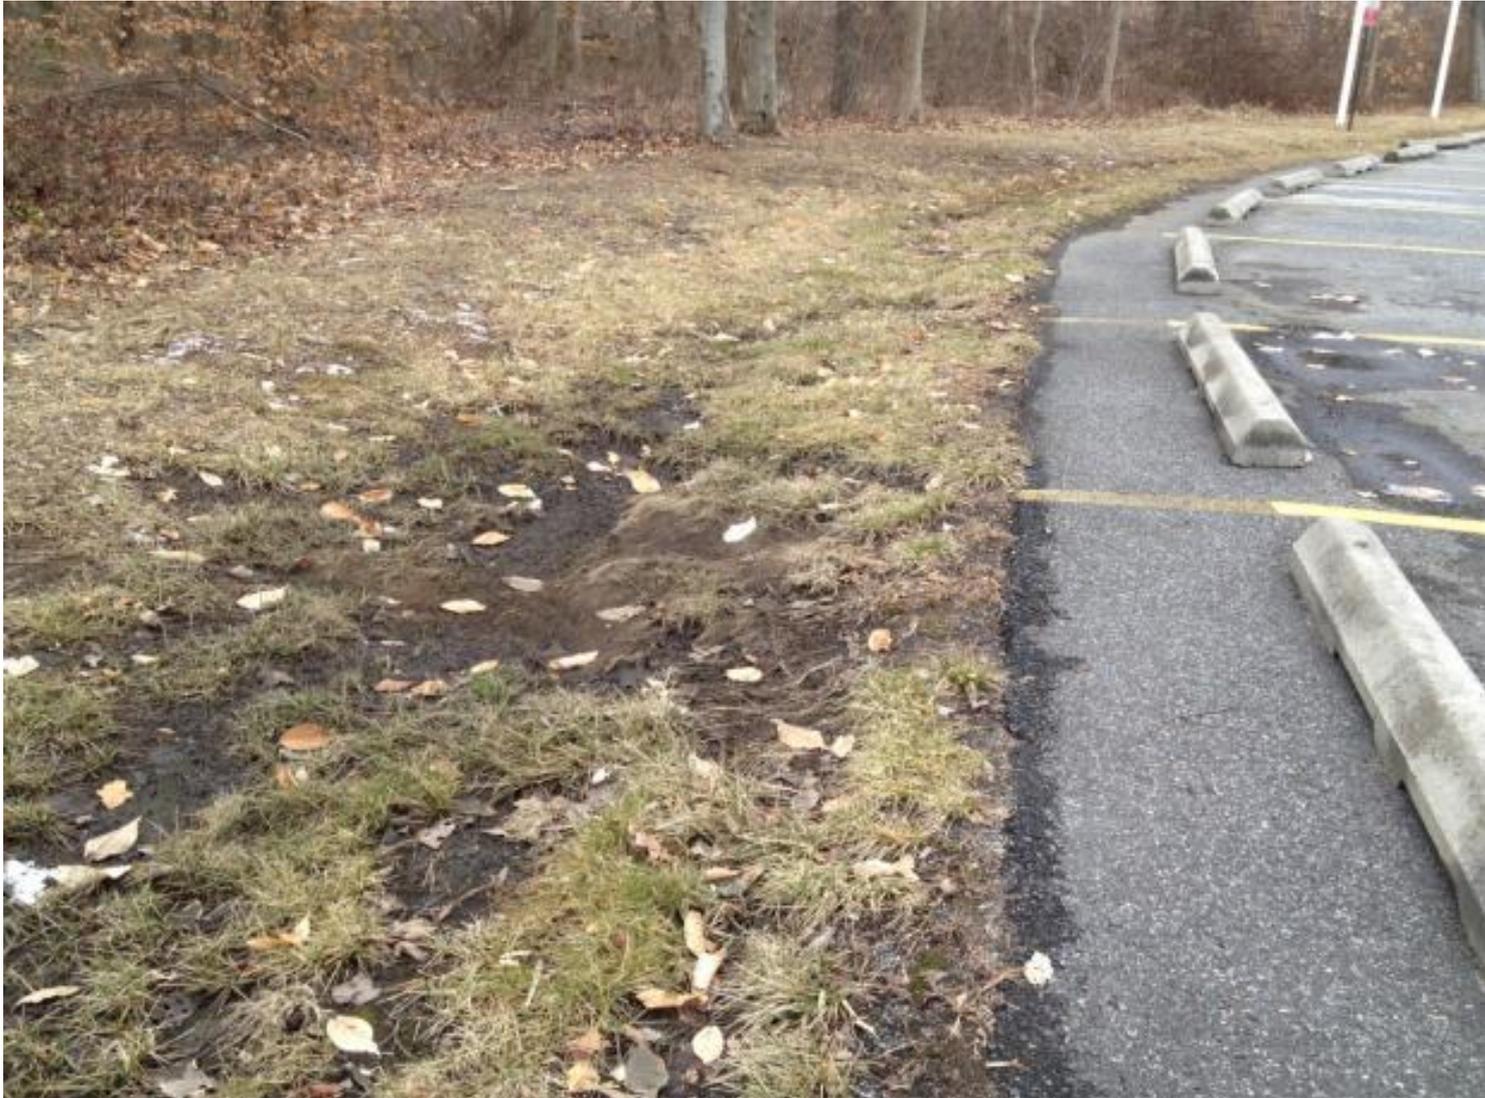
Q2: You are doing a post-construction maintenance inspection of this filter strip. What should the vegetative cover density be?

A: 90% cover. SECTION 9.2.

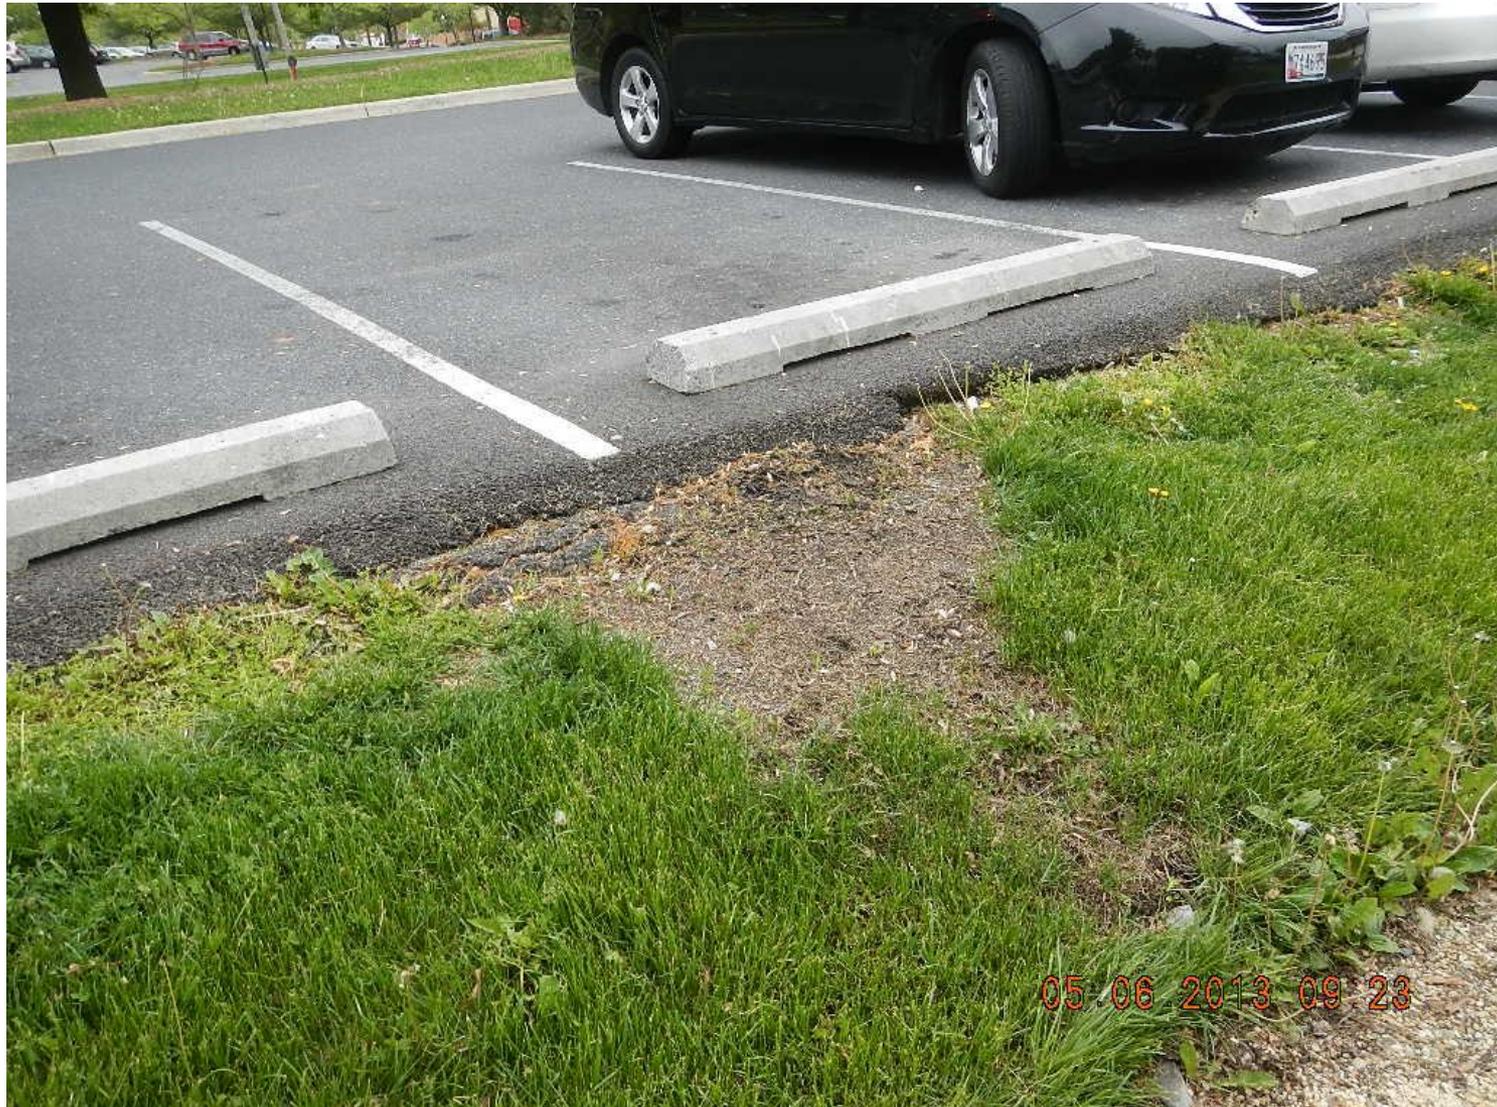
Q3: You are doing a post-construction maintenance inspection of this grass channel. What is your assessment of the grass filter strip to grass channel shown below?

A: Shows signs of erosion – stormwater is concentrating at this location.

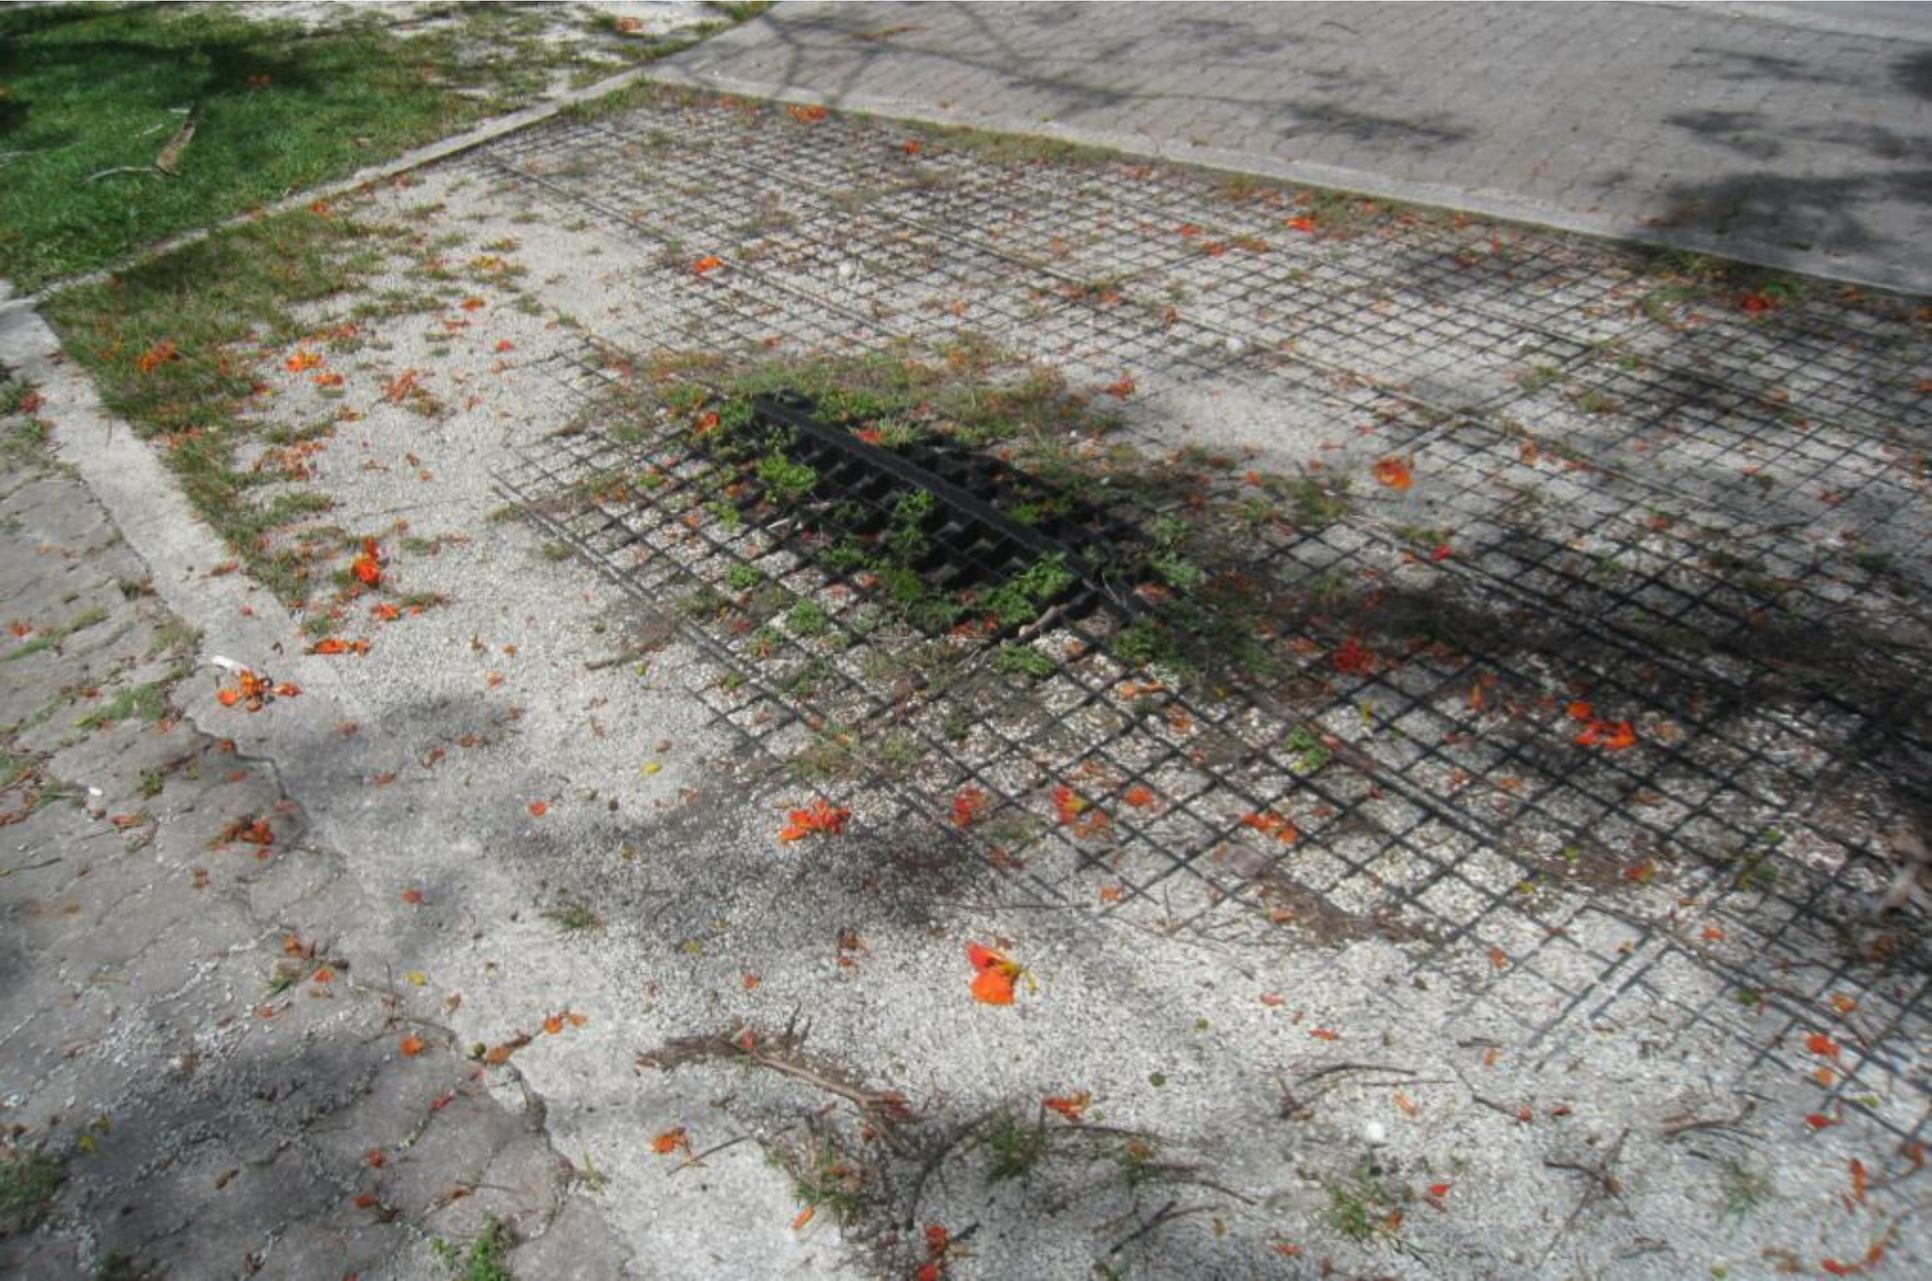
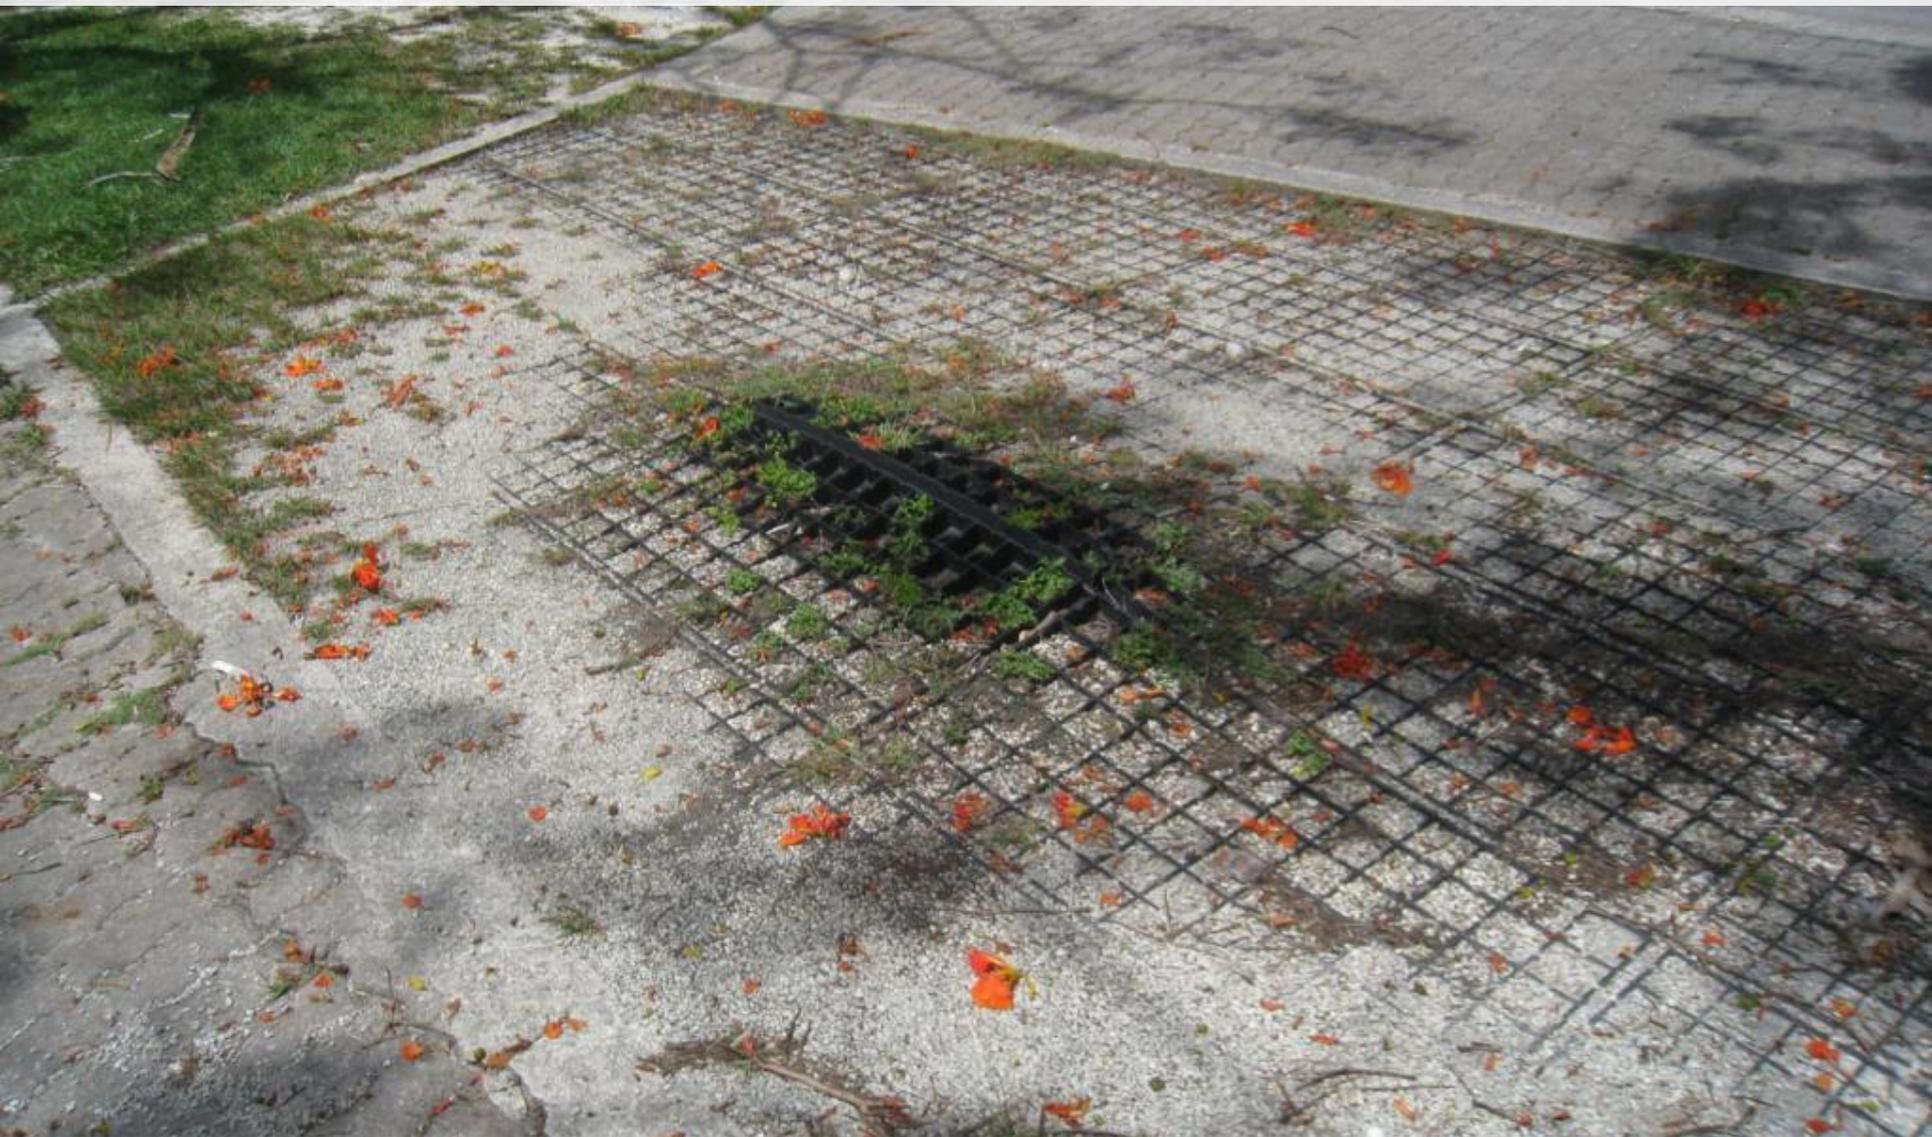
Q4: You are conducting a post-construction maintenance inspection, and see the following. What do you think the cause is and recommended solution?

A: Tree roots or other source causing structural damage. These sections need to be replaced and any obstructions removed.

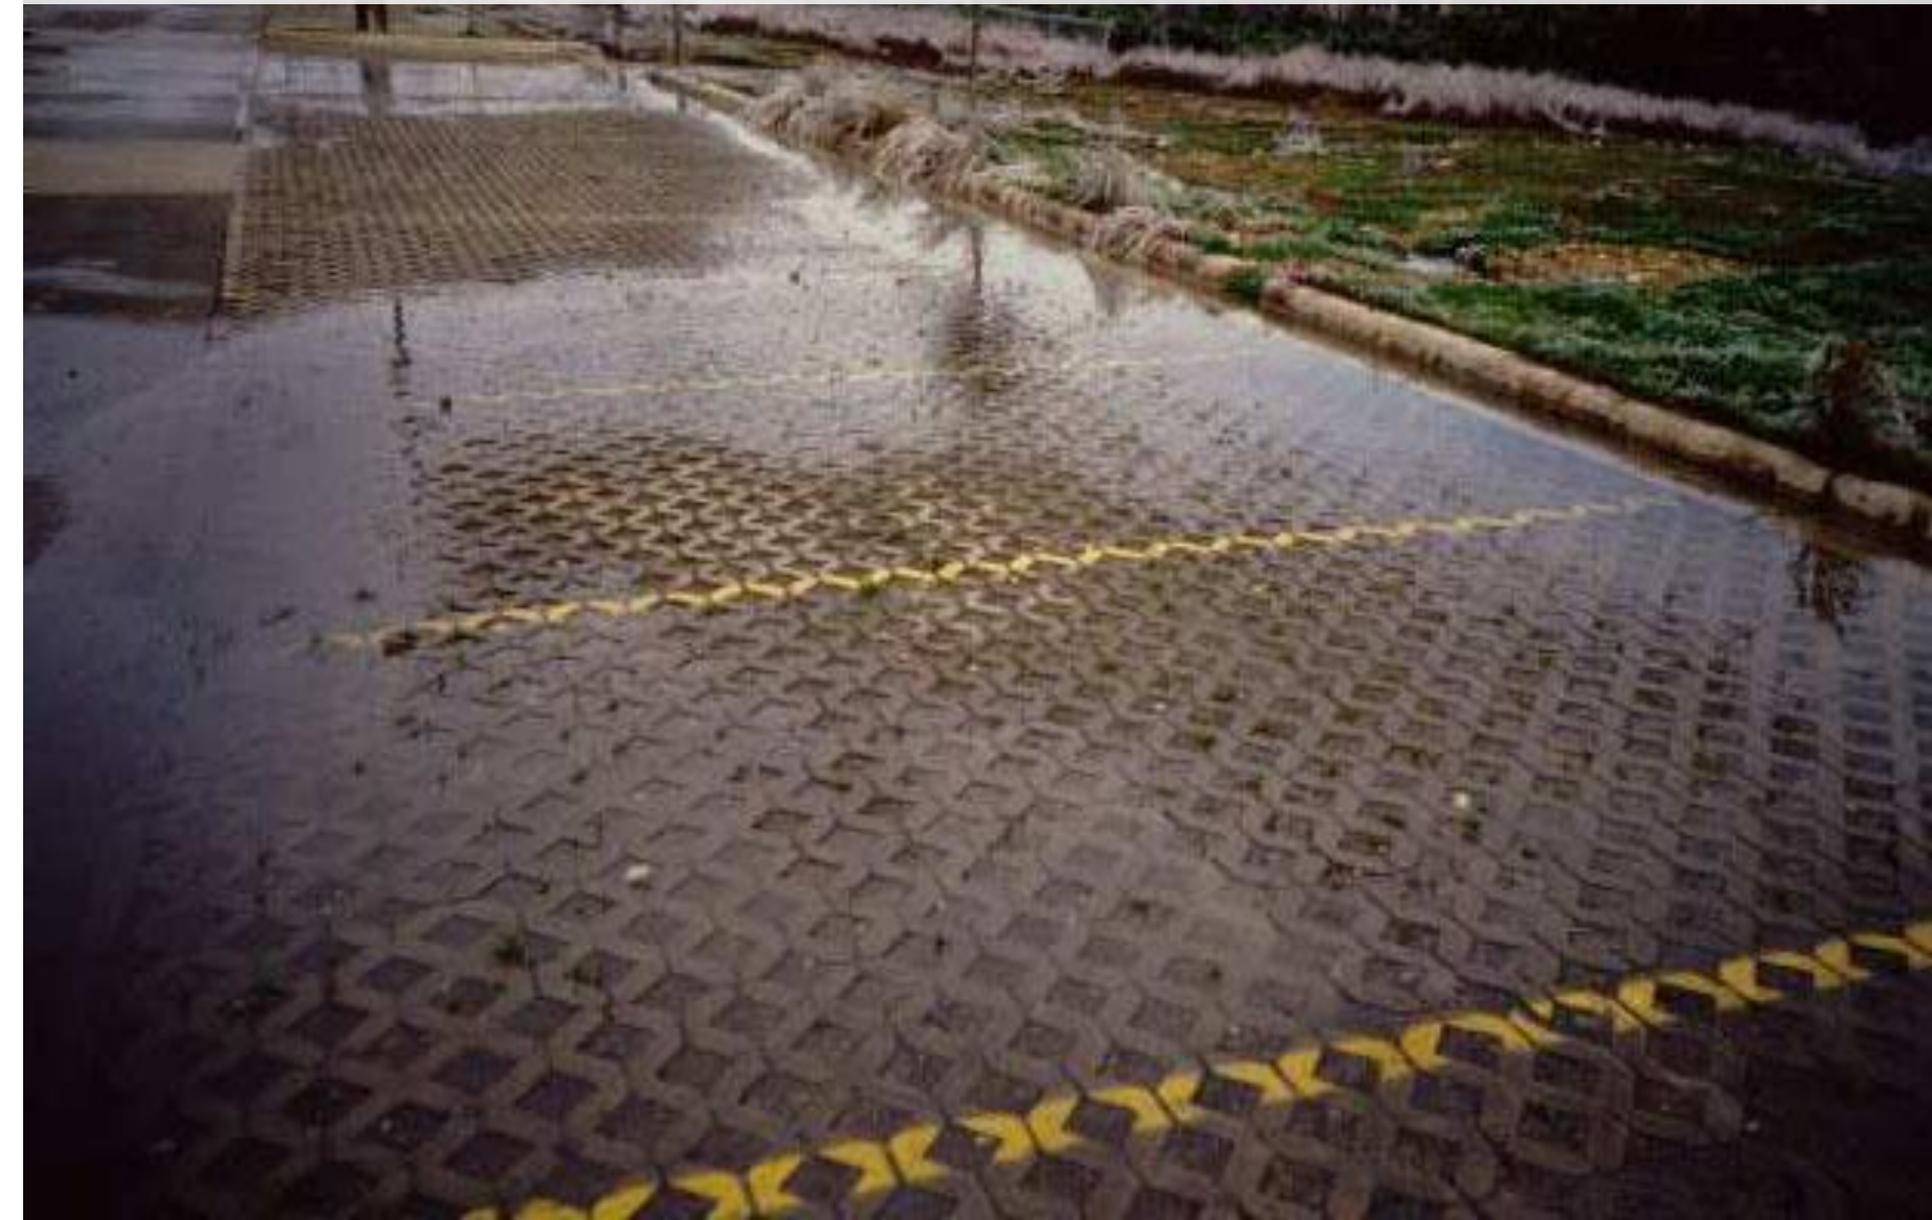
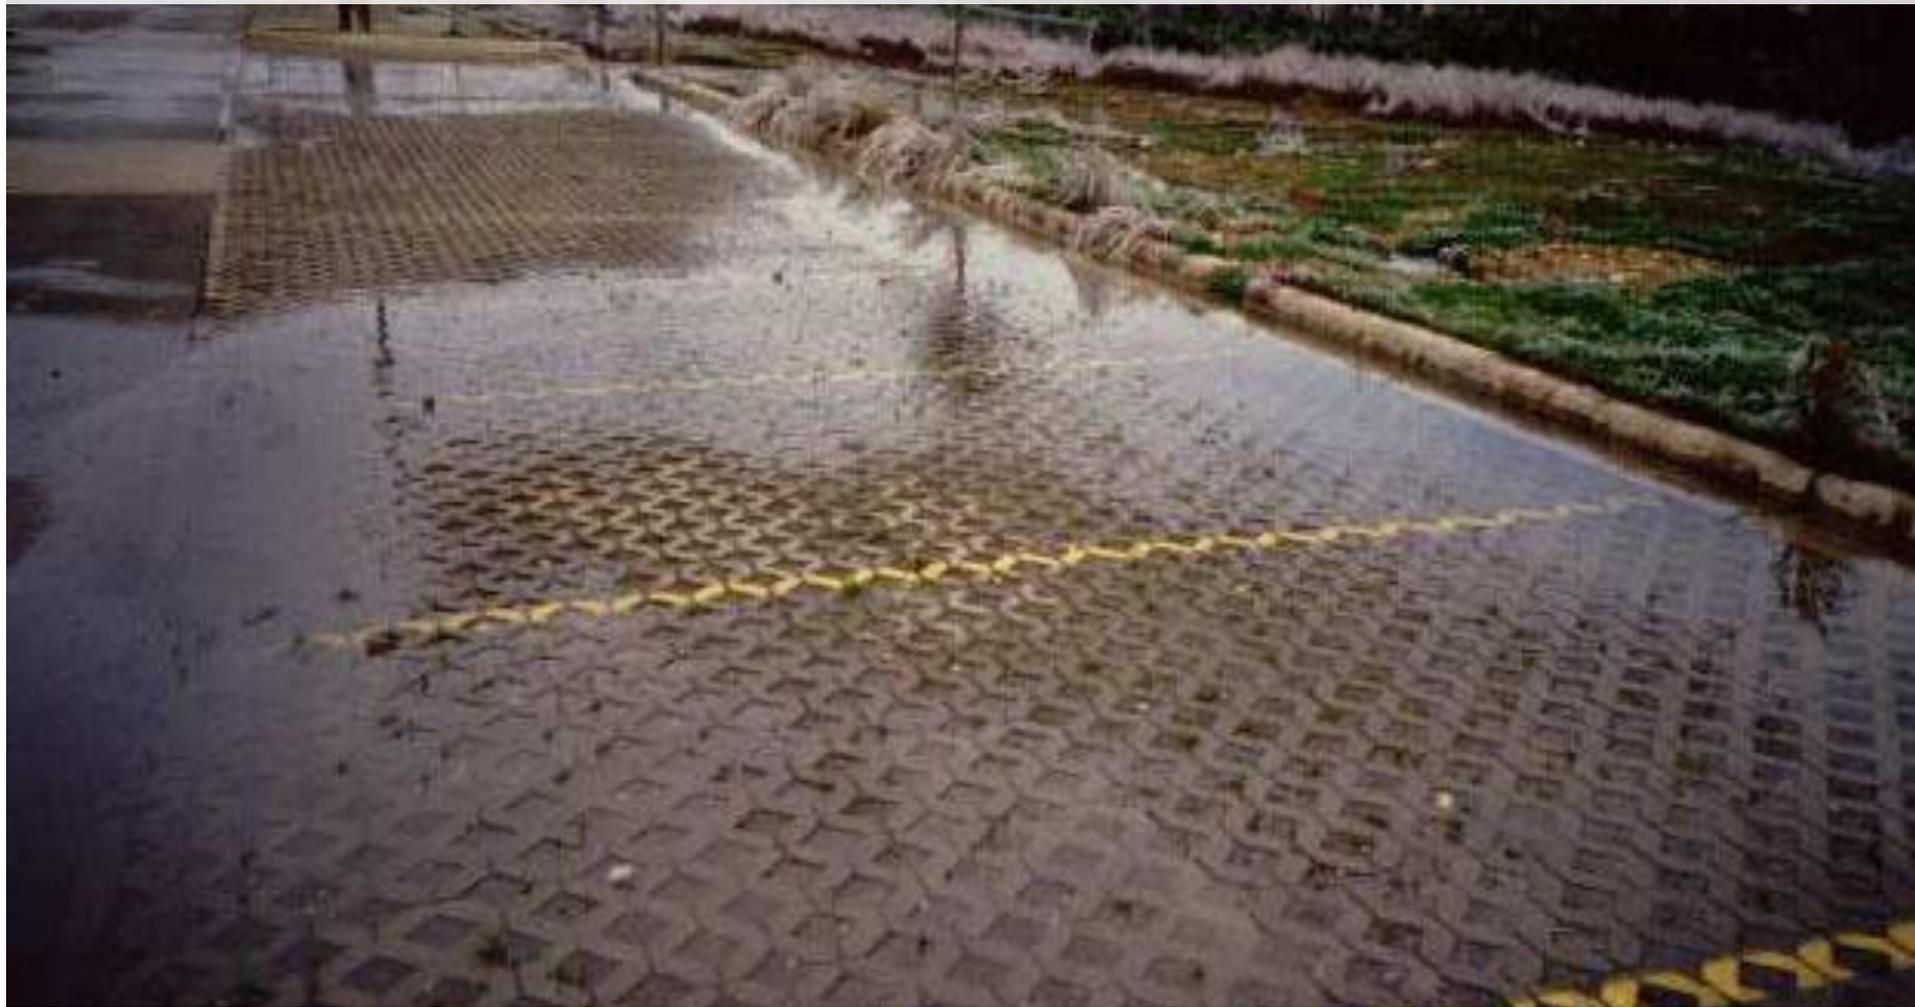
Q5: Another post-construction inspection reveals the following. Assuming there is an observation well, water should be drawn down in the well how many days after a storm event of ½ inch or more? What are probable causes of this clogging?

A: No standing water in observation well after 3 days. SECTION 9.3. Winter sanding could be problem here or other more serious issues with design/installation. Schedule vacuum sweeping in spring to see if it fixes problem. Could require rebuild.

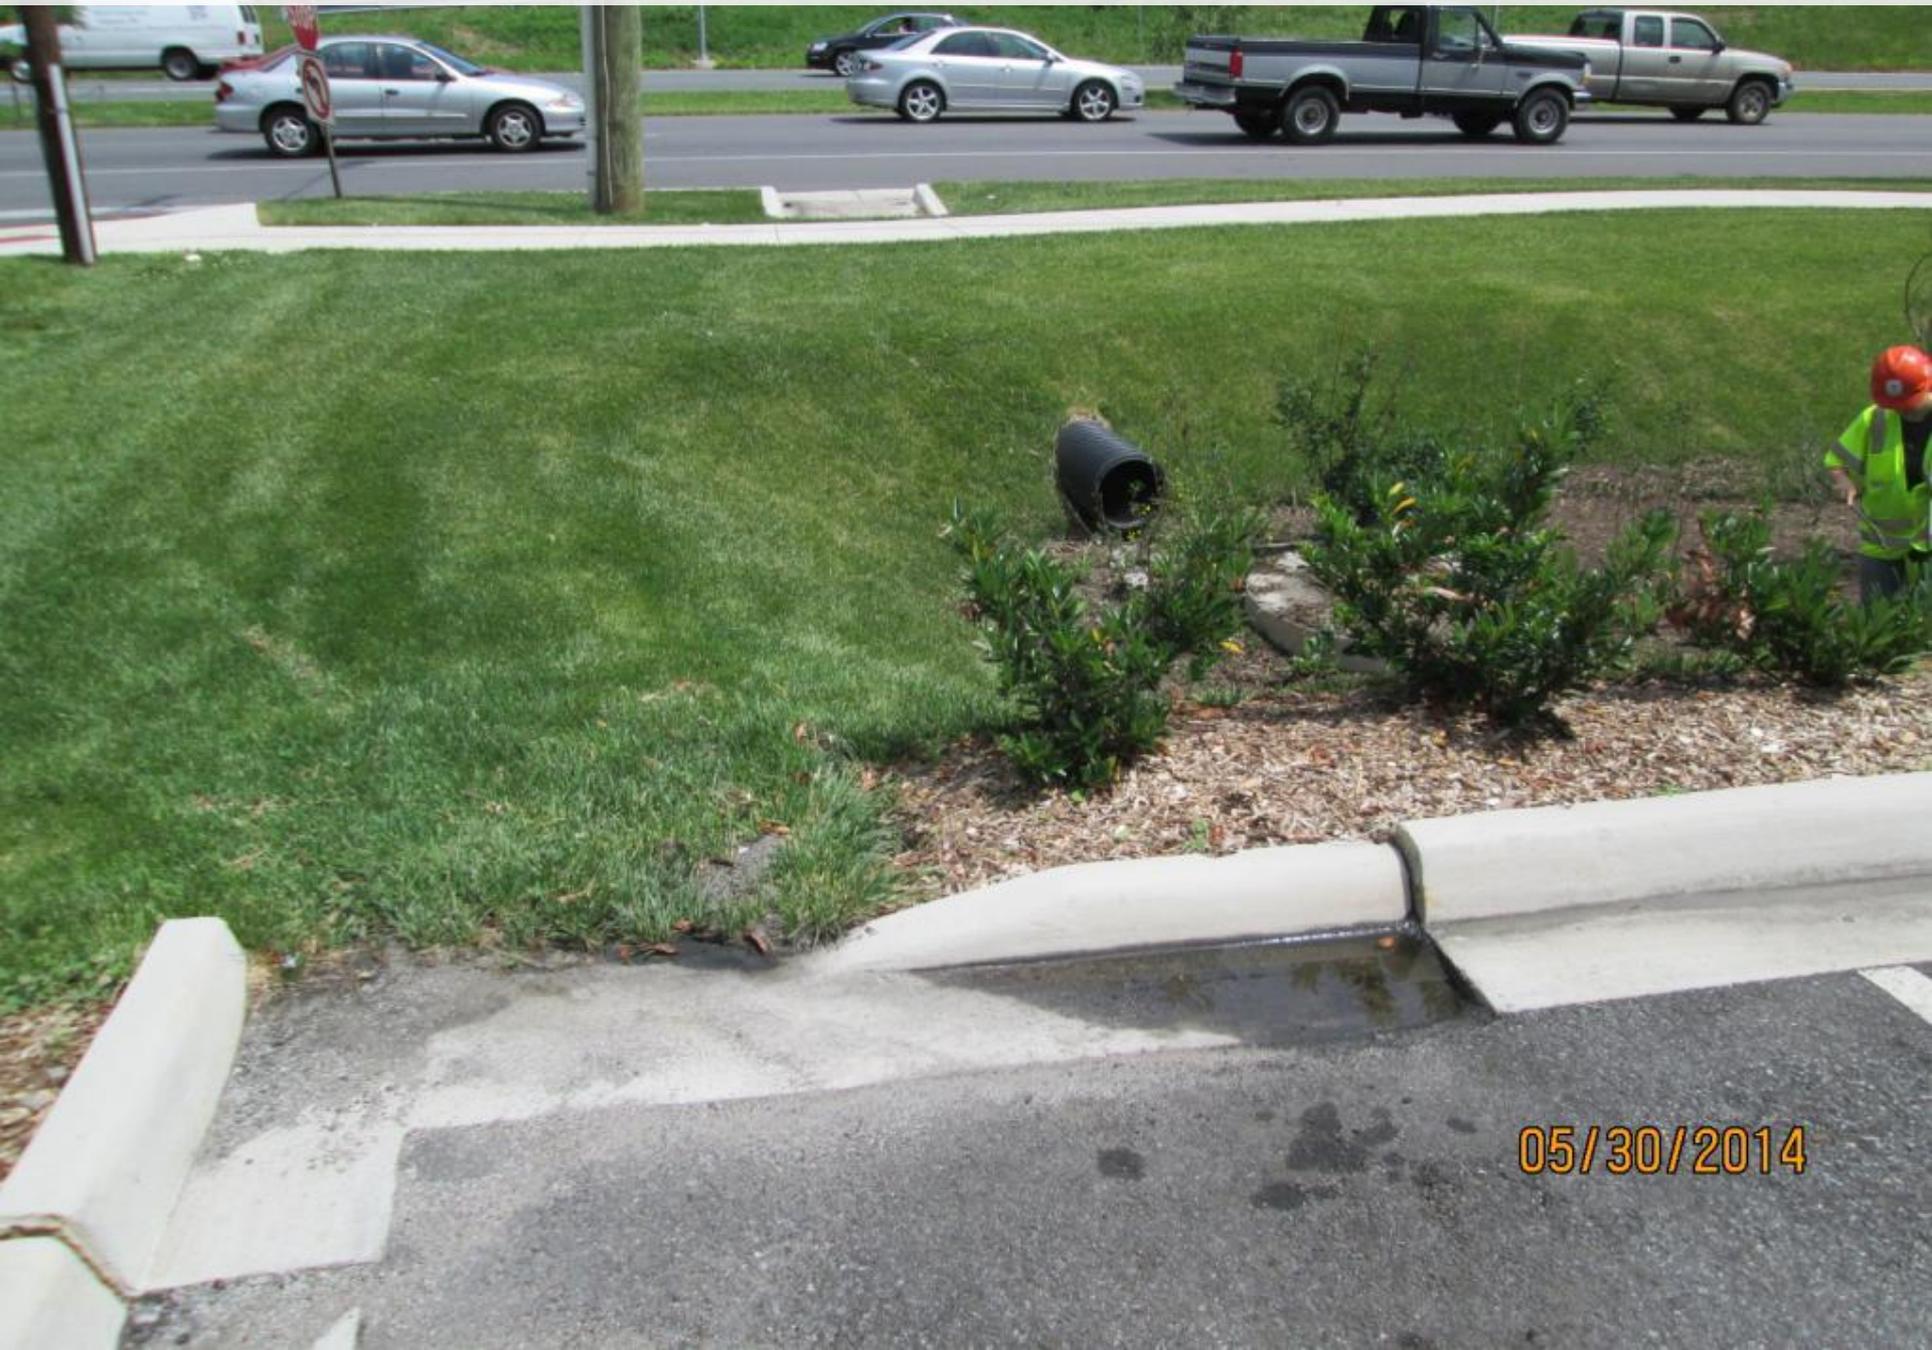
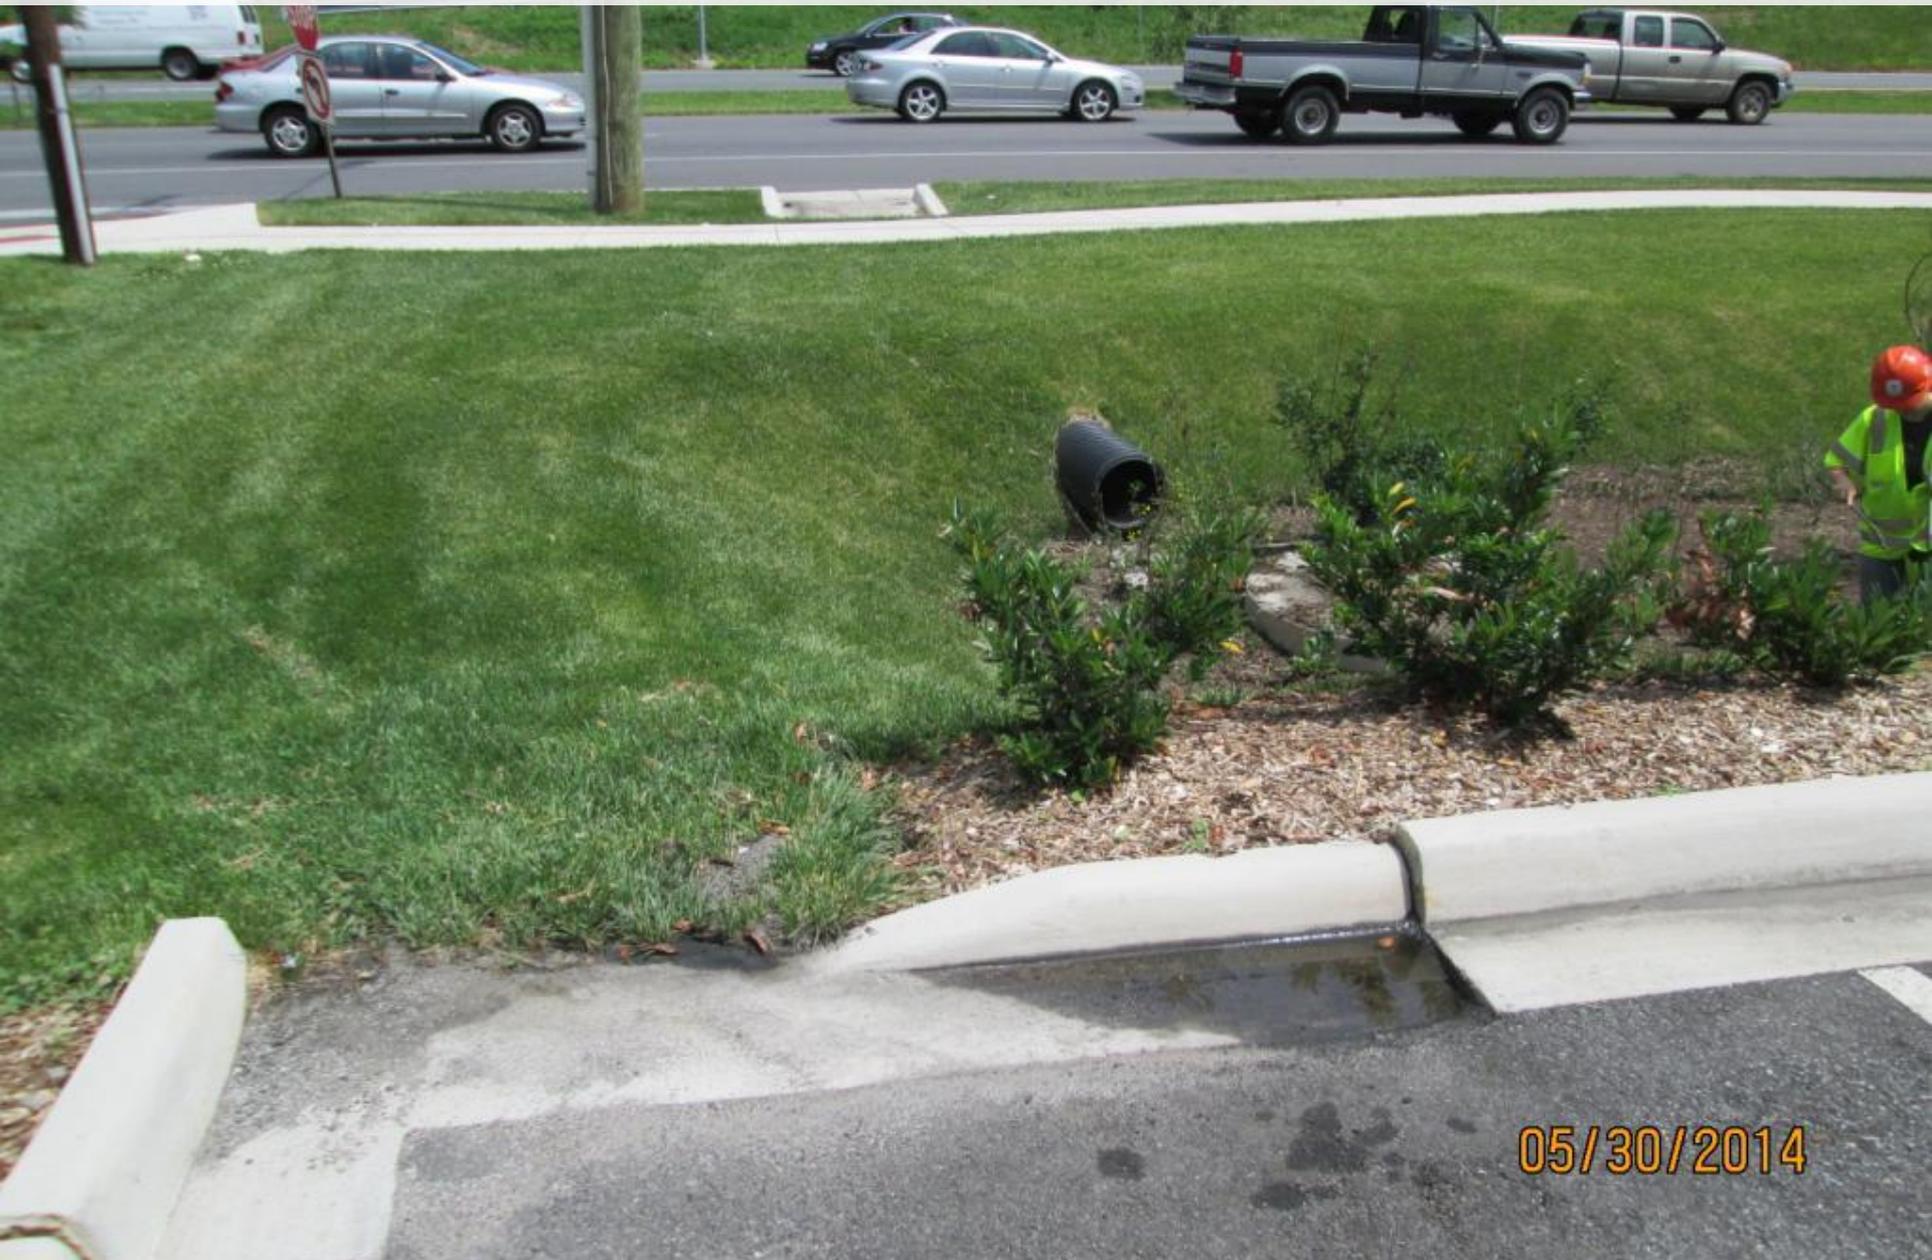
Q7: As an inspector, what would you recommend to the owner for this practice?

A: Clear sediment from inlet; make sure water gets in. SECTION 9.3, 2ND BULLET
