Sheet Flow to Vegetated Filter Strips & Conserved Open Space

Grass Channel Exercise

Permeable Pavement Exercise

Bioretention Exercise

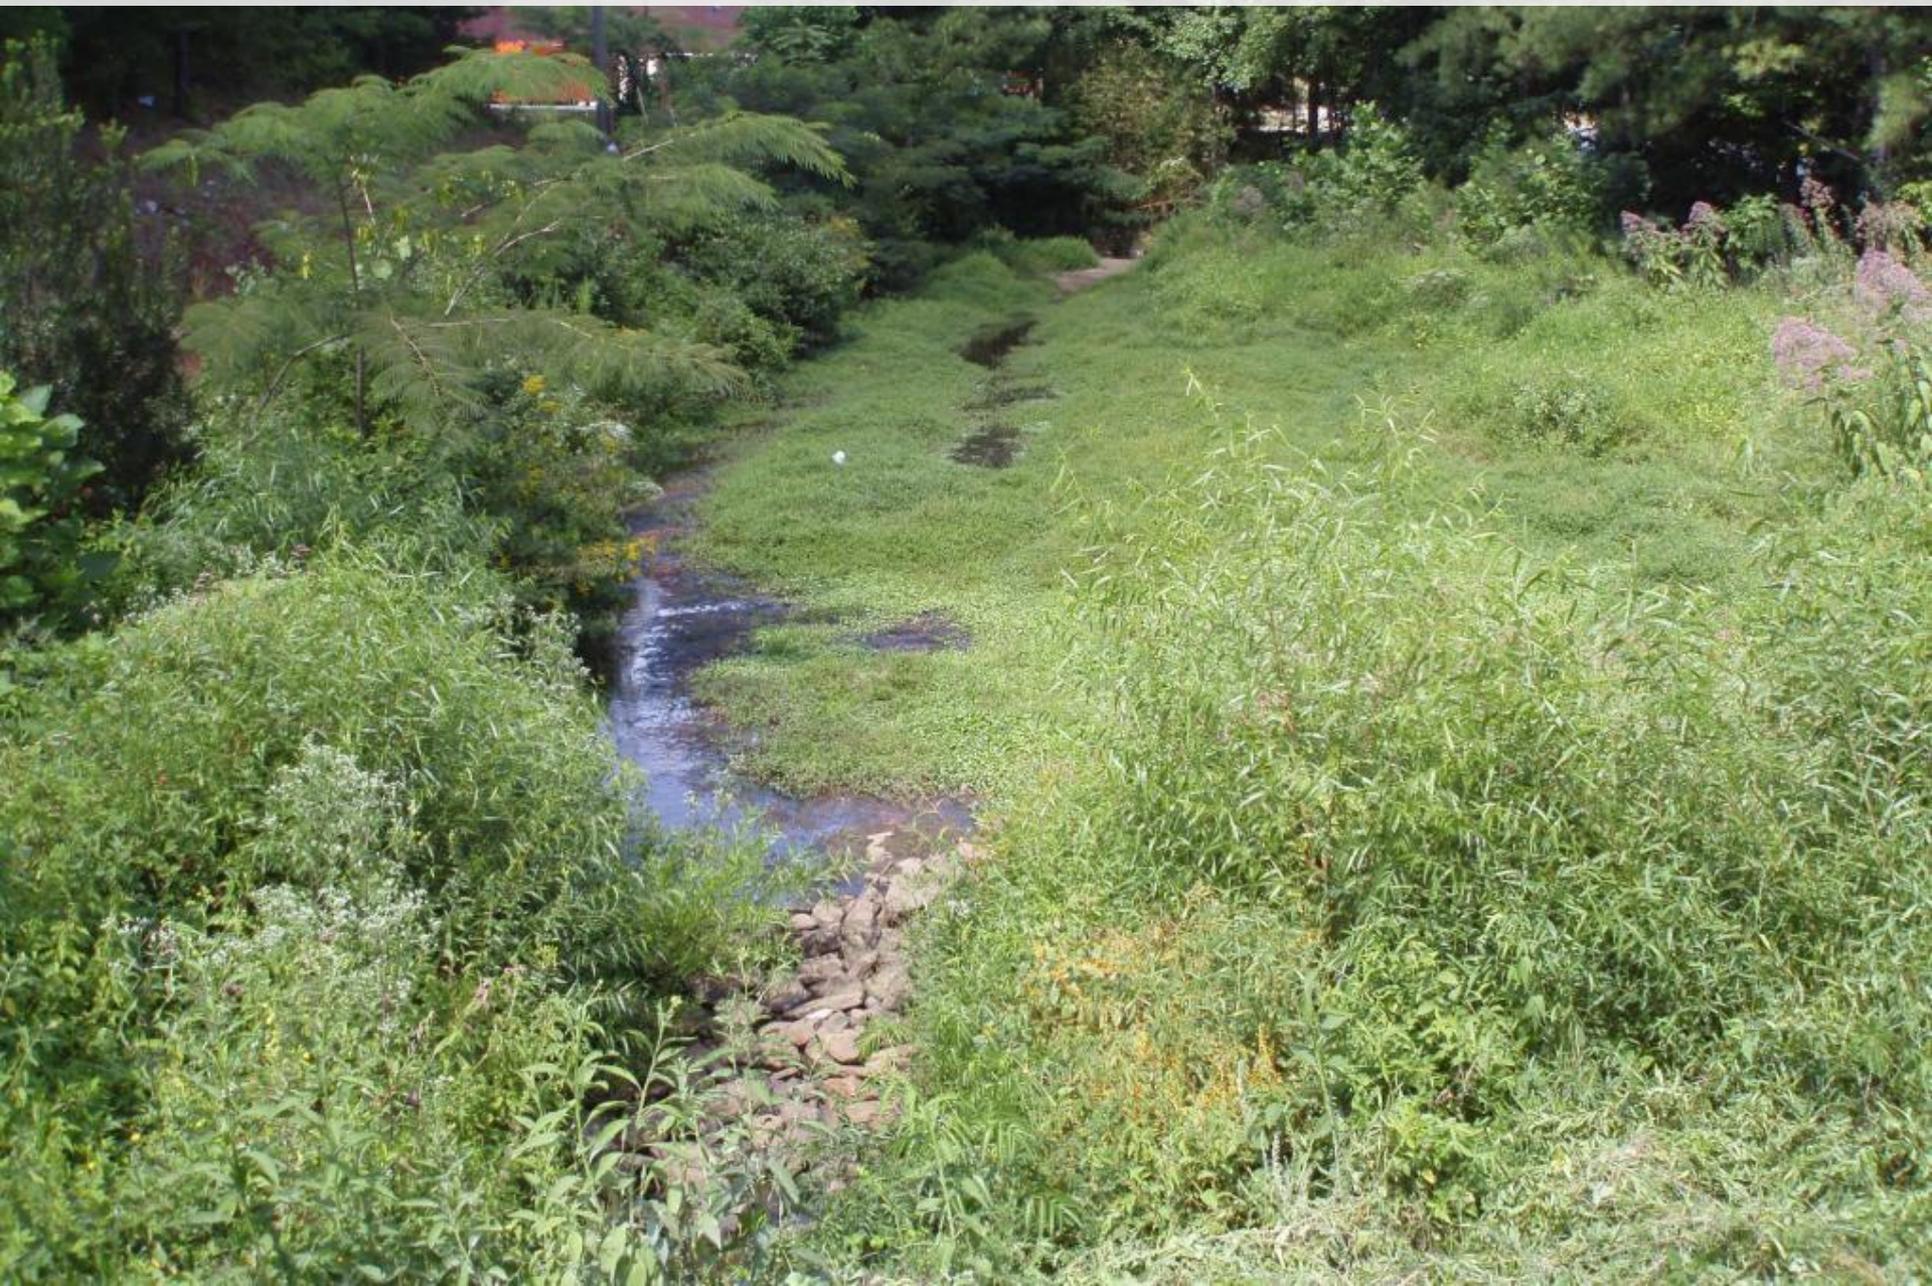
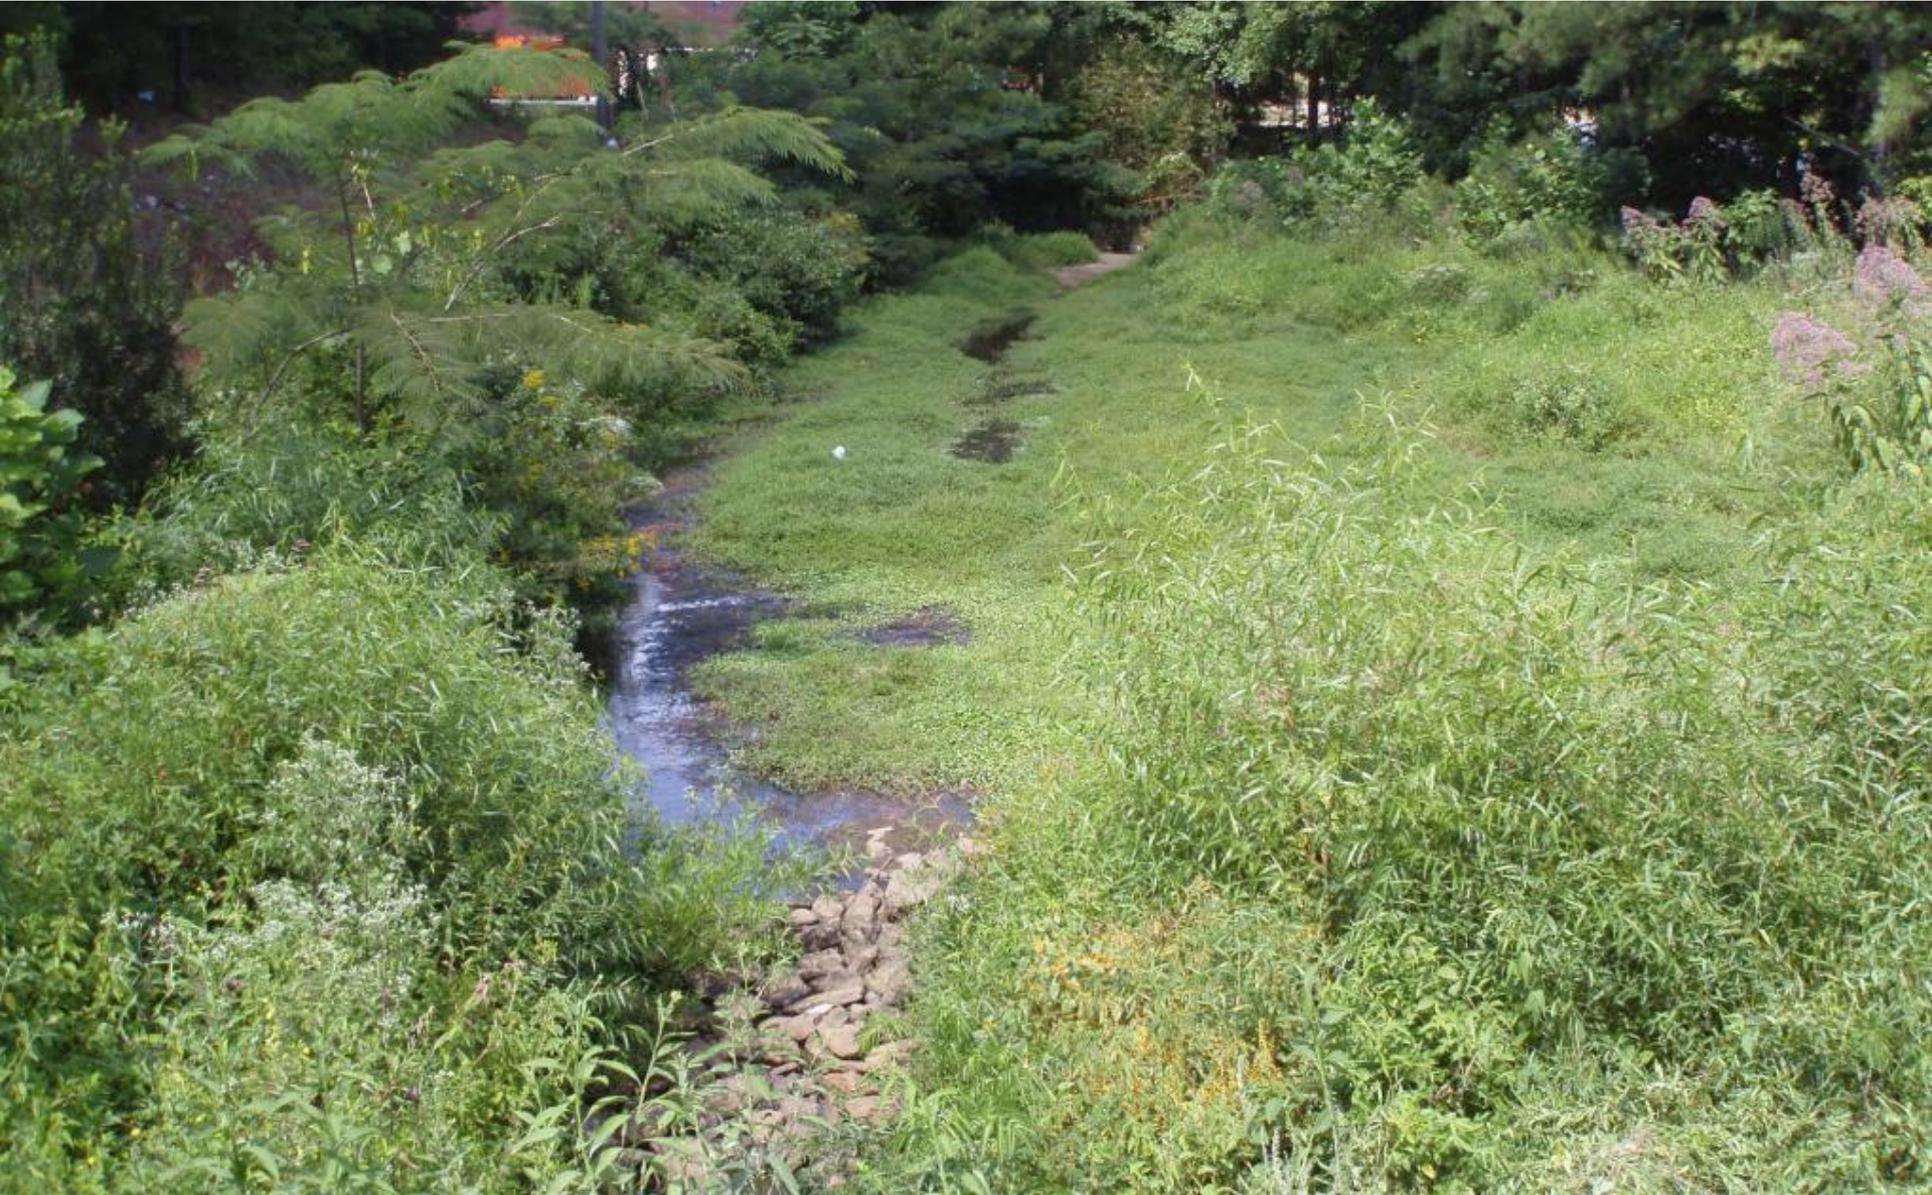
Q8: This is a sediment forebay. What is the recommended schedule to clean out sediment from forebays?

A: Every 5 – 7 years OR when 50% of forebay capacity has been filled. SECTION 9.3.

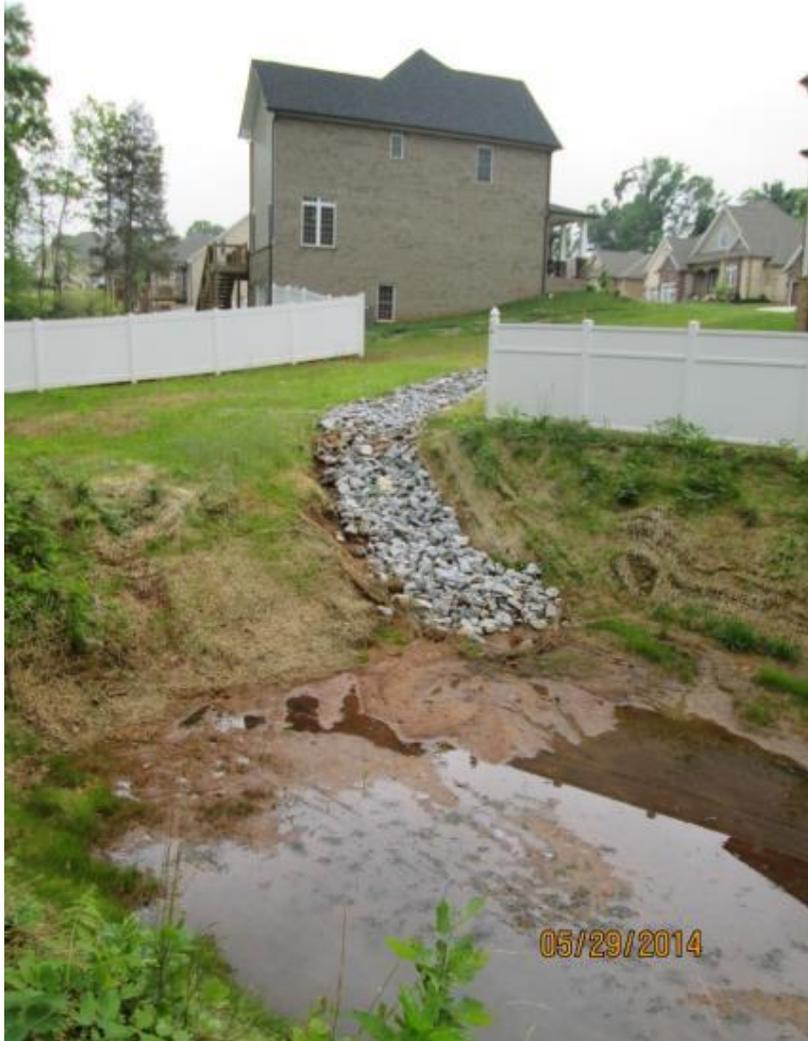
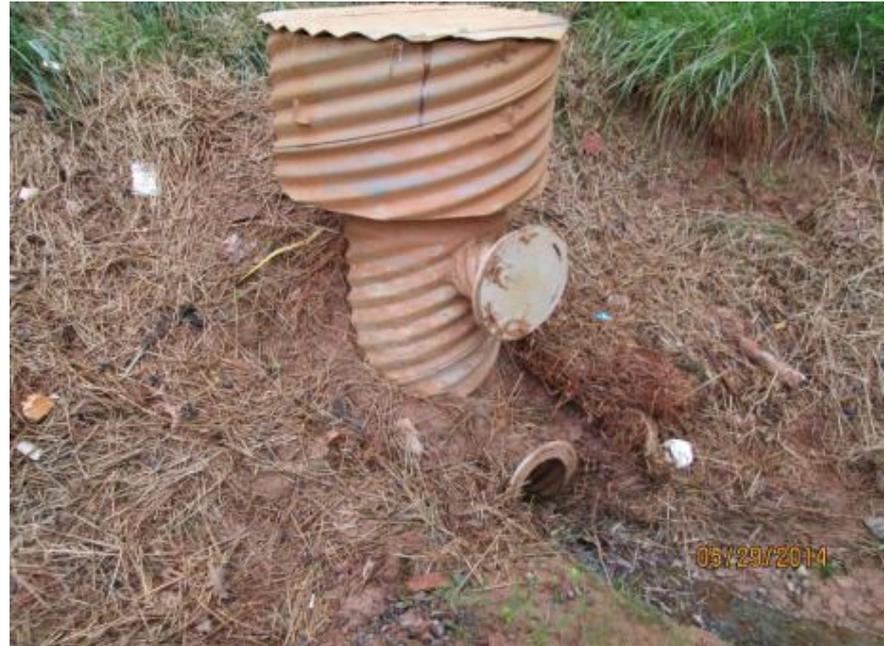
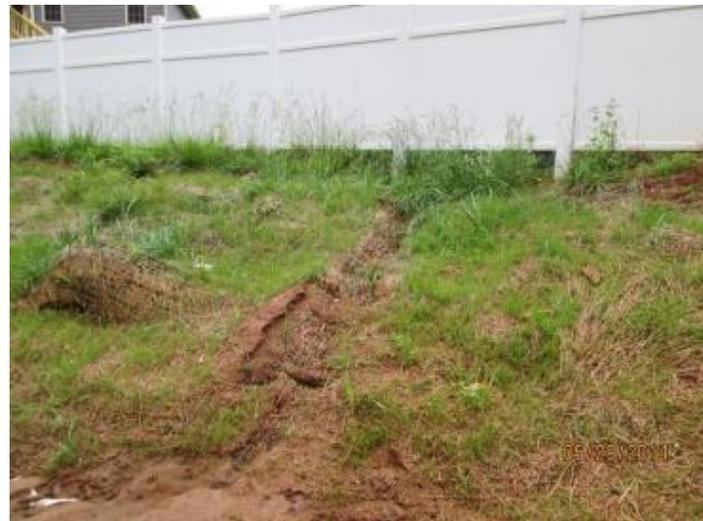
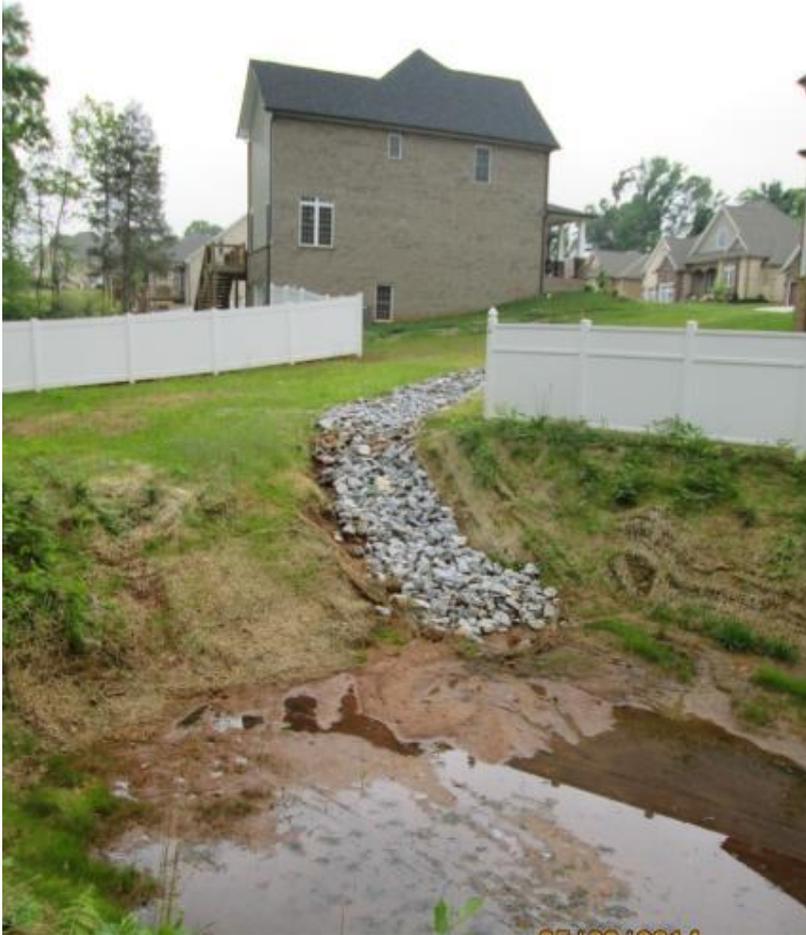
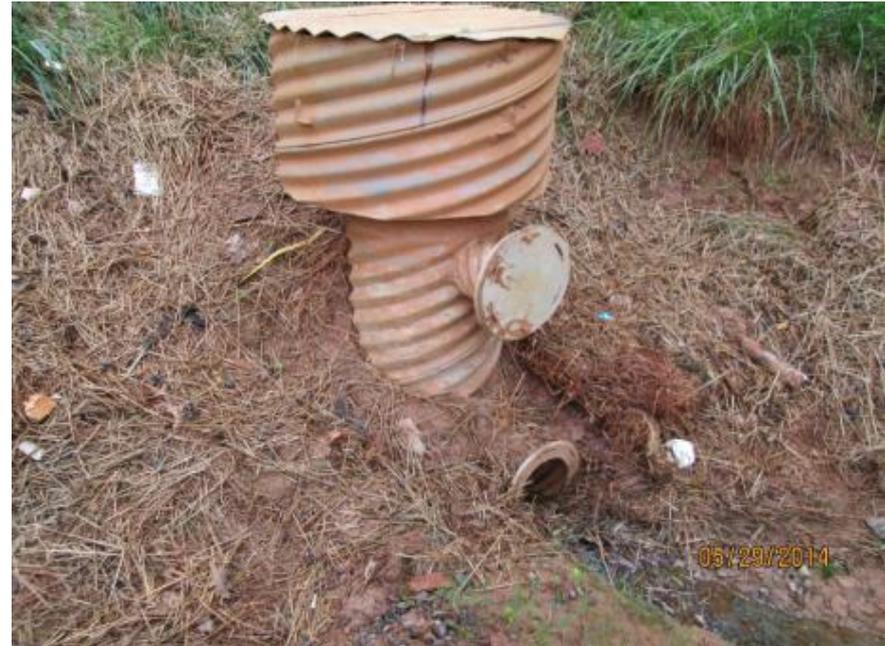
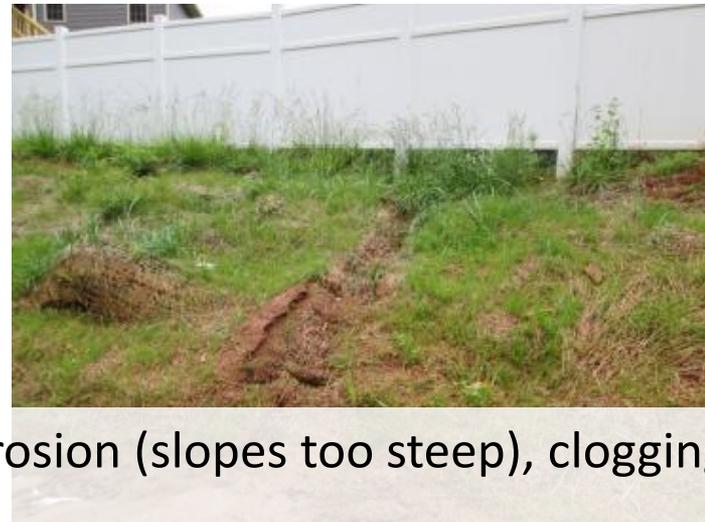
Q9: What comments would you make in your post-construction inspection for this facility?

A: Sediment accumulation, side slope erosion (slopes too steep), clogging of low-flow orifice. SECTION 9.2.

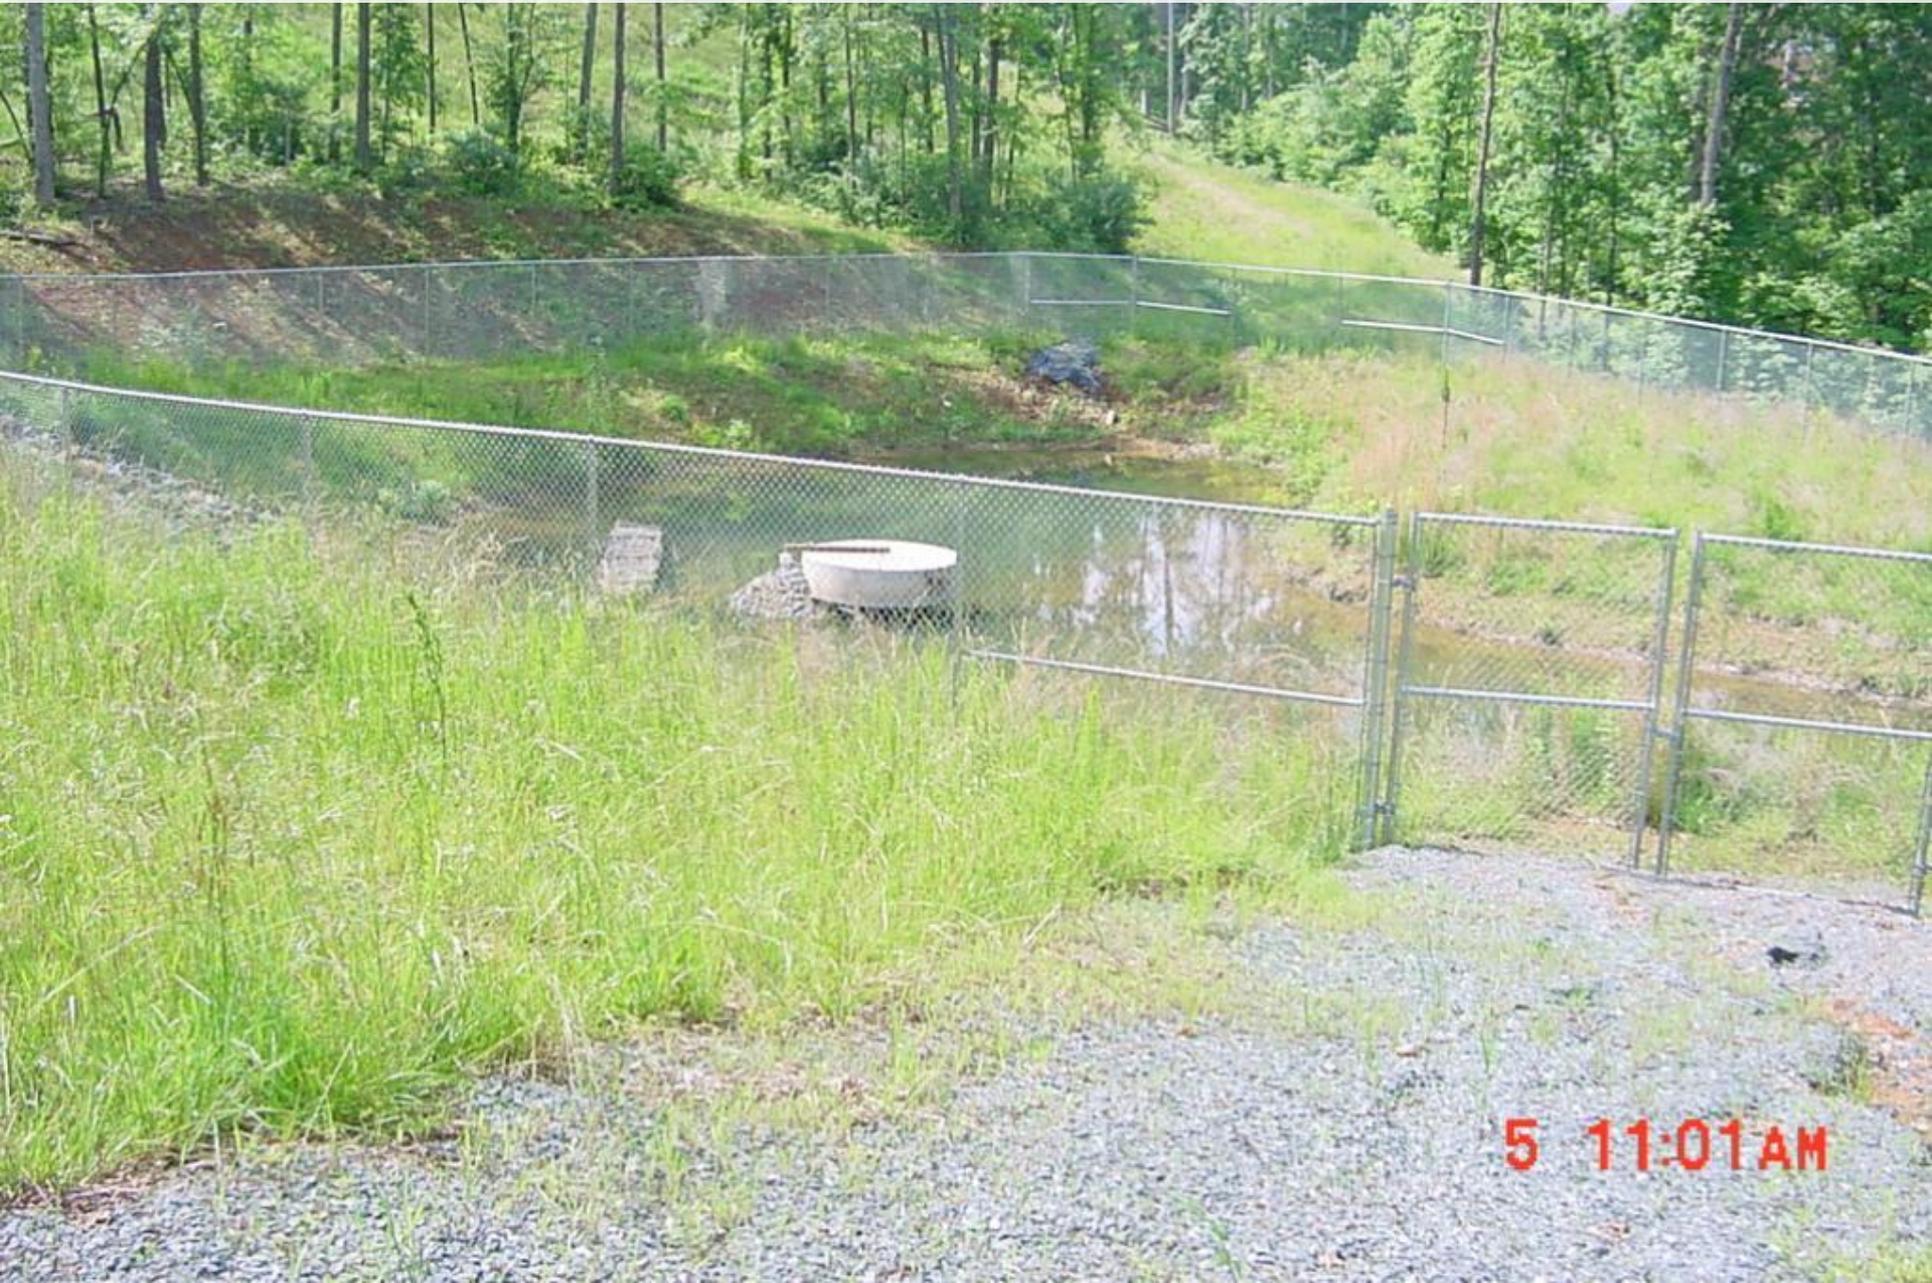
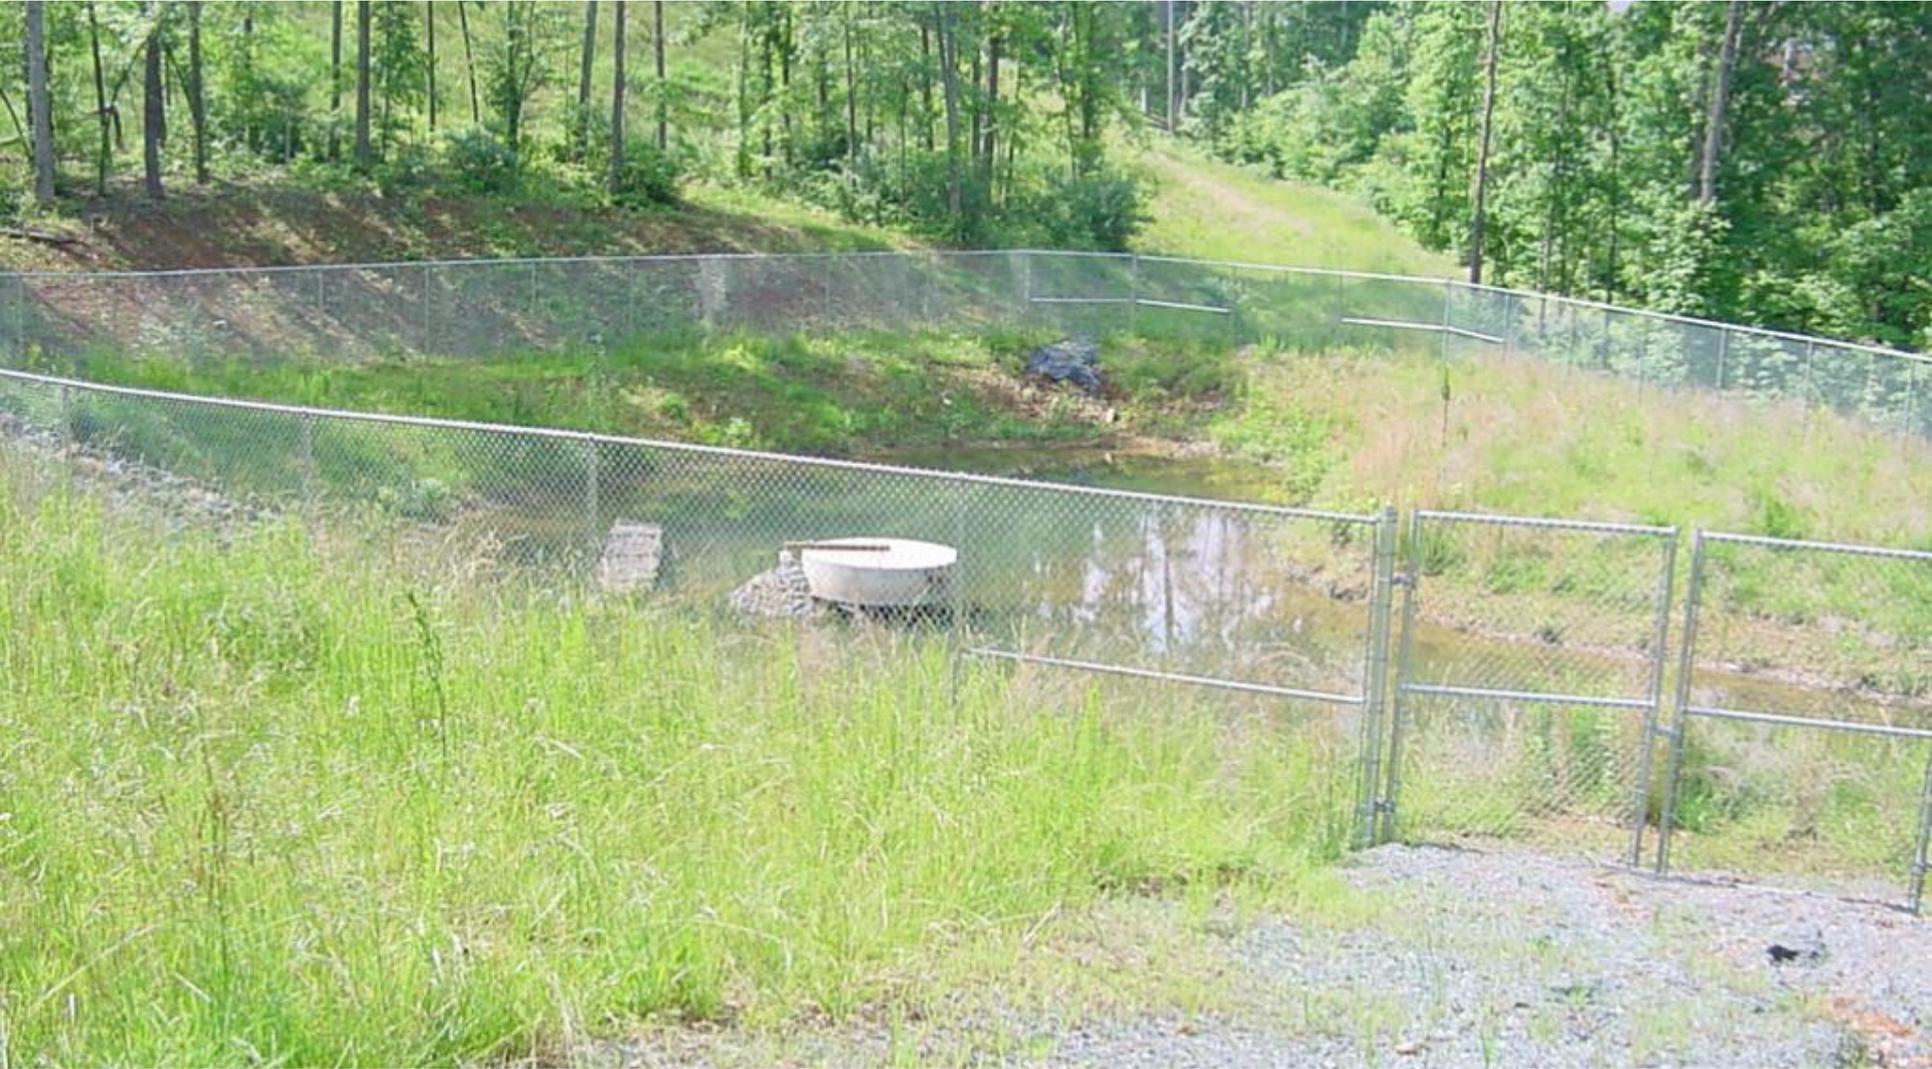
Q10: What features/standards for this maintenance access road would you look for?
Is this one adequate?

A: (1) Constructed of load-bearing materials, (2) minimum width of 12', (3) profile less than 15% or gravel road. Also, extend to forebay, micro-pool, safety benches, riser, outlet structure, are to turn around. For this one, no access to riser. SECTION 6.8.
