### **Geotechnical Design Report:**

# GEOTECHNICAL DESIGN REPORT

Closure of North, East, and West Ash Ponds  
Bremo Power Station  
Bremo Bluff, Virginia

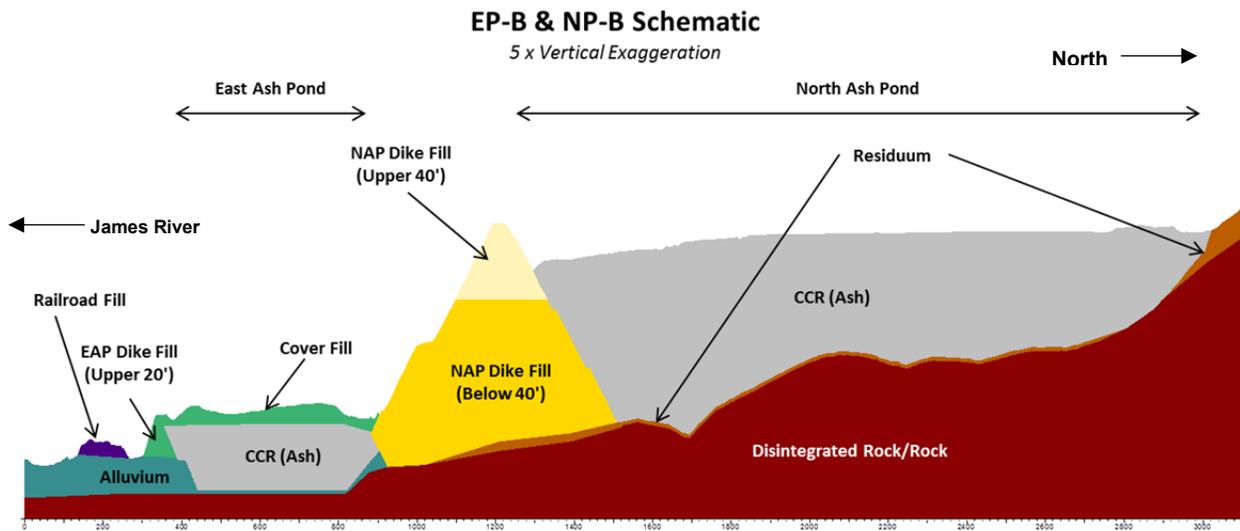
**Figure 2:** Schematic cross-section of existing (2015) subsurface conditions at EAP and NAP

disintegrated rock, each material was further subdivided with potential different properties for materials at various depths in different locations and using accepted methods to extrapolate properties around and between exploratory points. Figure 2 illustrates schematically the subsurface materials from the James River to the north end of the NAP. Strength, compressibility, permeability, and dynamic properties for these materials were developed based on field and laboratory data, and parameters were selected for the various analytical models used and described in the following paragraphs. Attachment 2 - Geotechnical Material Properties outlines the properties, selection process, and methods for each material.

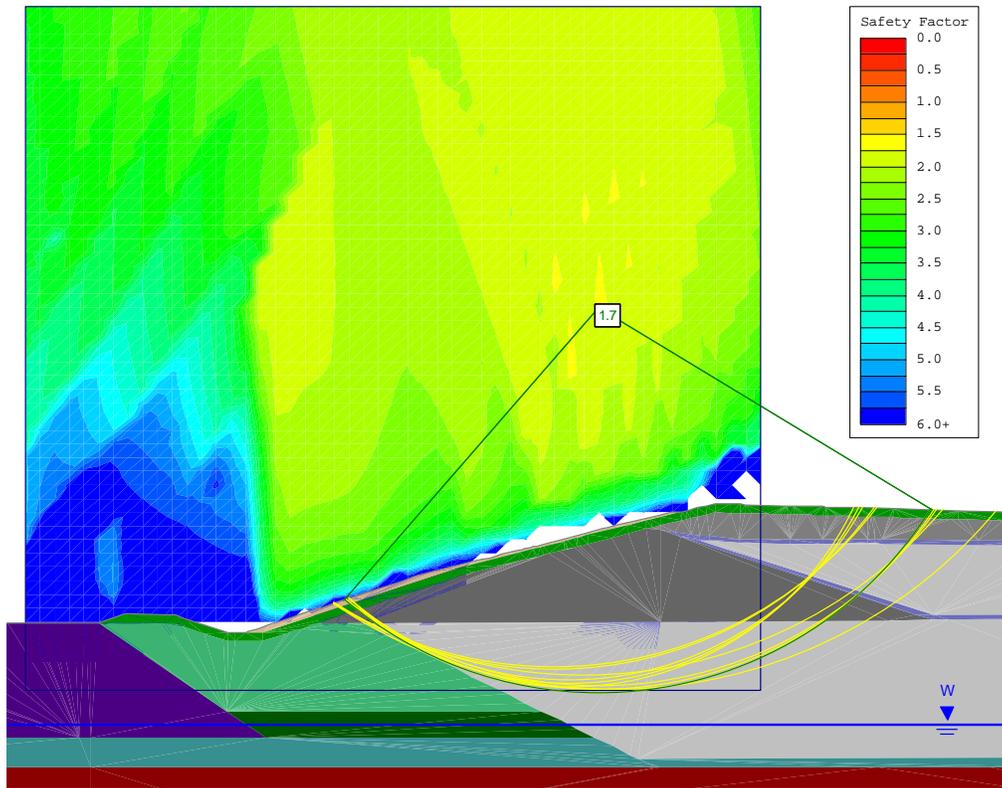
**Figure 3:** Example of slope stability analysis results from SLIDE 6.0

Slope stability analysis was conducted on selected sections of perimeter dikes, as well as proposed interior slopes (ditches and other slopes in the ponds), for the existing condition and design configurations. The purpose was to assess compliance with regulatory requirements for stability under static and seismic conditions, including with liquefied ash. Stability analyses were completed using the computer program SLIDE 6.0 Version 6.036 by RocScience. SLIDE computes potential failure surfaces using a general limit equilibrium (GLE) method developed by Morgenstern and Price (Abramson *et al.*, 2002). The method is based on the principle of limit equilibrium (i.e., the method calculates the shear strengths that would be required to maintain equilibrium, and then calculates a factor of safety by dividing the available shear strength by the shear strength required to maintain stability). A "grid" circular failure surface search-method was used in this study and checked with SLIDE's "auto refine" circular failure surface search method. For these iterations, safety factors in excess of 1.0 indicate stability, and those less than 1.0 indicate a potential for instability. Figure 3 illustrates the results of a typical slope stability analysis using a grid search and SLIDE 6.0. See Attachment 4 for details and reference information.

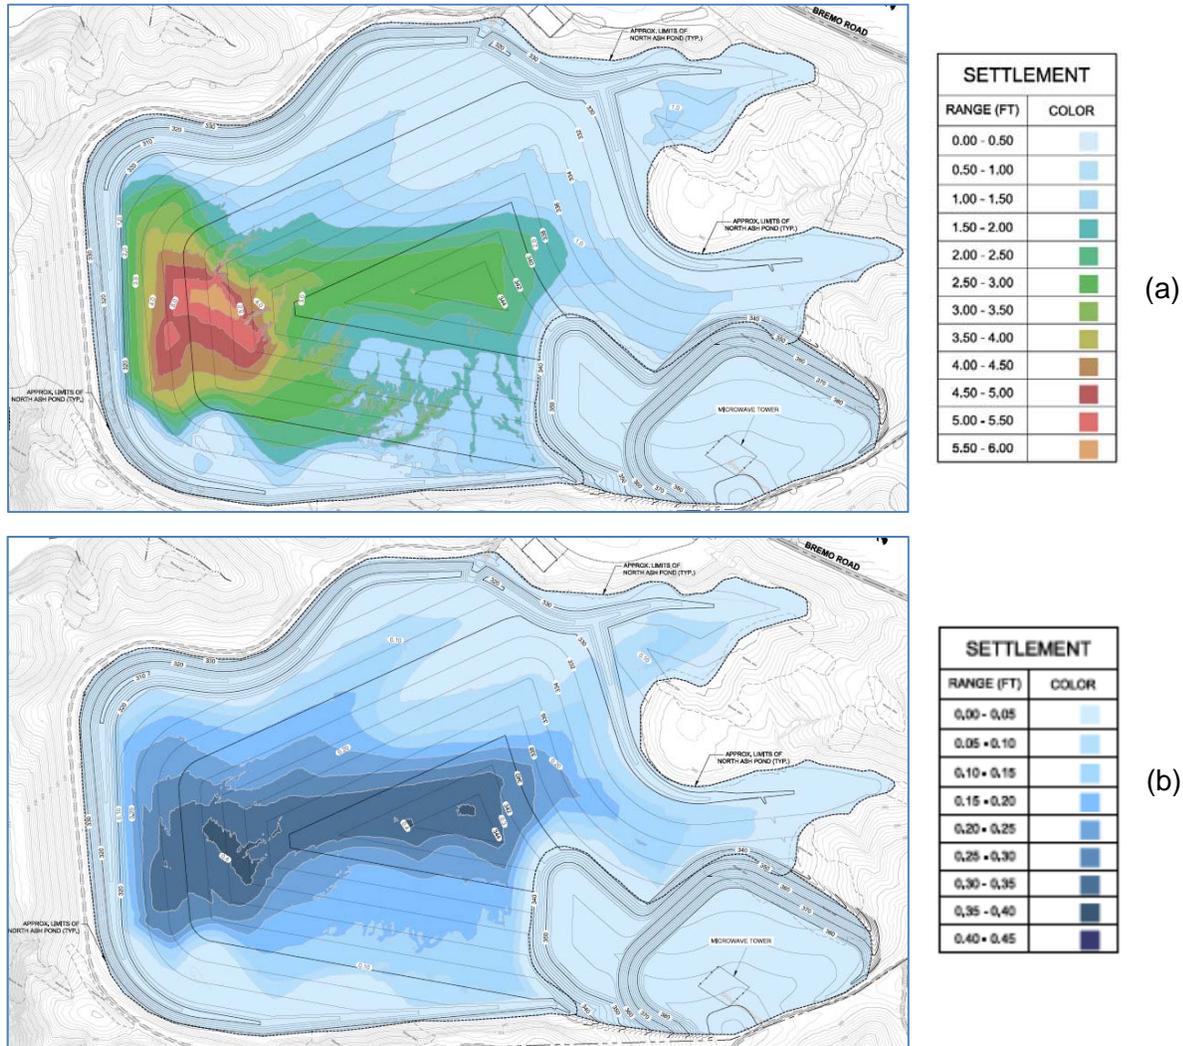
**Figure 4:** Example of results from (a) conservative and (b) predicted settlement approaches.

Settlement of the ash ponds was assessed considering two approaches: a relatively conservative method using one-dimensional consolidation based on laboratory data, and an elastic model based on shear wave velocity. The latter method, based on experience, will provide a better prediction of anticipated settlement. The complete analysis is provided in Attachment 5. Drawings GD-6A through 9A present isopachs of settlements derived from the available subsurface data using these two approaches for the EAP and NAP.

Drawings GD-6B through -9B present potential effects of the settlement on the proposed design grades. The consolidation approach is termed “Conservative” and the elastic approach termed “Predicted” to differentiate the approaches and methods used. Figure 4 above illustrates results from the conservative and predicted approaches. The WAP was not included in the analysis

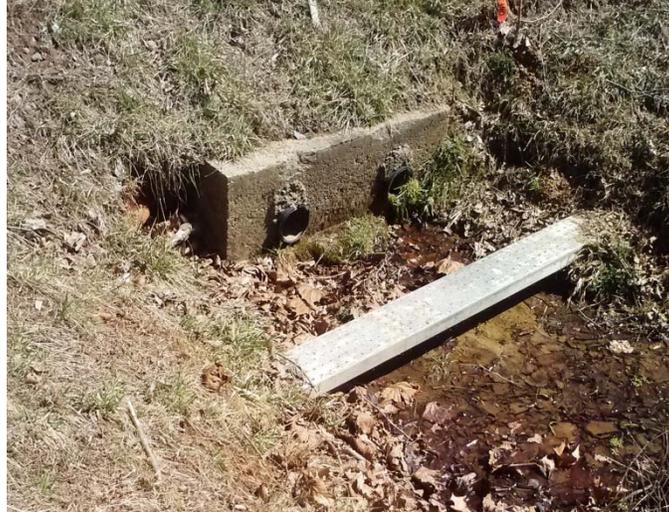
**Figure 5: Outlet of NAP Seepage Drains**

The NAP dike is provided with seepage controls (Figure 5: Outlet of NAP Seepage Drains), in the form of blanket drains that protect the embankment fill from seepage erosion and soil piping.

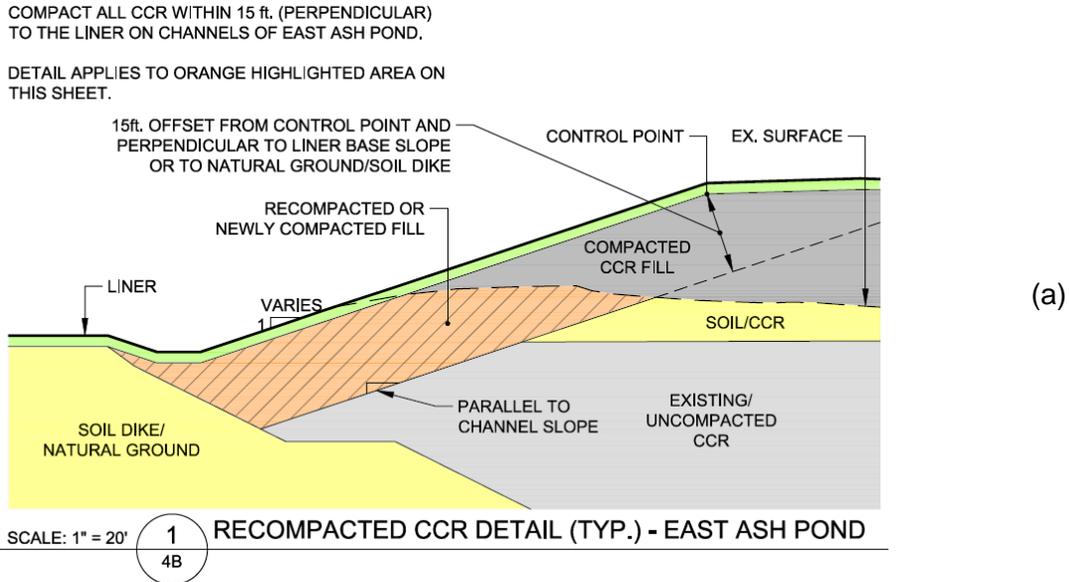
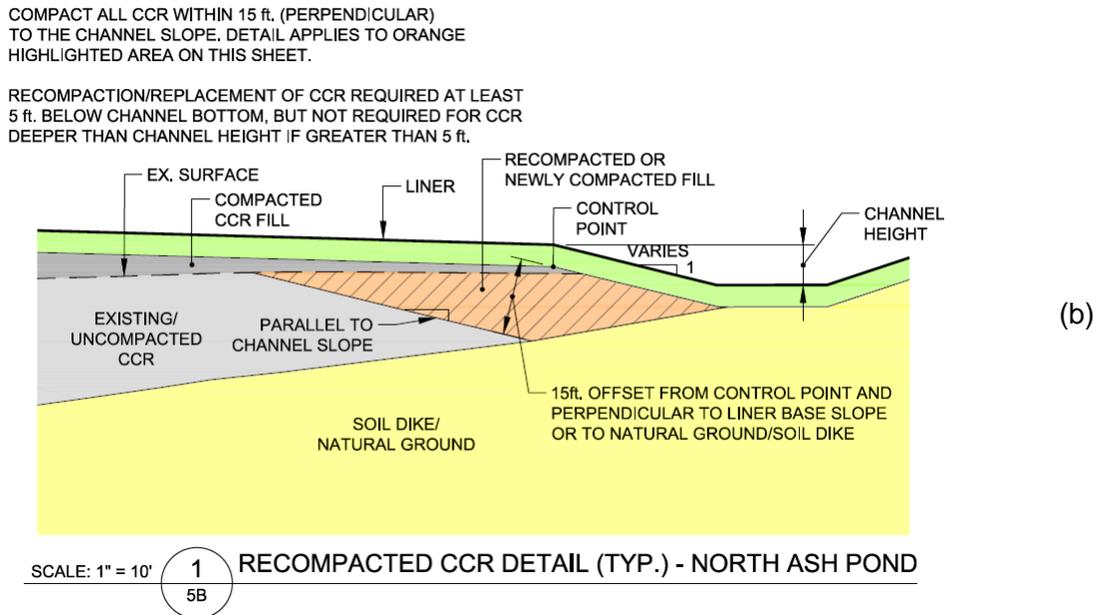
**Figure 6: Re-compaction / Replacement Detail for (a) EAP slopes and (b) NAP Slopes**

Most of the existing ash in the EAP and NAP may remain in place under new grades with no need for disturbance, excavation, or dewatering. However, at ditches in the NAP and EAP (see Drawings GD-4B and -5B), existing ash may not provide acceptable factors of safety for seismic stability and liquefaction, and will need to be reworked within 15 feet of proposed cap slopes (see Figure 6 below). Reworking will entail:

- Replacement – The excavated volume will need to be replaced with compacted ash or soil meeting embankment structural fill requirements and benched into excavated slopes to mitigate veneer failures.

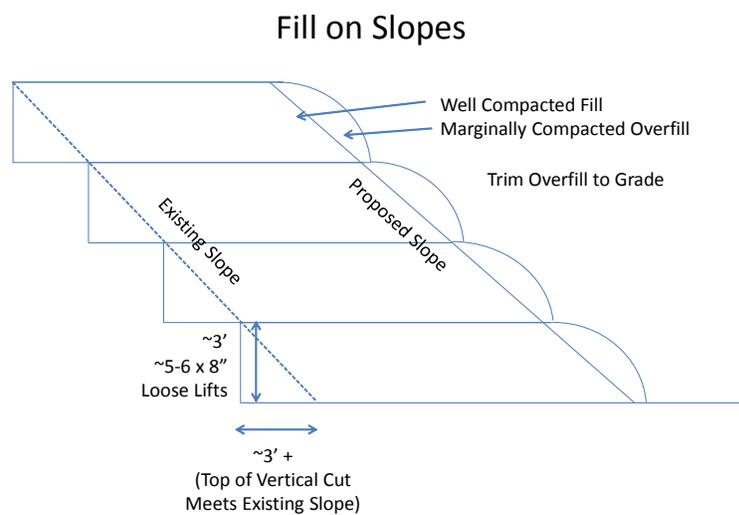
**Figure 7: Schematic of recommended slope fill benching and edge compaction**

Fill placed on slopes steeper than 6H:1V should be benched into the slope to reduce the potential for sliding along the former slope surface. Figure 7, below, shows a general benching concept. Immediately prior to fill placement, a near vertical cut up to 4 feet high should be made in the existing slope. Depending on the existing slope, such a cut will typically require excavation of more than 4 feet horizontally into the slope. This cut will provide a horizontal “bench” for fill placement.

Fill lifts shall be placed and compacted in accordance with the construction specifications on the horizontal surface produced until the top of the vertical cut is reached. At that point, the process should be repeated for the next bench. If excavated material from the bench is acceptable for use as fill, it may be incorporated into the fill placement.

Acceptable compaction is difficult to achieve on sloping surfaces or near the slope surface due to lack of confinement. Therefore, when creating a fill slope, fill lifts should generally extend beyond the planned fill slope such that acceptable compaction is achieved at the planned slope and the edge of the fill lift, which may not be acceptably compacted if beyond the planned fill (overfill). This excess fill material may then be graded off to leave the planned fill slope.

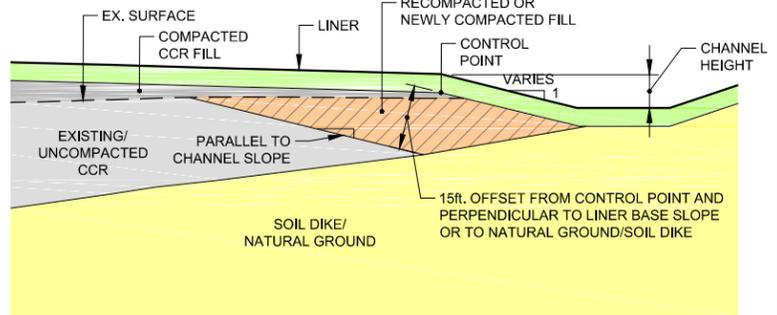
SCALE: 1" = 10' **1** RECOMPACTION CCR DETAIL (TYP.) - NORTH ASH POND **5B**

COMPACT ALL CCR WITHIN 15 ft. (PERPENDICULAR) TO THE CHANNEL SLOPE. DETAIL APPLIES TO ORANGE HIGHLIGHTED AREA ON THIS SHEET.

RECOMPACTION/REPLACEMENT OF CCR REQUIRED AT LEAST 5 ft. BELOW CHANNEL BOTTOM, BUT NOT REQUIRED FOR CCR DEEPER THAN CHANNEL HEIGHT IF GREATER THAN 5 ft.
