# **Post-Closure Care Plan**

Pond 1 Ash Disposal Area Closure  
Clinch River Plant

Appalachian Power Company  
Clinch River Plant, Carbo, Virginia

**November 2016**

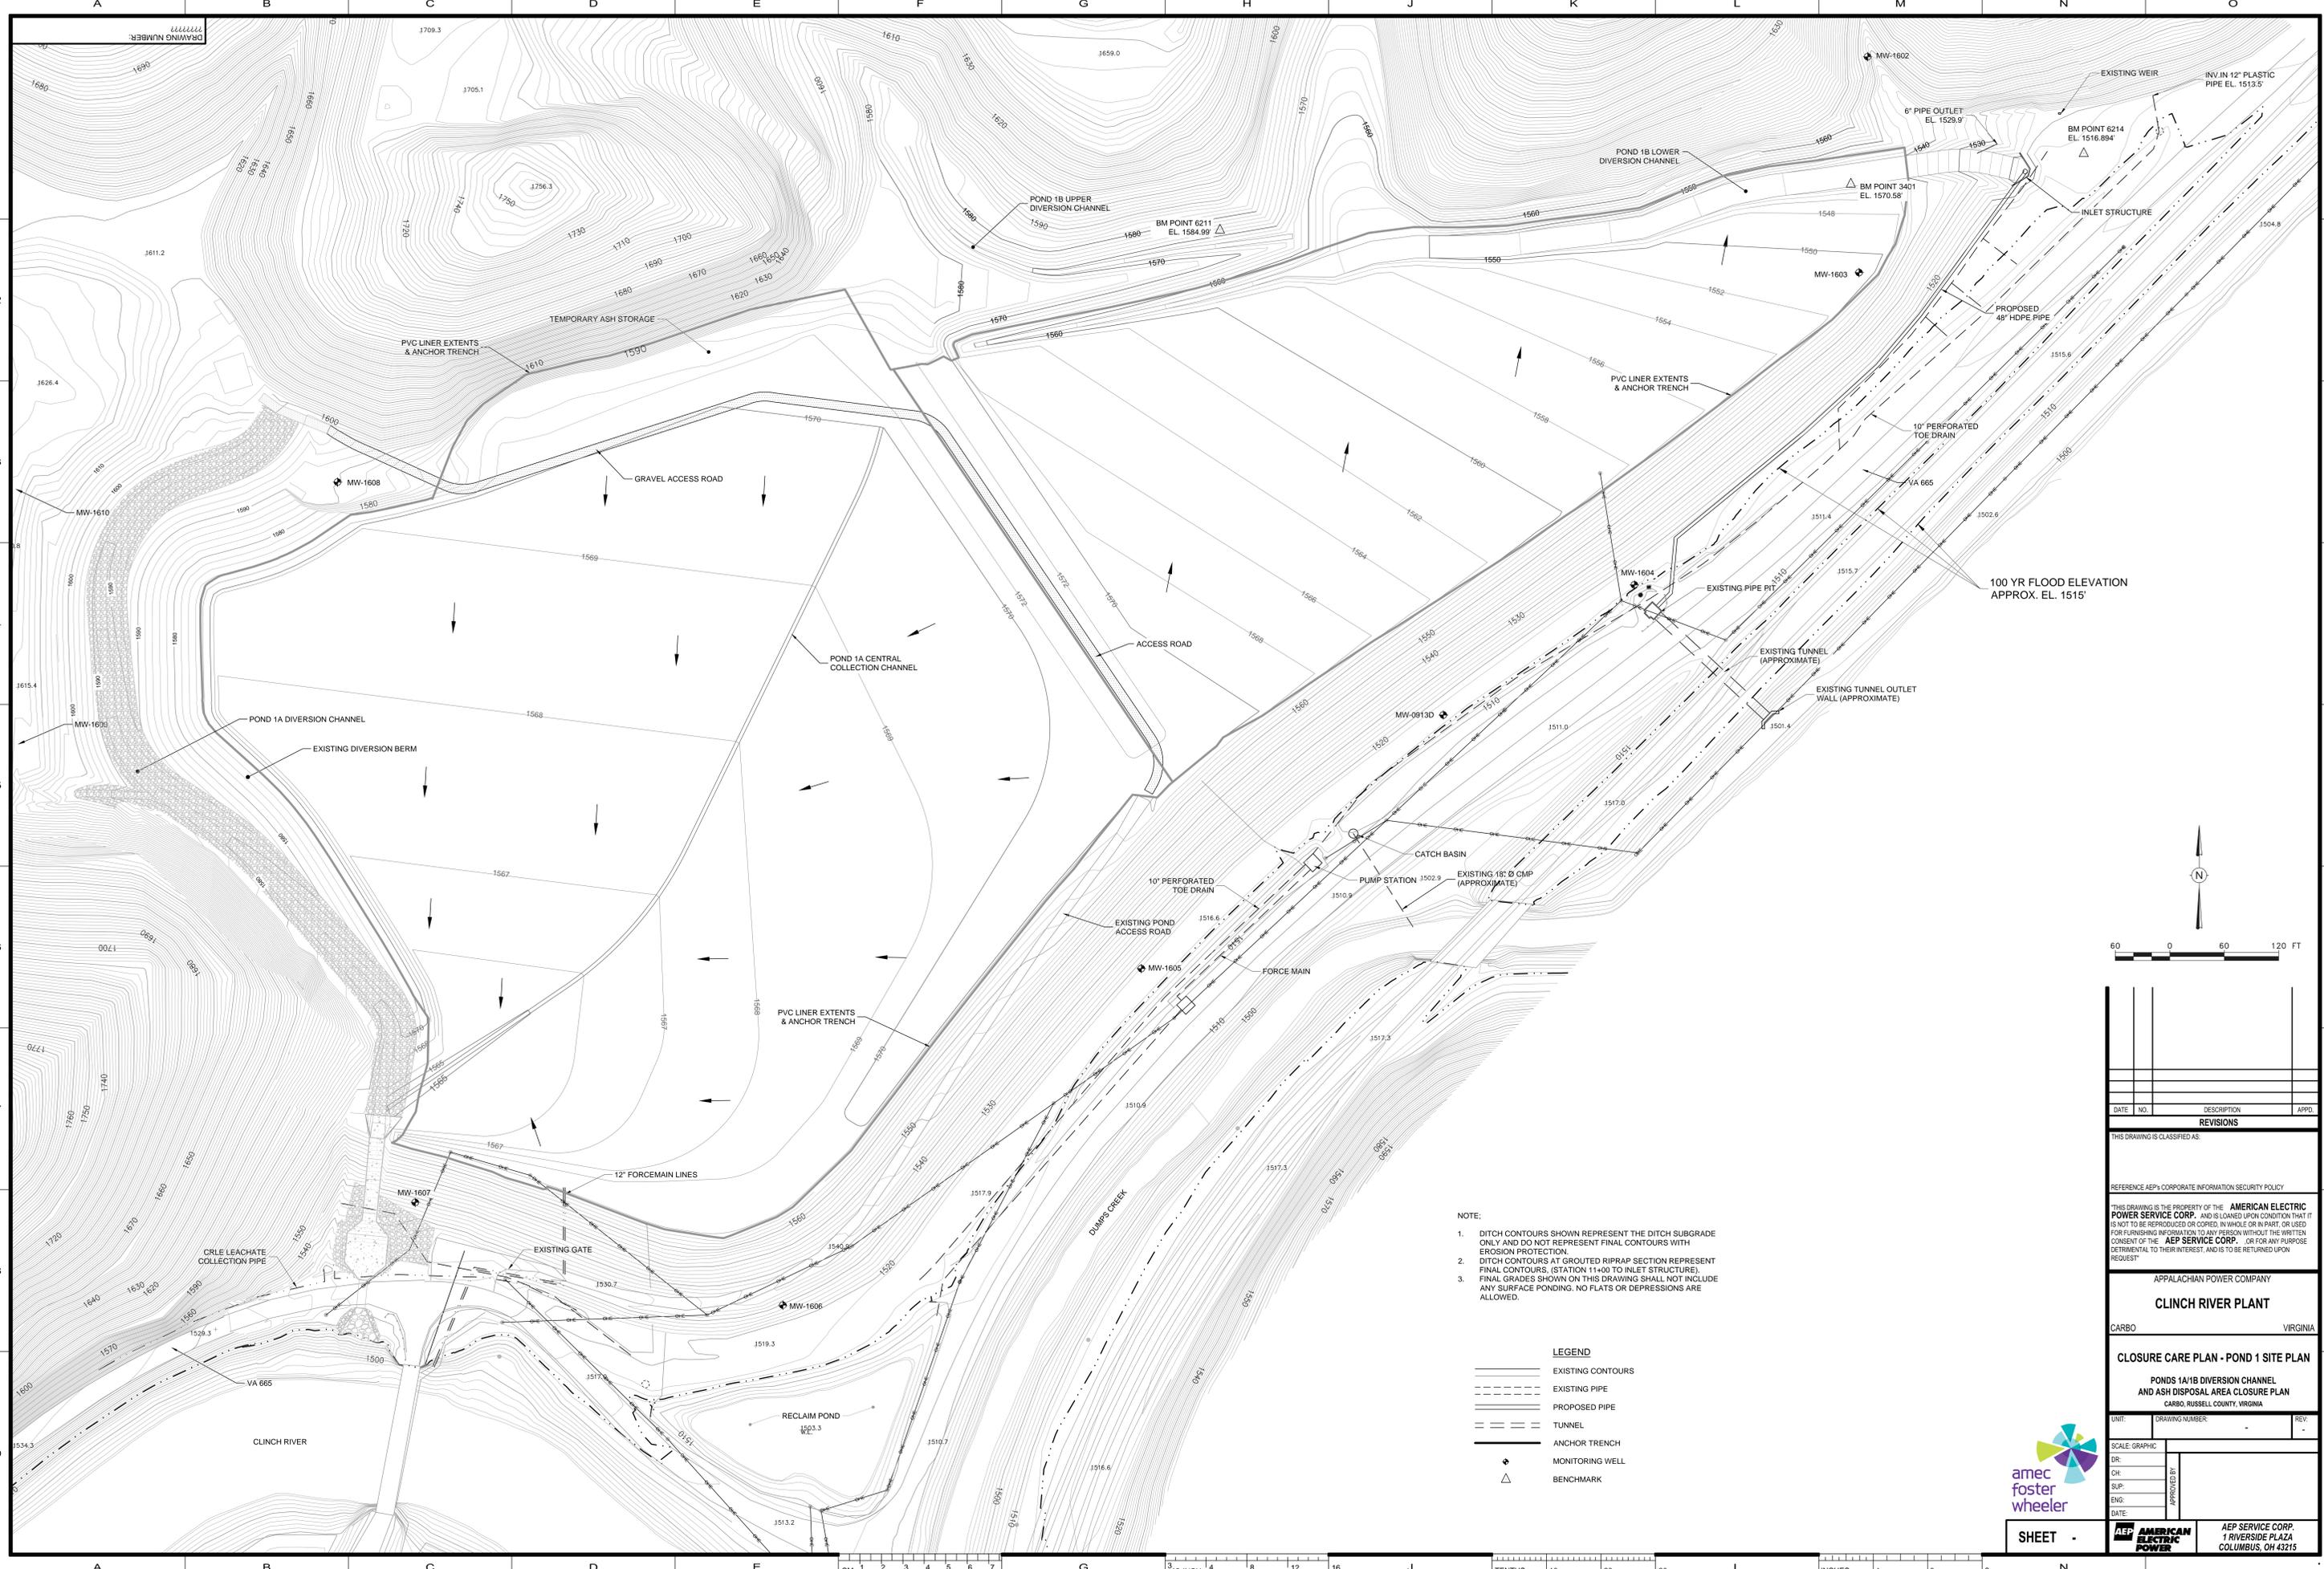
- NOTE:
1. DITCH CONTOURS SHOWN REPRESENT THE DITCH SUBGRADE ONLY AND DO NOT REPRESENT FINAL CONTOURS WITH EROSION PROTECTION.
  2. DITCH CONTOURS AT GROUDED RIPRAP SECTION REPRESENT FINAL CONTOURS. (STATION 11+00 TO INLET STRUCTURE).
  3. FINAL GRADES SHOWN ON THIS DRAWING SHALL NOT INCLUDE ANY SURFACE PONDING. NO FLATS OR DEPRESSIONS ARE ALLOWED.

Appendix B – Pond 1 Site Plan
