Jackson River Success Story

To address this impairment, the [Jackson River Benthic TMDL study](#) was completed in 2010.

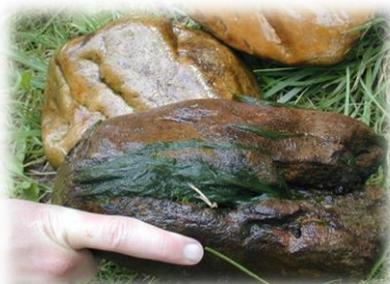
Periphyton is a mixture of organisms, including algae, that are attached to objects such as rocks on the riverbed

Figure 2. Periphyton on rocks

While these reductions were crucial for restoring the aquatic habitat and community of organisms, summertime low flow conditions due to the upstream Gathright Dam complicated restoration efforts. Low flow conditions allowed for low dissolved oxygen concentrations, more time for periphyton to assimilate the large nutrient loads, and less scouring of the periphyton since water velocities rarely increased. Therefore, in partnership with the Army Corps of Engineers, the TMDL study concluded that implementation of the TMDL should include pulsing the flow in the main stem of the Jackson River in order to mimic summertime storm flow and scour the periphyton off of the river bed. In February 2013, the most recent report, titled [Characterization of Jackson River Base Flow and Pulse Flow Water Quality: 2011 and 2012](#) was released, outlining the most recent findings of the TMDL implementation. Of the many results outlined in that report, it was concluded that dissolved oxygen levels were improved and periphyton levels were reduced following pulse events.

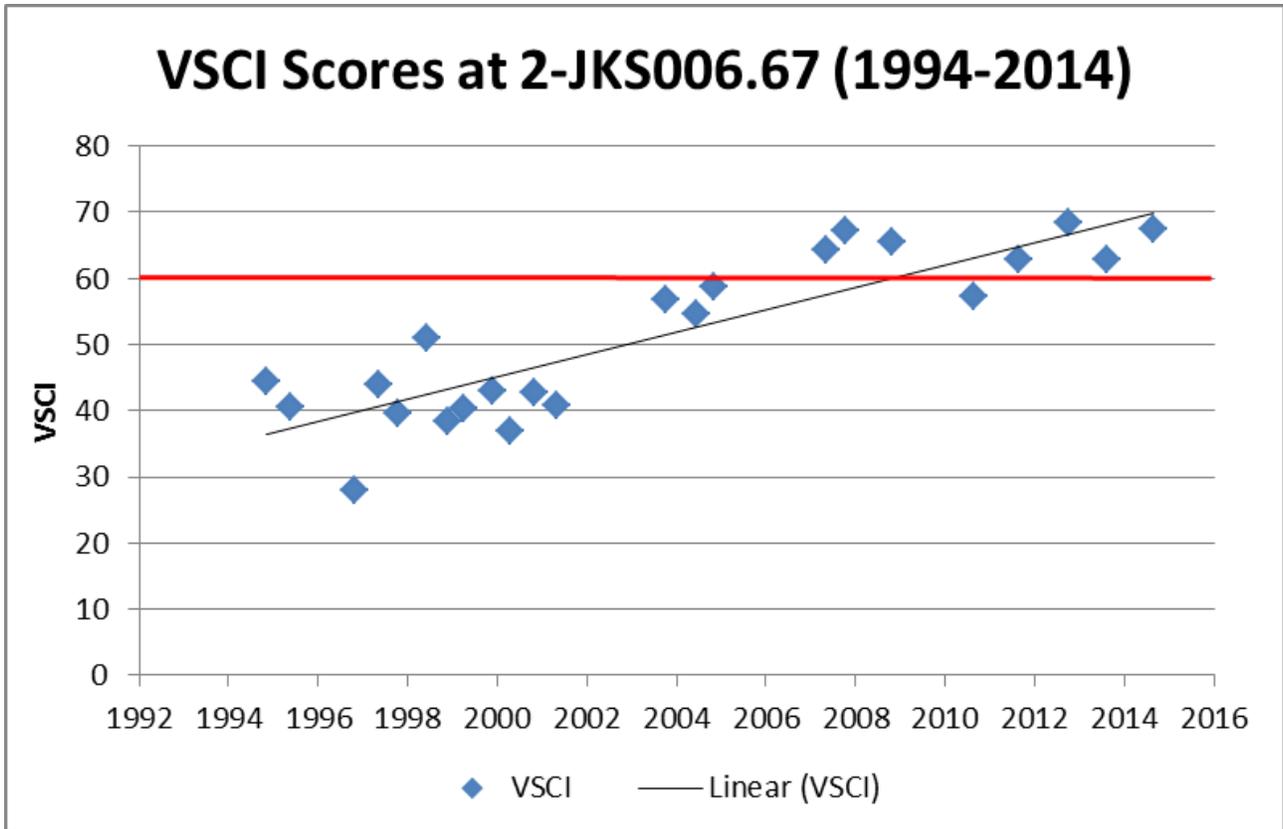
Figure 3. VSCI Scores for a monitoring station located near Dabney Lancaster Community College, 6.67 miles from the mouth of the Jackson River, during 1994-2014.

Due to the efforts of the point source dischargers, the Army Corps of Engineers, and DEQ, about 10 of the 24 impaired miles of the Jackson River saw a benthic macroinvertebrate community recover as shown by an increase in VSCI scores above the impairment threshold of 60 (Figure 2). Additionally, about 20 miles of the James River immediately below this section of the Jackson River also saw a benthic macroinvertebrate community recovery as a result of the efforts of this project.
