DAN RIVER COAL ASH SPILL

VA Roanoke River Basin Advisory Committee

April 21, 2014

John Kennedy, Office of Ecology & Infrastructure

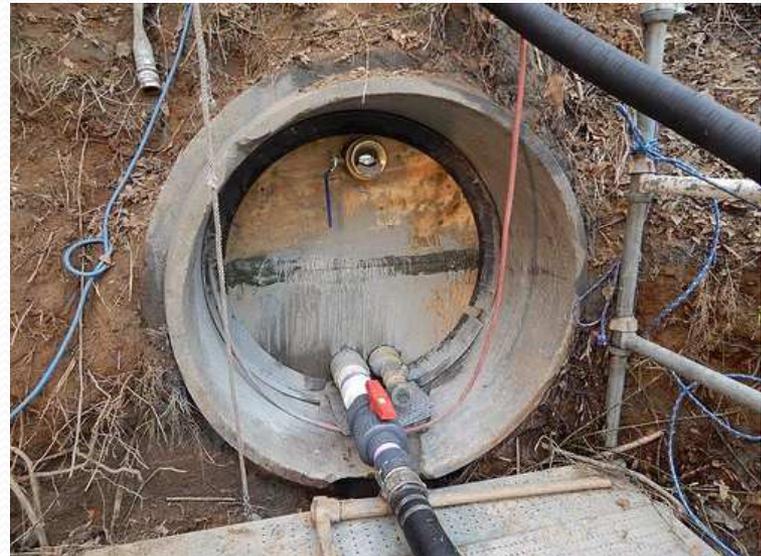
- Immediately began river water monitoring at drinking water intakes.
- All drinking water has met standards; monitoring continues.
- Saturday, 2/8 – Duke plugged damaged 48” storm water pipe.
- Friday, 2/21 - second, 36” pipe discharging arsenic-contaminated groundwater was plugged.
- Water quality, sediment and fish monitoring ongoing by DEQ, North Carolina, and EPA contractor.

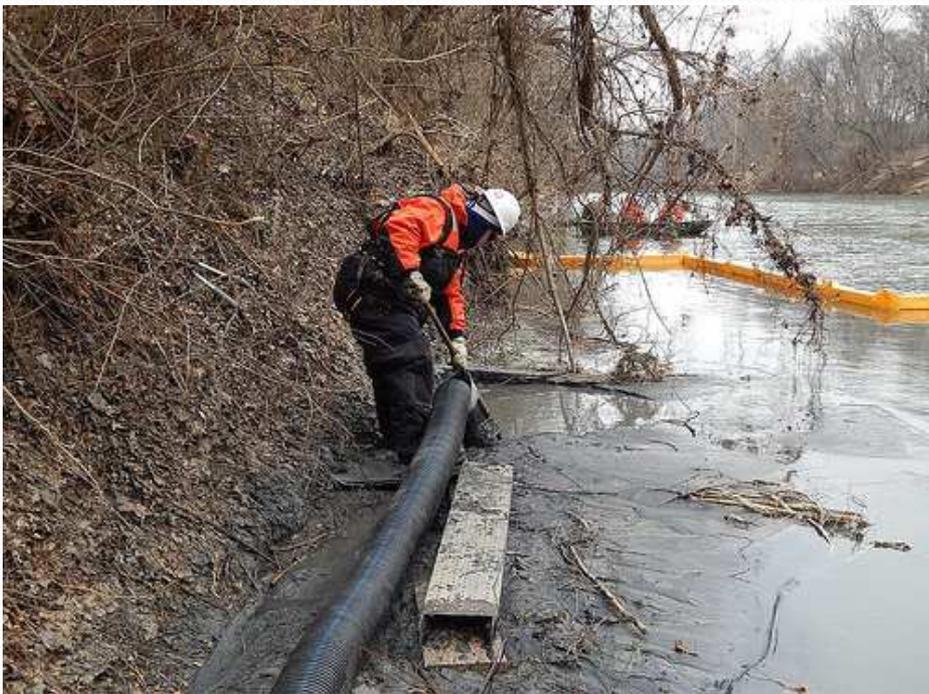
- Crews recovered coal ash deposit just below discharge.
- Ash recovery at two additional sites planned:
 - west of Schoolfield Dam
 - near Towns Creek, downstream of Eden, NC
- VA Health Dept. posted signs along Dan River advising limited contact with coal ash; adverse health effects not likely.

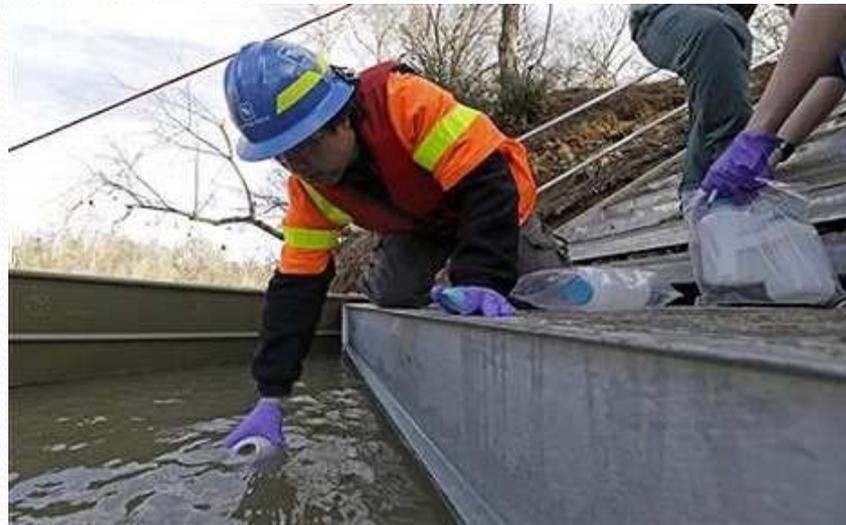
- 2/11 – VADEQ collected water and sediment samples at 4 sites from state line to halfway between Danville and South Boston.
- Samples analyzed for metals:
 - Water sample concentrations did not exceed VA Water Quality Standards.
 - No sediment levels above freshwater screening values.
- Preliminary review of all other Virginia water quality data collected by EPA contractor shows no exceedances of VA Water Quality Standards.

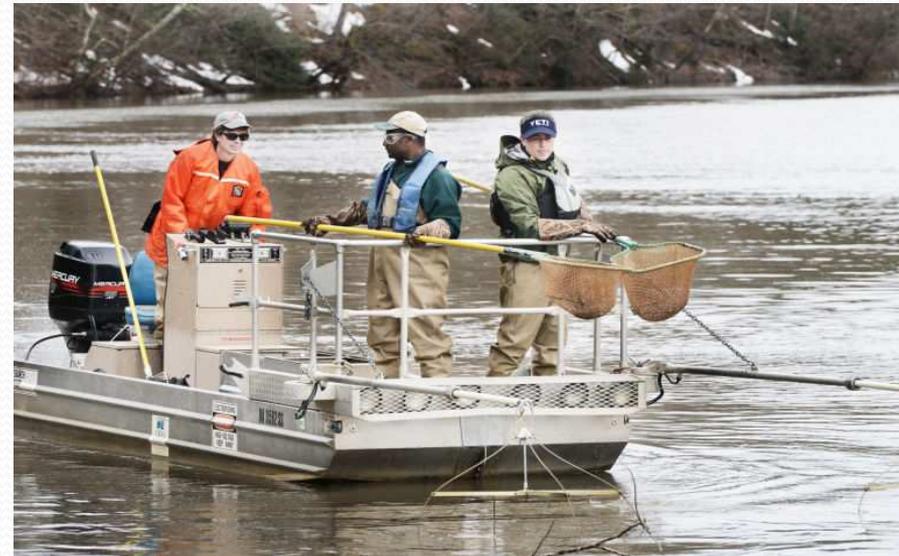
- 2/20 – fish collected upstream of Schoolfield Dam.
- 25 fish tissue samples analyzed for 23 metals:
 - Arsenic level not elevated; per VA Health Dept., no reason found to change current advisory.
 - Mercury concentration below VA Health Dept. level of concern.
 - Levels of other 21 metals either:
 - Below detection limit, or
 - Screening value not available
- Too soon for fish to take up recently spilled coal ash metals.

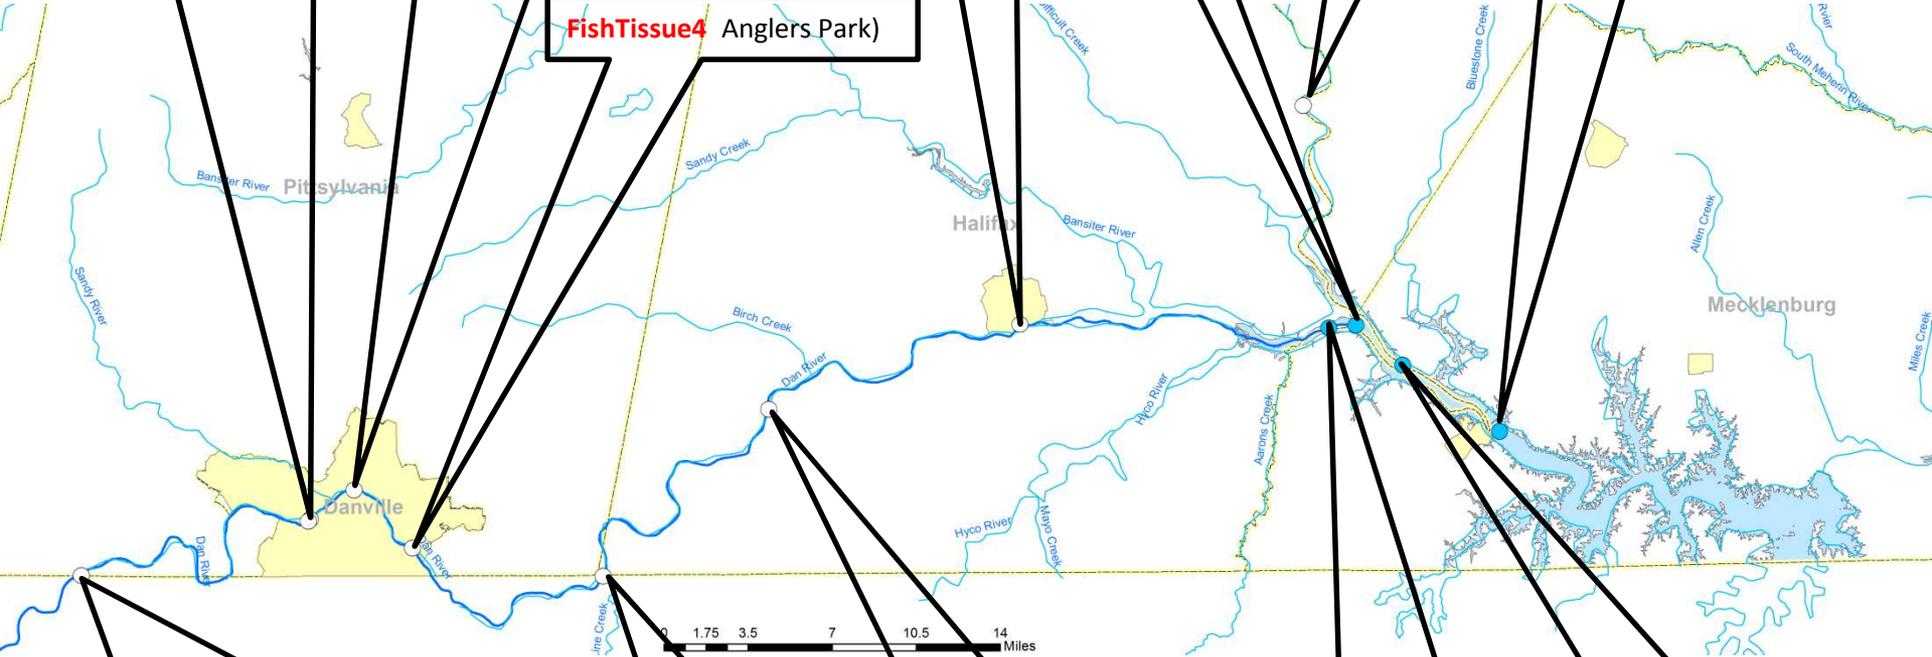
DEQ's Long-Term Monitoring Plan

4ADAN059.97/**FishTissue2** (Above Schoolfield Dam)
Monthly Metals in Water Column and Sediment

FishTissue3 (Union Street Dam)

FishTissue4 (Anglers Park)

FishTissue5 (South Boston)

FishTissue6
(Near State Park)

FishTissue8 (Clover, VA)
Control Site on Roanoke River

FishTissue7 (Clarksville Marina)

4ADAN075.22/**FishTissue1** (Rte. 880)
Monthly Metals in Water Column and Sediment
Boatable Probabilistic Site

4ADAN028.90 (Rte. 691)
Monthly Metals in Water Column and Sediment

4AROA043.14
(Lake Site April - October)
Monthly Metals in Water Column and Sediment

4ADAN042.80 (Rte. 62)
Monthly Metals in Water Column and Sediment
Boatable Probabilistic Site

4ADAN000.00 (**Lake Site April - October**)
Monthly Metals in Water Column and Sediment
