**York County, Virginia
Shoreline Inventory Report
Methods and Guidelines**

**Comprehensive Coastal Inventory Program
Center for Coastal Resources Management
Virginia Institute of Marine Science, College of William and Mary
Gloucester Point, Virginia**

Special report in Applied Marine Science and Ocean Engineering No. 415 of the Virginia Institute of Marine Science

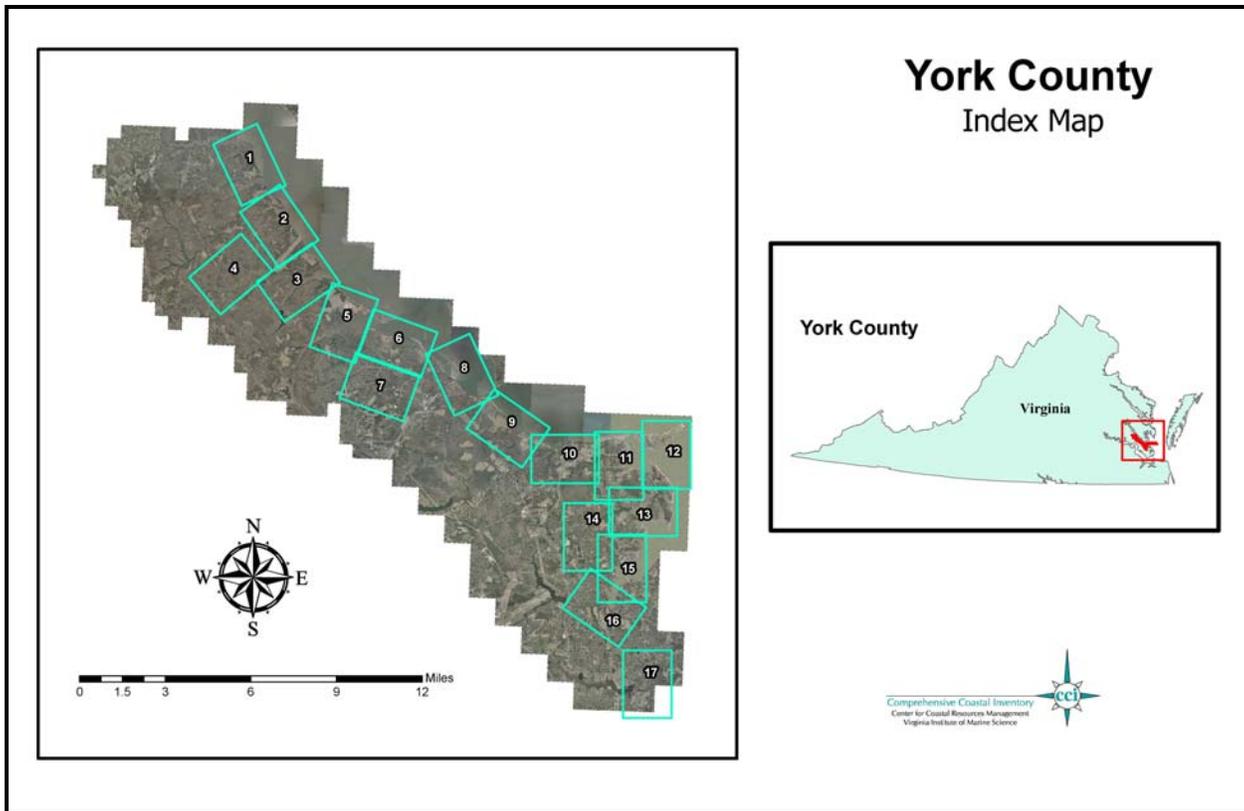
Figure 2. Map index for York County

For publication purposes the City is divided into a series of maps. Maps are scaled at 1:12,000 for publication at 11x17. Scale will vary if printed at a different size. There are 17 maps for York County; determined the county's geographic size and shape. For each map there are four plates (plate 1a, 1b, 1c, 1d, etc.), for a total of 68 map compositions. On the website (Figure 1), an index is provided to help users locate the area of interest and view the orientation of the maps to each other (Figure 2).

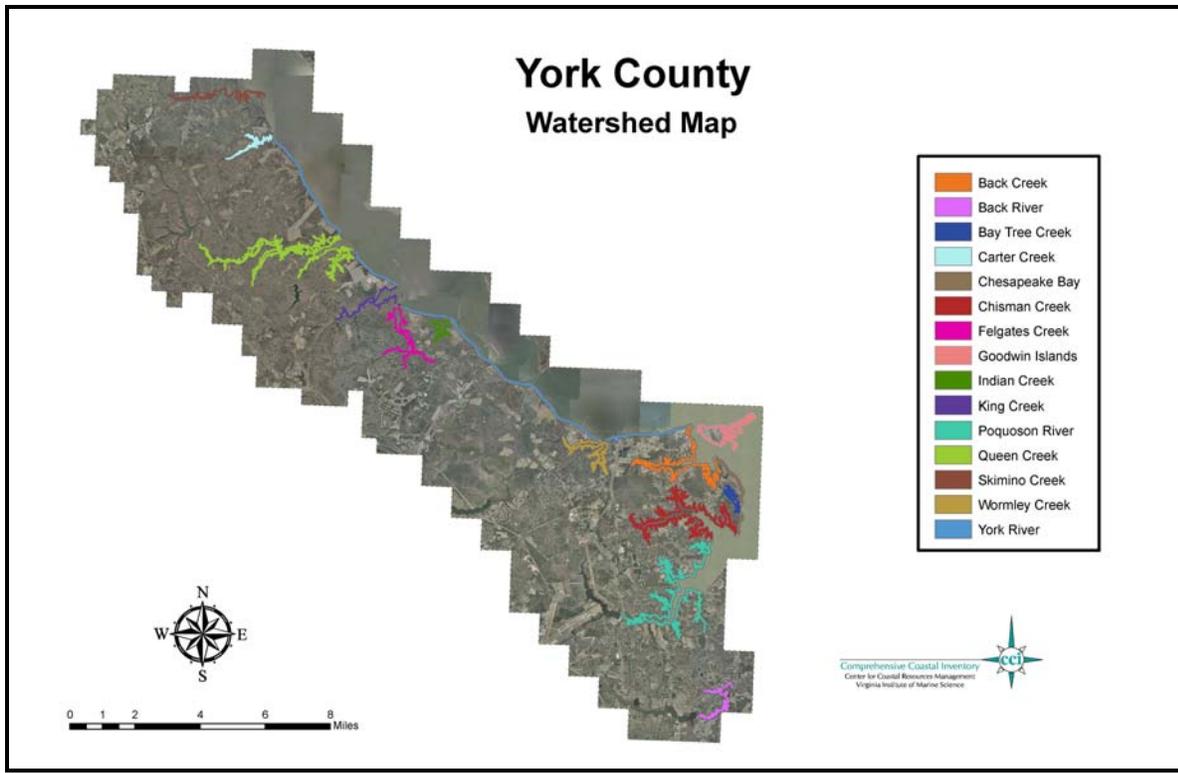
Figure 3. Delineation of county watersheds used for data reporting

Tables 4, 5, and 6 quantify features and conditions mapped along the rivers using frequency analysis techniques in ArcInfo. The values quantify features by river system (Figure 3). For linear features, values are reported in actual miles surveyed. Point features are enumerated. The total miles of shoreline surveyed for each tributary is reported. For the county, a total of 160.59 miles (258.44 km) were surveyed in the field. Approximately 71.13 miles (114.47 km) of shoreline were surveyed using remote sensing techniques. Figure 4 illustrates where field surveys were conducted and where remote sensing techniques were applied. The majority of these miles were places where navigation was restricted. Table 6 reports the survey dates, miles surveyed, and miles surveyed remotely.

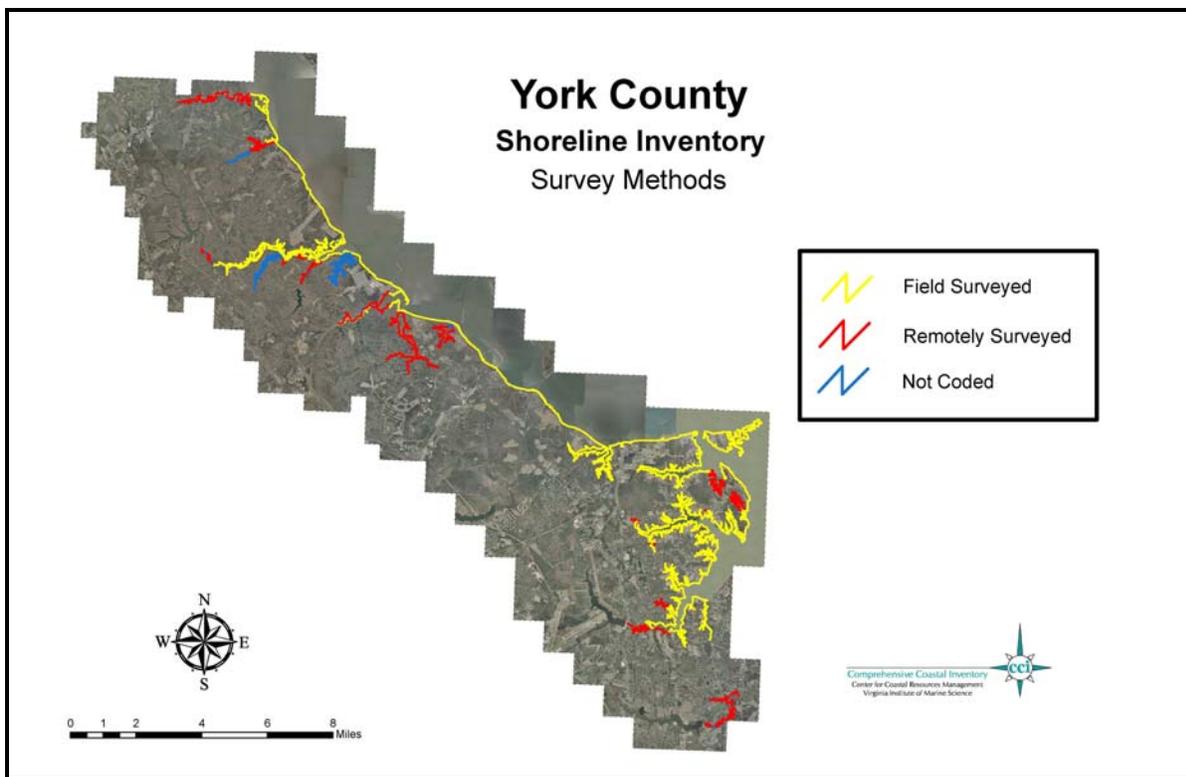
Figure 4. Location of field surveys and remotely sensed data collection.

Shoreline condition is described for York County along primary and secondary shoreline. Characteristics are described for all navigable tidal waterways contiguous to these shorelines. A total of 231.72 miles (372.91 km) of the total 246.55 miles of shoreline are described. Field surveys covered 160.59 miles (258.44 km) of shoreline. Remote sensing was used to code 71.13 miles (114.47 km) of shoreline in the county (Figure 4).

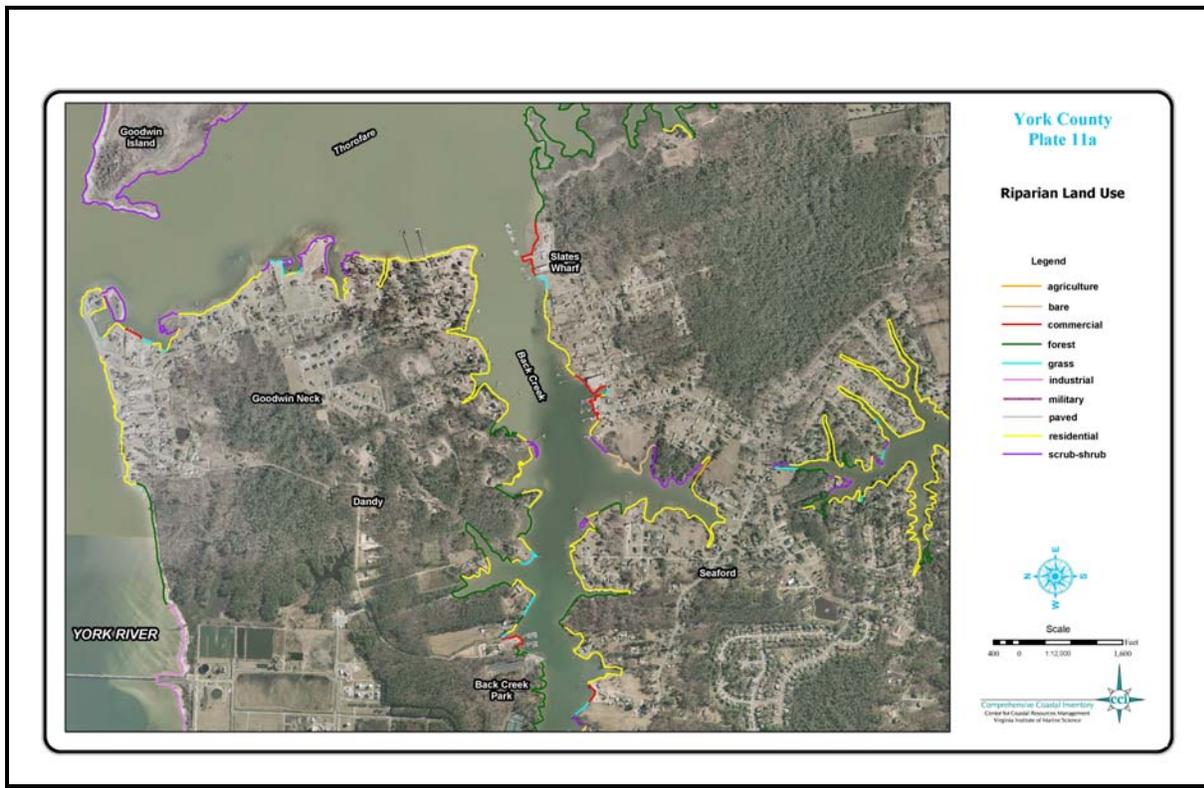
Figure 6. Sample riparian land use map for York County

Plate A describes the riparian land use as color-coded bars along the shore. The background imagery is natural color VBMP imagery at a publication scale of 1:12,000. Users should note that the imagery is sometime rotated in order to meet the scale requirements. This means that “north” is not always to the top of the page.

Once you determine which plate you want, the scroll down menu on the left has links to the four part series for each plate (Figure 5). At the top of the scroll bar Riparian Land Use (plate a) is first. You can scroll down to see links to maps illustrating Bank Conditions (plate b), Shoreline Features (plate c), and Natural Buffers (plate d). The content and details of the four part plate series was described in detail in Chapter 2. The actual map will come up when you click on the plate number. For example, Figure 6 is the riparian land use map for plate 11. Figure 7 is the map illustrating bank conditions for plate 11. Figure 8 shows all the shoreline features for that same area, and Figure 9 the natural buffers associated with that section.

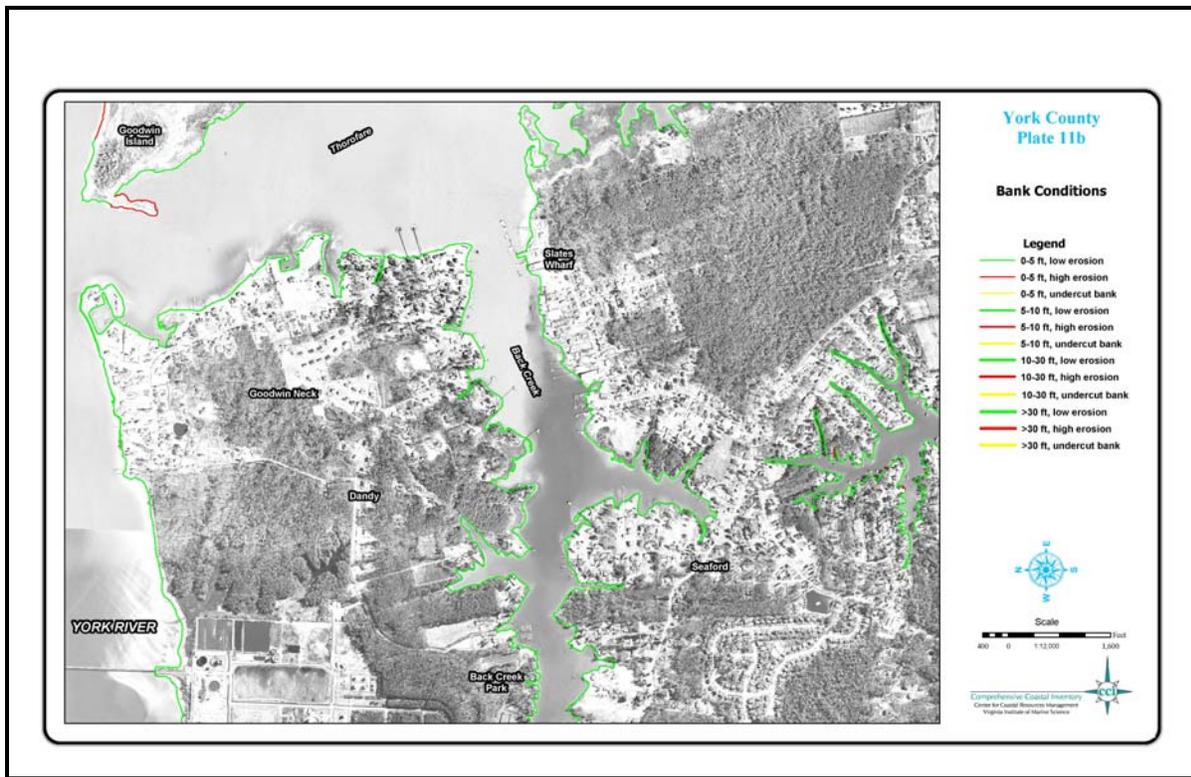
Figure 7. Map illustrating bank conditions for plate 11 in York County

Plate B depicts the condition of the bank; specifically bank stability, bank cover, and

bank height. The colors light green, red and yellow are used to report if the bank presents low erosion, high erosion, or undercut, respectively. The thickness of the line reflects the bank height; where the thickest lines designate the highest banks (> 30 feet). Plate B uses a grey scale version of the natural color image for the backdrop.

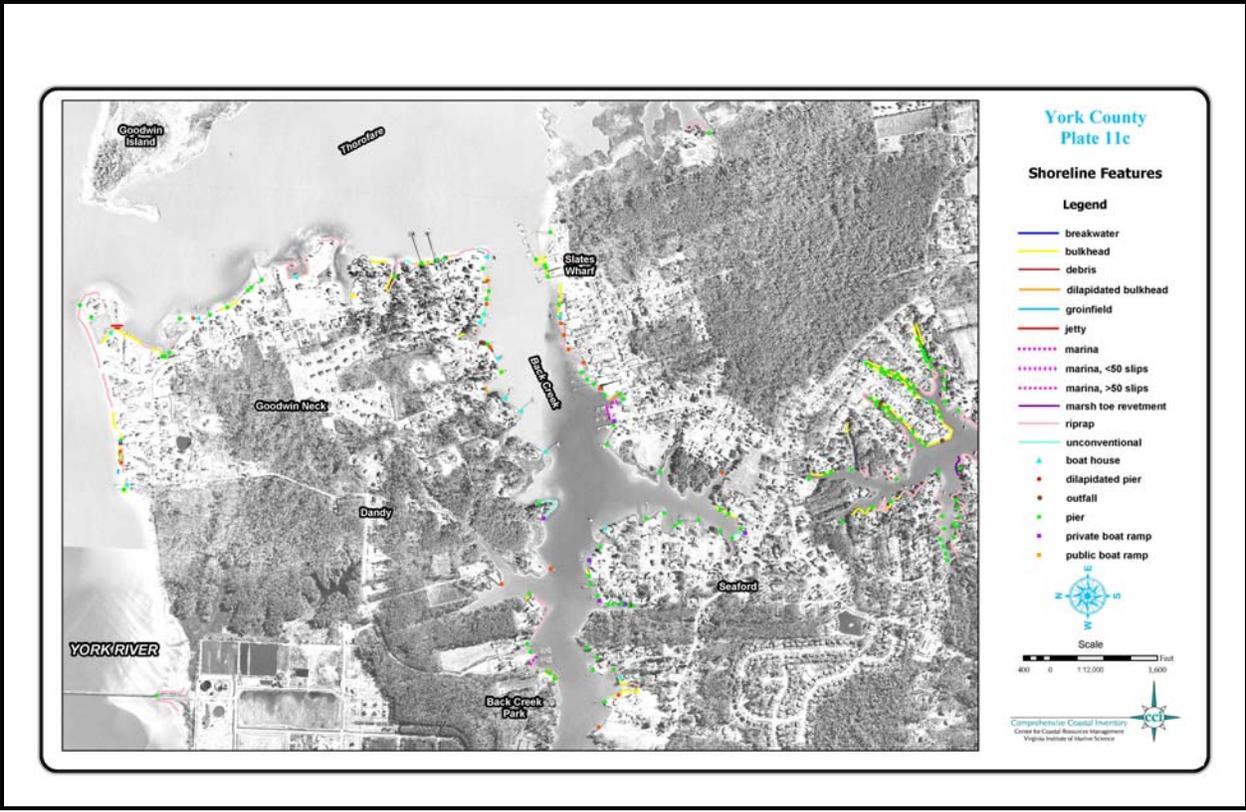
Figure 8. Map illustrating shoreline features for plate 11 in York County

Plate C combines recreational and shoreline protection structures in a composition called Shoreline Features. These are generally anthropogenic alterations constructed to gain access to the water or to stabilize a shoreline from existing and future bank erosion. Linear features, described previously (Table 3), are mapped using color coded bar symbols that follow the orientation of the shoreline. Point features use a combination of colors and symbols to plot the positions on the map. Gray scale imagery is used as a backdrop.

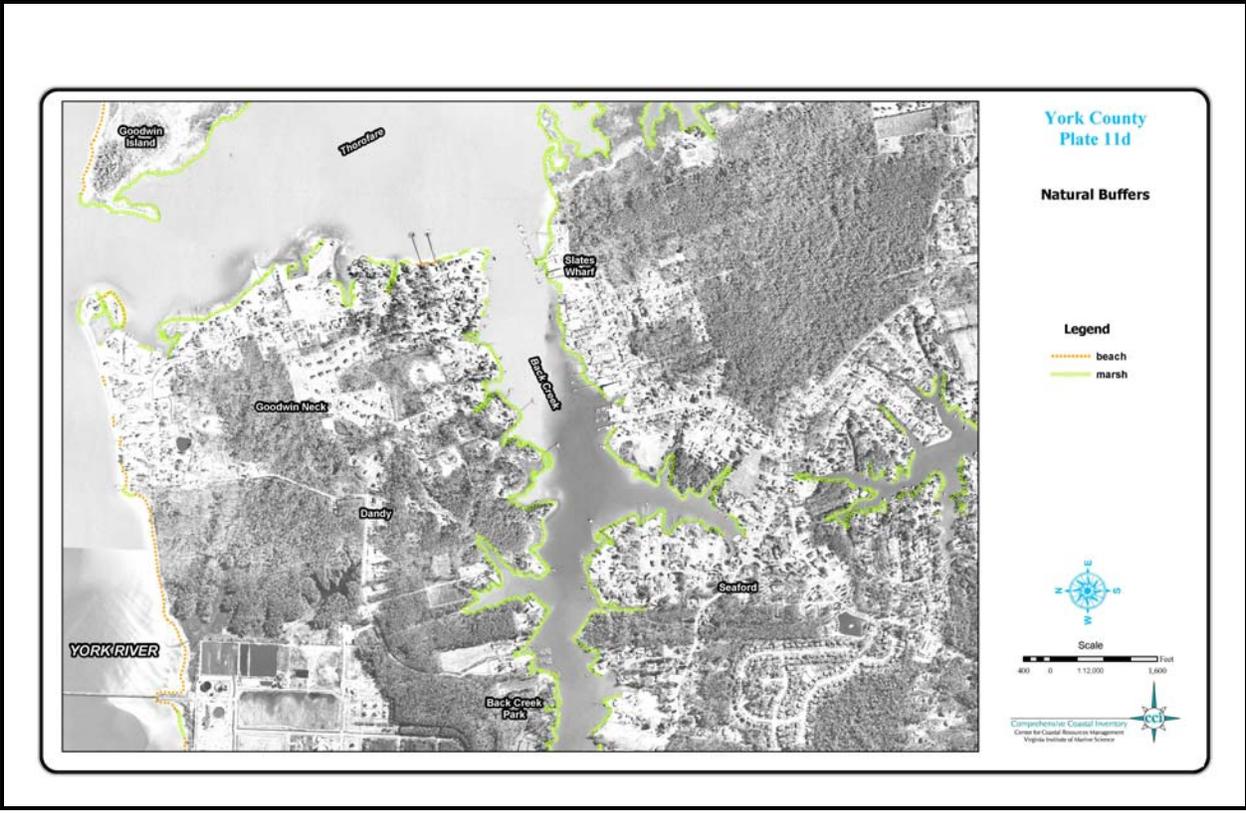
Figure 9. Map illustrating natural buffers for plate 11 in York County

On Plate D, a pattern of small colored circles along the shoreline describes any natural buffers present. These are limited to marshes and beaches. Orange solid circles represent the presence of beaches and green open circles represent marshes.
