COMPLAINT INSPECTION REPORT

Project Name:	Mountain Valley Pipeline	Inspector:	Marshall Willis
Inspection Date:	Monday, October 28, 2019	Project Contact:	Brian Clauto
Spread H: Montgomery County	STA 12175+00 – 12200+00 ATWS 703, ATWS 704A, ATWS 1446 & ATWS 1375 MVP-MN-275/274	Weather (Wet/Dry/Rain):	Wet

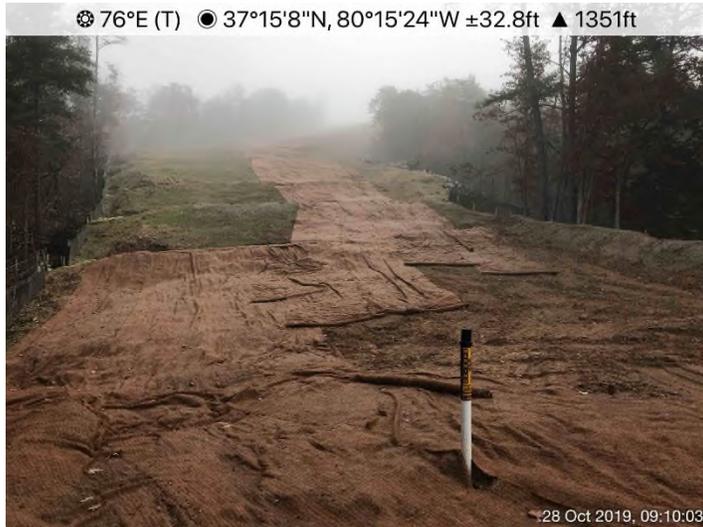
Fig. 1: STA 12201+00 – Controls in place and functioning. Area stabilized with erosion fabric and seed.

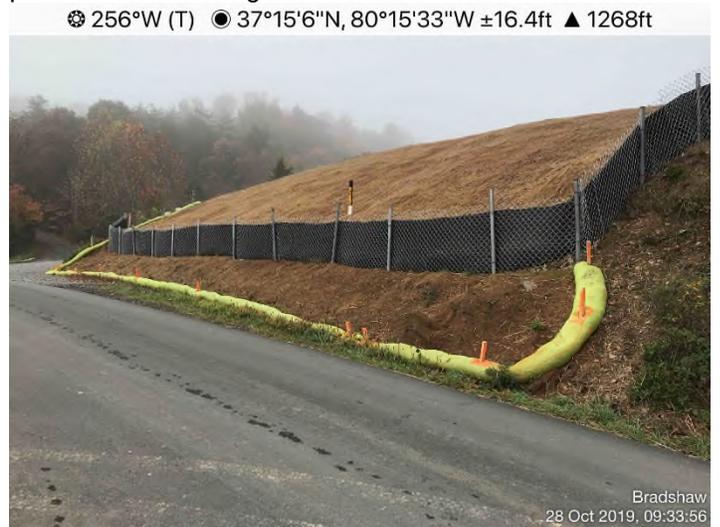
Fig. 2: STA 12190+75 – Bradshaw Road crossing. No evidence of sediment discharge from ROW. Controls in place and functioning.

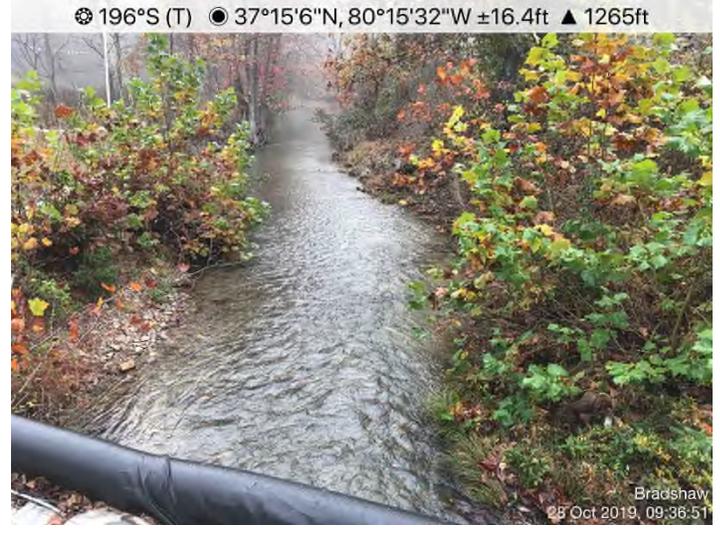
Fig. 4: Stream S-C21 – Looking downstream at Bradshaw Creek crossing. No evidence of sediment discharge from ROW. Controls in place and functioning.

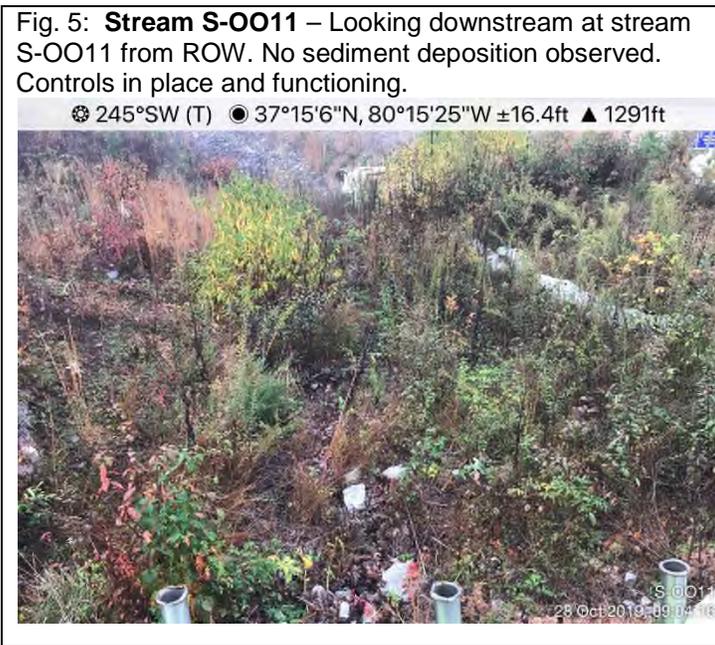
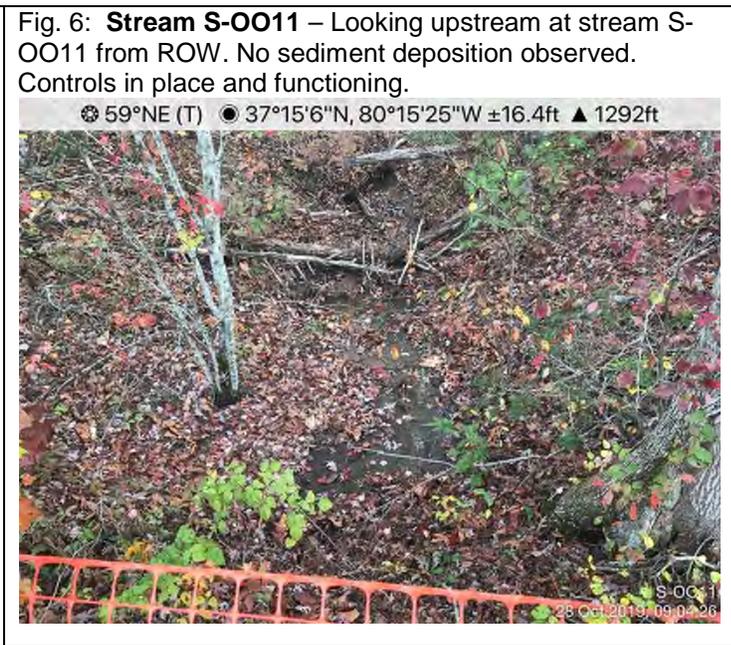
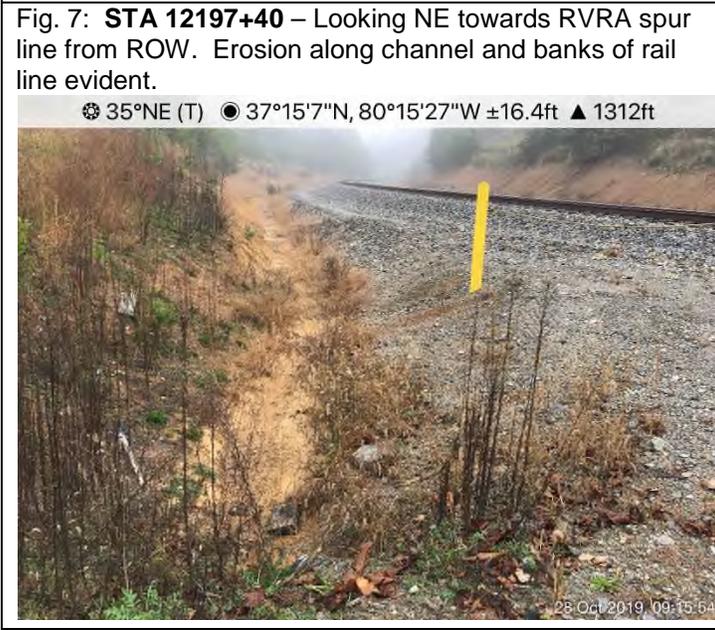
1. At the time of inspection, there was no evidence of sediment discharge from MVP ROW onto Bradshaw Road or into Bradshaw Creek. See Figures 2, 3, 4, 5 & 6.
2. ECDs within the MVP LOD and along the resources were installed per the approved plans and appeared to be functioning as designed. See Note #3.
3. One maintenance item was found at STA 12179+50 (see Figure 8). P1 Silt Fence was undermined at that location, however no sediment was discharged off ROW as a result.
4. There was no evidence of high turbidity upstream or downstream of the MVP crossing of Bradshaw Creek (S-C21). See Figures 3 & 4.
5. Erosion occurring along the Roanoke Valley Resource Authority (RVRA) spur line was documented during the inspection. Discharge from these channels flows through the MVP ROW and into S-OO11. See Figure 7.

Recommended Corrective Action: Maintain and install all controls per the approved plans and PSS&S.
