COMPLAINT INSPECTION REPORT

Project Name:	Mountain Valley Pipeline	Inspector:	John McCutcheon
Inspection Date:	Wednesday, July 25, 2018	Project Contact:	Brian Clauto, Tracy Hilbun
Spread:	Spread I	Weather (Wet/Dry/Rain):	Dry

PIPELINE SWPPP INSPECTION REPORT REQUEST FOR CORRECTIVE ACTION

FIELD INSPECTION PHOTO LOG

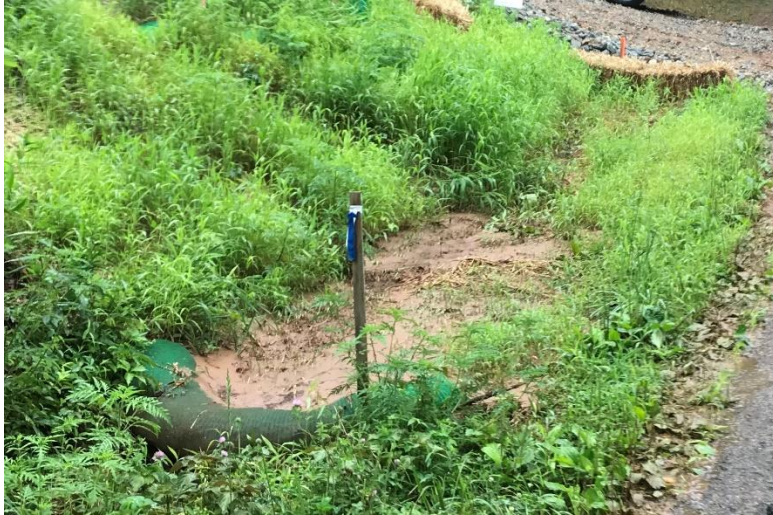
Comment 1.

1. Compost filter socks check dams in ditch on west side of Green Level Road are full of sediment and need maintenance.
2. Ditch between and below compost filter sock check dams contains sediment.

Compost filter sock check dam needs maintenance.

Comment #	Regulatory Citation/Legal requirement ¹	Observation/Recommended Corrective Action
1	(Va. Code §62.1-44.15:31) (MVP Standards & Specifications for VA, p. 1) (9VAC 25-840-60.A).	<p>Observation: Compost filter socks check dams in ditch on west side of Green Level Road are full of sediment and need maintenance</p> <p><u>Recommended Corrective Action:</u> <i>Clean out filter sock and stabilize if denuded channel as needed.</i></p>
2	(Va. Code §62.1-44.15:31) (MVP Standards & Specifications for VA, p. 1) (9VAC 25-880-70.II.G.2.)	<p>Observation: Ditch between and below compost filter sock check dams contains sediment.</p> <p><u>Recommended Corrective Action:</u> <i>Clean out accumulated sediment in ditch to Teels Creek.. Stabilize denuded areas as needed</i></p>

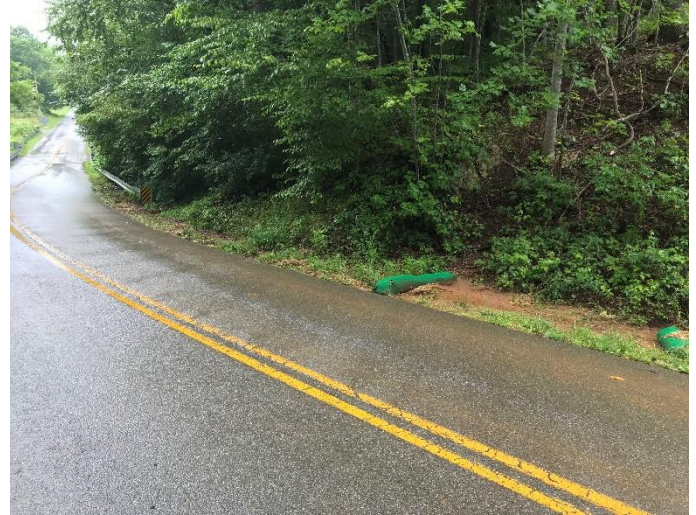
Comments 2.

Filter sock check dam loaded with sediment. Sediment in roadside ditch to Teels Creek.
