FIELD INSPECTION

Project Name:	Mountain Valley Pipeline	Inspector:	Matthew Grant
Inspection Date:	Wednesday, July 18, 2018	Project Contact:	Brian Clauto
Spread: Locations in Spread I inspected included MP 273.56-273.95, MP 277.26-278, MP 259.4 -259.56	Spread I	Weather (Wet/Dry/Rain):	Dry

FIELD INSPECTION PHOTO LOG

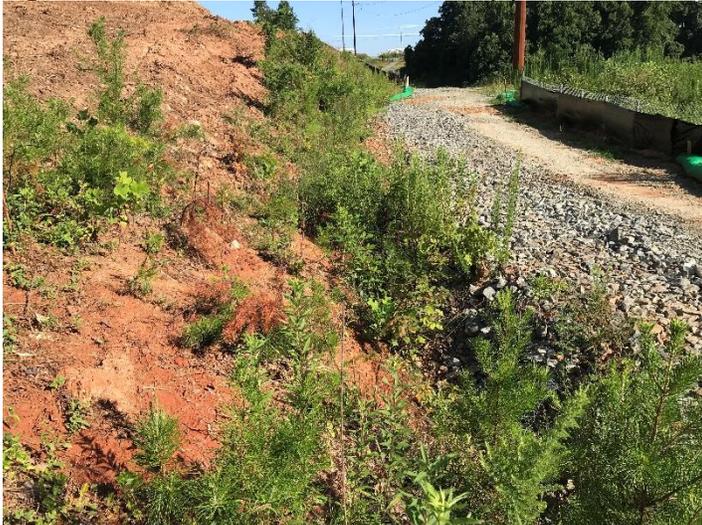
Area 1 - Spread I, near MP 273 at station 14461+02 culvert pipe is not protected

Fig. 1 near station 14461+02 culvert inlet pipe

Recommended Corrective Action: protect culvert inlet pipe

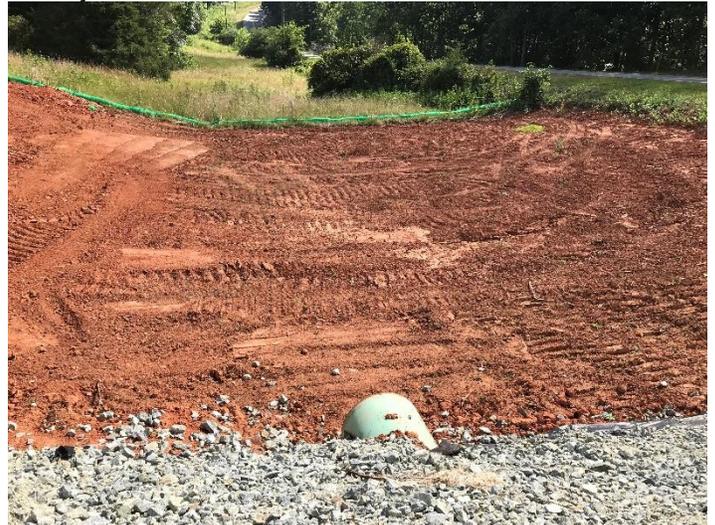
Area 2 - Spread I, near MP 277 at station 14649+00 culvert pipe under construction entrance lacks outlet protection and conveyance channel below pipe lacks stabilization.

Fig. 2 near station 1469+00 culvert pipe outlet and conveyance channel

Recommended Corrective Action: protect outlet and stabilize conveyance channel

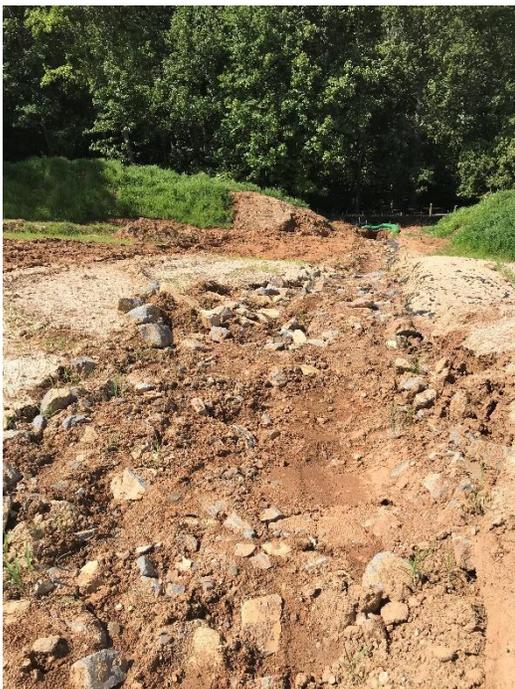
Area 3 - Spread I, near MP 259.4 to MP 259.3 conveyance channels below water bars has escaped sediment in channel.

Fig. 3 near MP 259.4 rock conveyance channel

Recommended Corrective Action: Clean conveyance channel and stabilize associated areas near channel

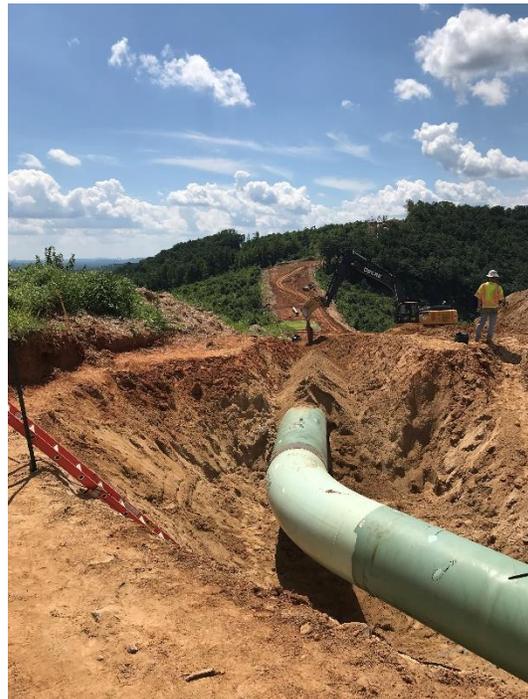
Area 4 - Spread I, near MP 254.4 to MP 254.5 areas where the pipe has been trenched and backfilled lacks stabilization.

Fig. 4 backfilling of trench is ongoing near MP 254.5

Recommended Corrective Action: Stabilize areas where backfilling has occurred and completed
